## Profile/Photo Observation Report

Street:	<b>W 40th ave</b>	Flow Control:	<b>Not Controlled</b>
City:	<b>Hobart, IN</b>	Year Renewed:	
Location:	<b>Other</b>	Tape/Media #:	
Purpose:	<b>Not Known</b>	Dia/Height:	<b>8"</b>
Use:	<b>Sanitary</b>	Material:	<b>PVC</b>
Drain Area:	<b>NA</b>	Lining:	
Category:	<b>NA</b>		
Comment:

Location Details:		Direction of Survey:	<b>Downstream</b>
US MH:	<b>M-703-022</b>	DS MH:	<b>M-703-026</b>
		Total Length Surveyed (ft):	<b>152.9</b>

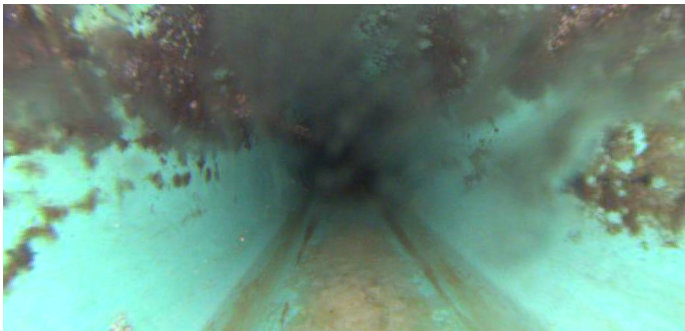
Code: **AMH**  
Description: **Manhole**

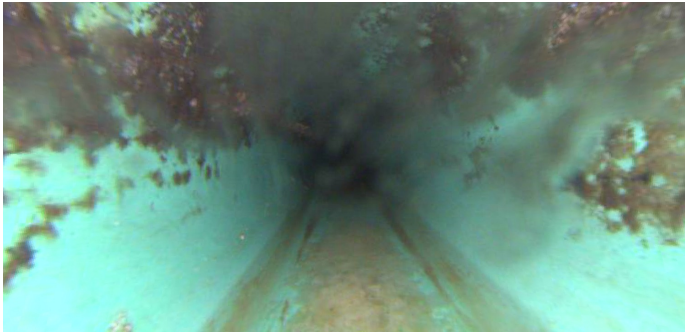
Code:	<b>MWL</b>
Description:	<b>Water Level</b>

Distance (ft):	<b>.0</b>
Structural Grade:	<b>0</b>
O&M Grade:	<b>0</b>
Clock Start/From:	
Clock To:	
1st Value:	
2nd Value:	
Value Percent:	<b>5.000</b>
Continuous Index:	
Within 8" of Joint:	<b>NO</b>
Remarks:

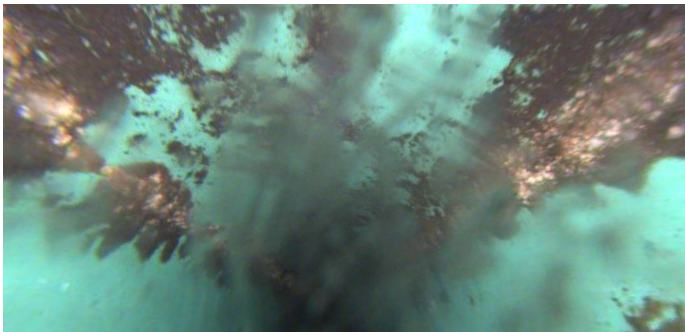
Code:	<b>DAGS</b>
Description:	<b>Deposits Attached Grease</b>

Distance (ft):	<b>2.0</b>
Structural Grade:	<b>0</b>
O&M Grade:	<b>2</b>
Clock Start/From:	<b>10</b>
Clock To:	<b>2</b>
1st Value:	
2nd Value:	
Value Percent:	<b>5.000</b>
Continuous Index:	<b>S01</b>
Within 8" of Joint:	<b>NO</b>
Remarks:

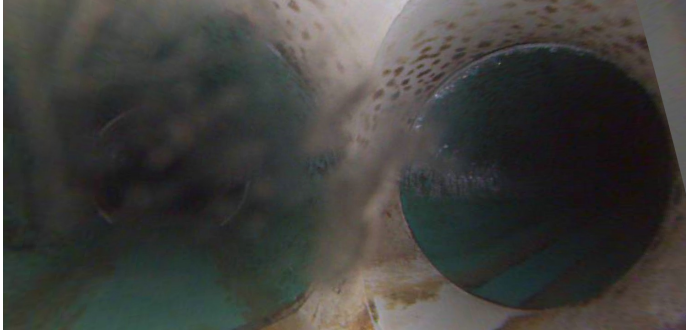
Code: **TF**  
Description: **Tap Factory**

Distance (ft): **109.1**  
Structural Grade: **0**  
O&M Grade: **0**  
Clock Start/From: **3**  
Clock To:  
1st Value: **4.000**  
2nd Value:  
Value Percent:  
Continuous Index:  
Within 8" of Joint:  
Remarks:

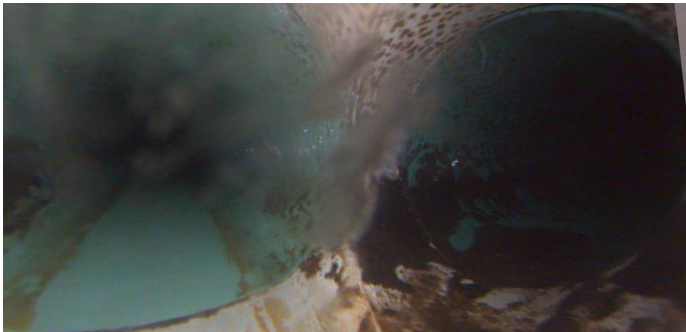
Code: **TF**  
Description: **Tap Factory**

Distance (ft): **110.8**  
Structural Grade: **0**  
O&M Grade: **0**  
Clock Start/From: **3**  
Clock To:  
1st Value: **4.000**  
2nd Value:  
Value Percent:  
Continuous Index:  
Within 8" of Joint:  
Remarks:

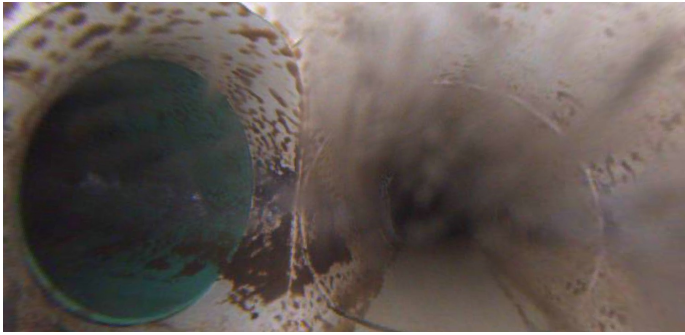
Code: **TF**  
Description: **Tap Factory**

Distance (ft): **119.3**  
Structural Grade: **0**  
O&M Grade: **0**  
Clock Start/From: **9**  
Clock To:  
1st Value: **4.000**  
2nd Value:  
Value Percent:  
Continuous Index:  
Within 8" of Joint:  
Remarks:

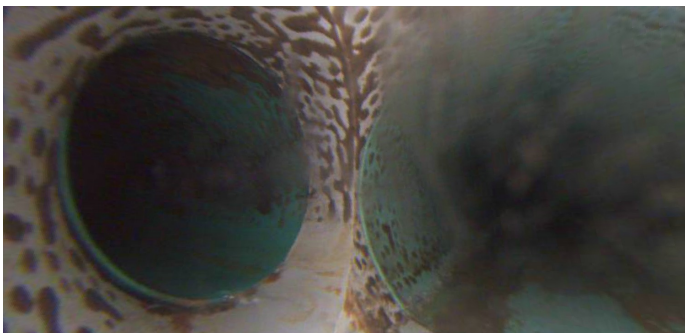
Code: **TF**  
Description: **Tap Factory**

Distance (ft): **121.1**  
Structural Grade: **0**  
O&M Grade: **0**  
Clock Start/From: **9**  
Clock To:  
1st Value: **4.000**  
2nd Value:  
Value Percent:  
Continuous Index:  
Within 8" of Joint:  
Remarks:

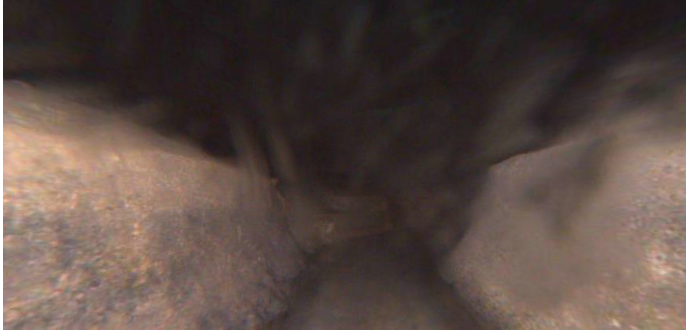
Code: **DAGS**  
Description: **Deposits Attached Grease**

Distance (ft): **151.1**  
Structural Grade: **0**  
O&M Grade: **2**  
Clock Start/From: **10**  
Clock To: **2**  
1st Value:  
2nd Value:  
Value Percent: **5.000**  
Continuous Index: **F01**  
Within 8" of Joint: **NO**  
Remarks:

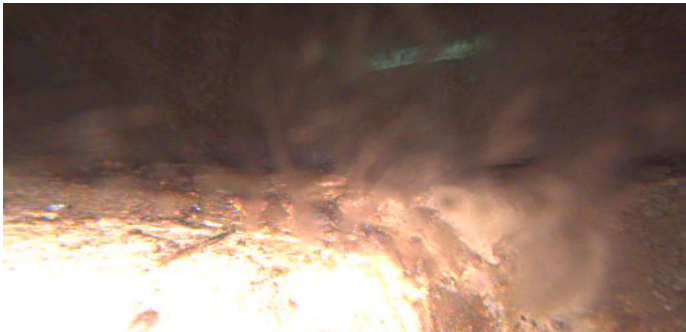
Code: **AMH**  
Description: **Manhole**

Distance (ft): **152.9**  
Structural Grade: **0**  
O&M Grade: **0**  
Clock Start/From:  
Clock To:  
1st Value:  
2nd Value:  
Value Percent:  
Continuous Index:  
Within 8" of Joint: **NO**  
Remarks: **M-703-026**
