## Profile/Photo Observation Report

Street:	<b>Summerlin</b>	Flow Control:	<b>Not Controlled</b>
City:	<b>Hobart, IN</b>	Year Renewed:	
Location:	<b>Light Highway</b>	Tape/Media #:	
Purpose:	<b>Not Known</b>	Dia/Height:	<b>8"</b>
Use:	<b>Sanitary</b>	Material:	<b>PVC</b>
Drain Area:	<b>NA</b>	Lining:	
Category:	<b>NA</b>		
Comment:

Location Details:		Direction of Survey:	<b>Downstream</b>
US MH:	<b>M-703-023</b>	DS MH:	<b>M-703-024</b>
		Total Length Surveyed (ft):	<b>180.8</b>

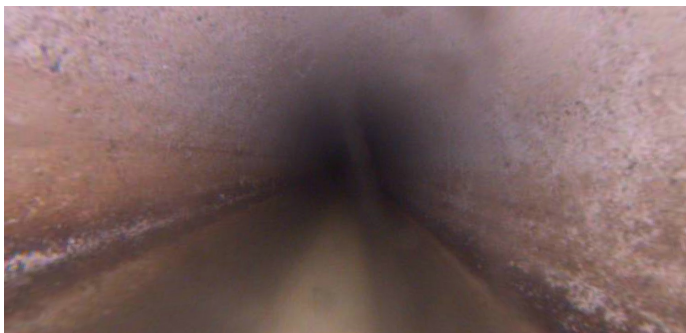
Code: **AMH**  
Description: **Manhole**

Distance (ft): **.0**  
Structural Grade: **0**  
O&M Grade: **0**  
Clock Start/From:  
Clock To:  
1st Value:  
2nd Value:  
Value Percent:  
Continuous Index:  
Within 8" of Joint: **NO**  
Remarks: **M-703-023**

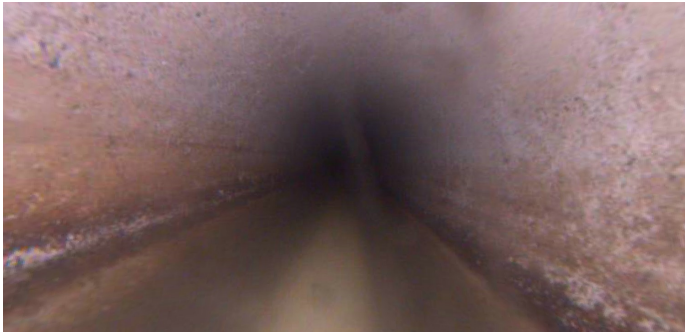
Code:	<b>MWL</b>
Description:	<b>Water Level</b>

Distance (ft):	<b>.0</b>
Structural Grade:	<b>0</b>
O&M Grade:	<b>0</b>
Clock Start/From:	
Clock To:	
1st Value:	
2nd Value:	
Value Percent:	<b>10.000</b>
Continuous Index:	
Within 8" of Joint:	<b>NO</b>
Remarks:

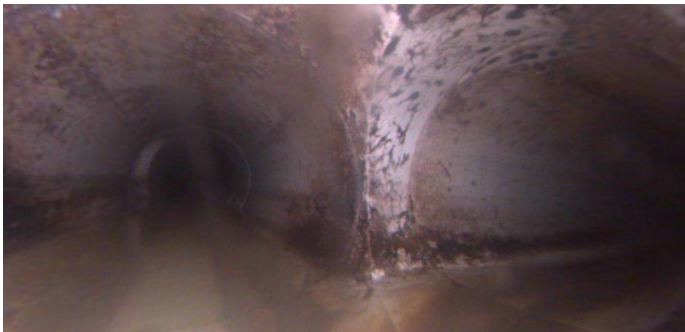
Code:	<b>TF</b>
Description:	<b>Tap Factory</b>

Distance (ft):	<b>86.6</b>
Structural Grade:	<b>0</b>
O&M Grade:	<b>0</b>
Clock Start/From:	<b>4</b>
Clock To:	
1st Value:	<b>4.000</b>
2nd Value:	
Value Percent:	
Continuous Index:	
Within 8" of Joint:	
Remarks:

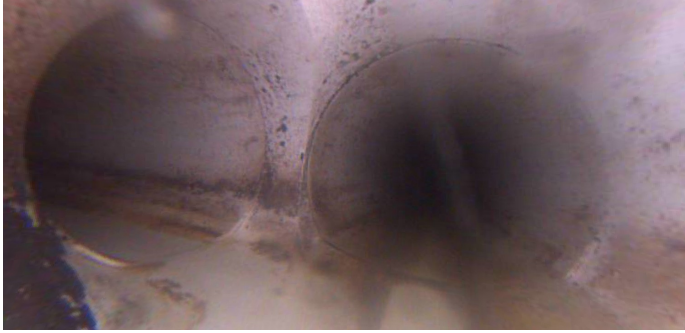
Code: **TF**  
Description: **Tap Factory**

Distance (ft): **88.7**  
Structural Grade: **0**  
O&M Grade: **0**  
Clock Start/From: **8**  
Clock To:  
1st Value: **4.000**  
2nd Value:  
Value Percent:  
Continuous Index:  
Within 8" of Joint:  
Remarks:

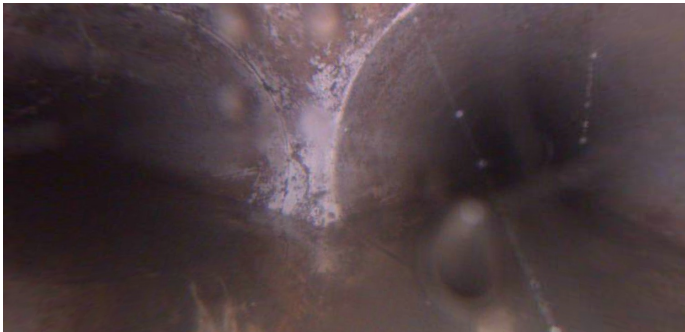
Code: **TF**  
Description: **Tap Factory**

Distance (ft): **161.6**  
Structural Grade: **0**  
O&M Grade: **0**  
Clock Start/From: **8**  
Clock To:  
1st Value: **4.000**  
2nd Value:  
Value Percent:  
Continuous Index:  
Within 8" of Joint:  
Remarks:

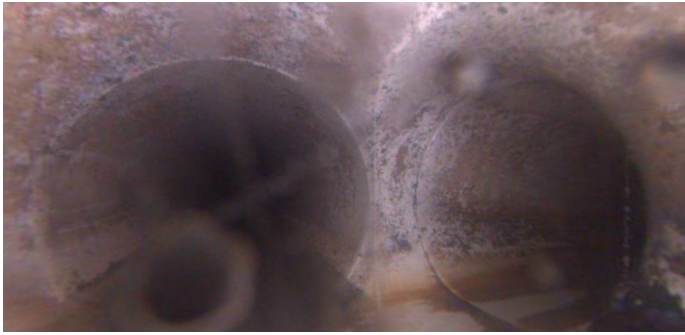
Code: **TF**  
Description: **Tap Factory**

Distance (ft): **165.3**  
Structural Grade: **0**  
O&M Grade: **0**  
Clock Start/From: **4**  
Clock To:  
1st Value: **4.000**  
2nd Value:  
Value Percent:  
Continuous Index:  
Within 8" of Joint:  
Remarks:

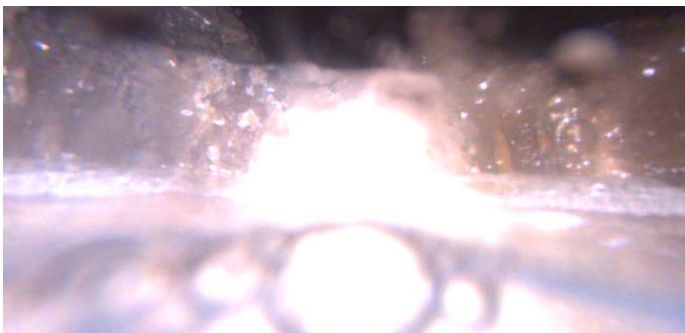
Code: **AMH**  
Description: **Manhole**

Distance (ft): **180.8**  
Structural Grade: **0**  
O&M Grade: **0**  
Clock Start/From:  
Clock To:  
1st Value:  
2nd Value:  
Value Percent:  
Continuous Index:  
Within 8" of Joint: **NO**  
Remarks: **M-703-024**
