Profile/Photo Observation Report

Date:	04/12/2018	Weather:		Coding:	PACP 6.0
Pipe Length (ft):	294.4	Owner:	NA	Pre Clean:	Not Known
P.O.#:		Surveyor:	Jen Costello	PSR:	P-703-025-023
Customer:		Clean Date:	01/01/1900	Shape:	C

Street:	W 40th ave	Flow Control:	Not Controlled
City:	Hobart, IN	Year Renewed:	
Location:	Other	Tape/Media #:	
Purpose:	Not Known	Dia/Height:	8"
Use:	Sanitary	Material:	PVC
Drain Area:	NA	Lining:	
Category:	NA		
Comment:

Location Details:		Direction of Survey:	Downstream
US MH:	M-703-023	DS MH:	M-703-025
		Total Length Surveyed (ft):	301.1

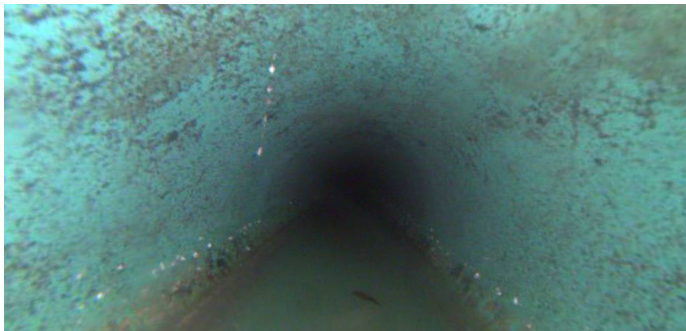
Code: **AMH**
Description: **Manhole**

Distance (ft): **.0**
Structural Grade: **0**
O&M Grade: **0**
Clock Start/From:
Clock To:
1st Value:
2nd Value:
Value Percent:
Continuous Index:
Within 8" of Joint: **NO**
Remarks: **M-703-023**

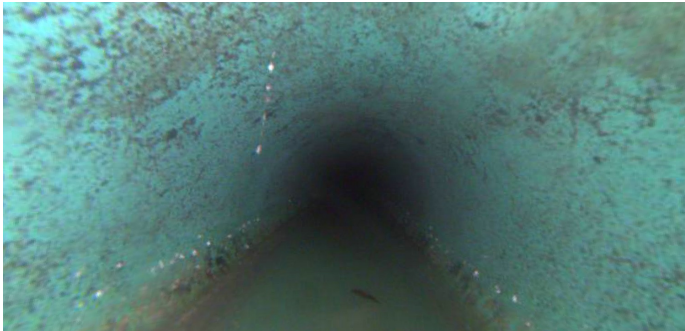
Code:	MWL
Description:	Water Level

Distance (ft):	.0
Structural Grade:	0
O&M Grade:	0
Clock Start/From:	
Clock To:	
1st Value:	
2nd Value:	
Value Percent:	10.000
Continuous Index:	
Within 8" of Joint:	NO
Remarks:

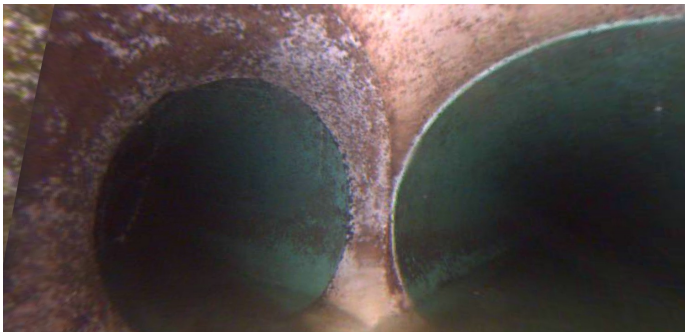
Code:	TFA
Description:	Tap Factory Active

Distance (ft):	39.7
Structural Grade:	0
O&M Grade:	0
Clock Start/From:	9
Clock To:	
1st Value:	4.000
2nd Value:	
Value Percent:	
Continuous Index:	
Within 8" of Joint:	
Remarks:

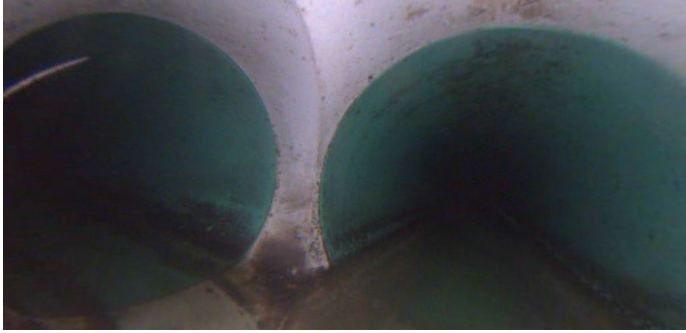
Code: **TFA**
Description: **Tap Factory Active**

Distance (ft): **100.1**
Structural Grade: **0**
O&M Grade: **0**
Clock Start/From: **9**
Clock To:
1st Value: **4.000**
2nd Value:
Value Percent:
Continuous Index:
Within 8" of Joint:
Remarks:

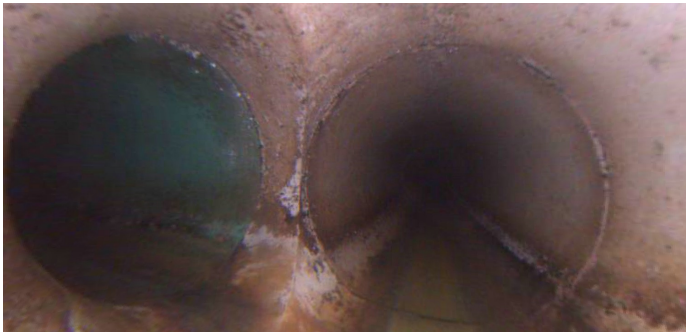
Code: **TFA**
Description: **Tap Factory Active**

Distance (ft): **185.4**
Structural Grade: **0**
O&M Grade: **0**
Clock Start/From: **9**
Clock To:
1st Value: **4.000**
2nd Value:
Value Percent:
Continuous Index:
Within 8" of Joint:
Remarks:

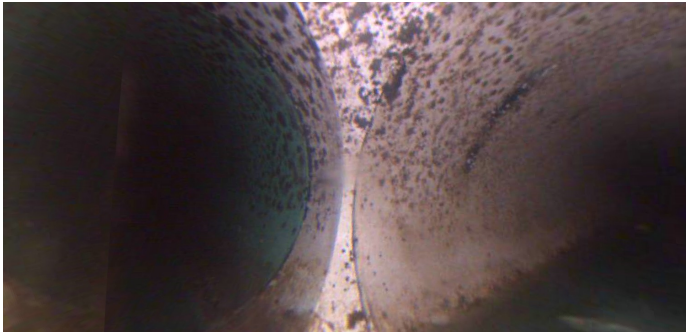
Code: **TF**
Description: **Tap Factory**

Distance (ft): **255.4**
Structural Grade: **0**
O&M Grade: **0**
Clock Start/From: **9**
Clock To:
1st Value: **4.000**
2nd Value:
Value Percent:
Continuous Index:
Within 8" of Joint:
Remarks:

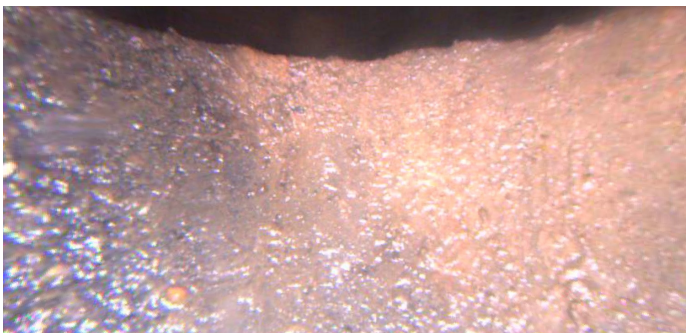
Code: **AMH**
Description: **Manhole**

Distance (ft): **301.1**
Structural Grade: **0**
O&M Grade: **0**
Clock Start/From:
Clock To:
1st Value:
2nd Value:
Value Percent:
Continuous Index:
Within 8" of Joint: **NO**
Remarks: **M-703-025**
