Profile/Photo Observation Report

Street:	MANOR DR	Flow Control:	Not Controlled
City:	Hobart, IN	Year Renewed:	
Location:	Other	Tape/Media #:	
Purpose:	Not Known	Dia/Height:	8"
Use:	Sanitary	Material:	PVC
Drain Area:	NA	Lining:	
Category:	NA		
Comment:

Location Details:		Direction of Survey:	Downstream
US MH:	M-703-029	DS MH:	M-703-028
		Total Length Surveyed (ft):	60.7

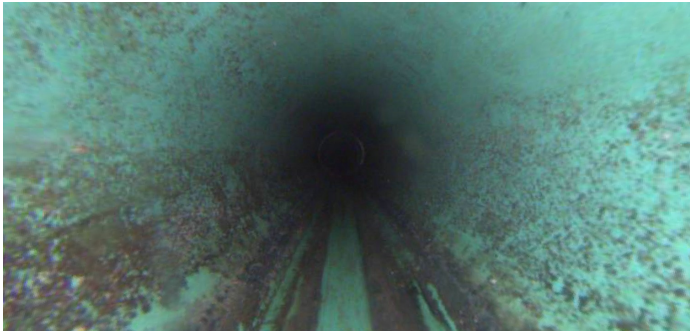
.0	AMH	Manhole	10	NA
	.0	MWL	Water Level	21	NA
	5.6	TF	Tap Factory	45	NA
	7.4	TF	Tap Factory	61	NA
	60.7	AMH	Manhole	180	NA
<div> <div> <div>Code:</div> <div>AMH</div> </div> <div> <div>Description:</div> <div>Manhole</div> </div> </div> <div>

<div> <div>Distance (ft):</div> <div>.0</div> </div> <div> <div>Structural Grade:</div> <div>0</div> </div> <div> <div>O&M Grade:</div> <div>0</div> </div> <div> <div>Clock Start/From:</div> <div></div> </div> <div> <div>Clock To:</div> <div></div> </div> <div> <div>1st Value:</div> <div></div> </div> <div> <div>2nd Value:</div> <div></div> </div> <div> <div>Value Percent:</div> <div></div> </div> <div> <div>Continuous Index:</div> <div></div> </div> <div> <div>Within 8" of Joint:</div> <div>NO</div> </div> <div> <div>Remarks:</div> <div>M-703-029</div> </div> </div>

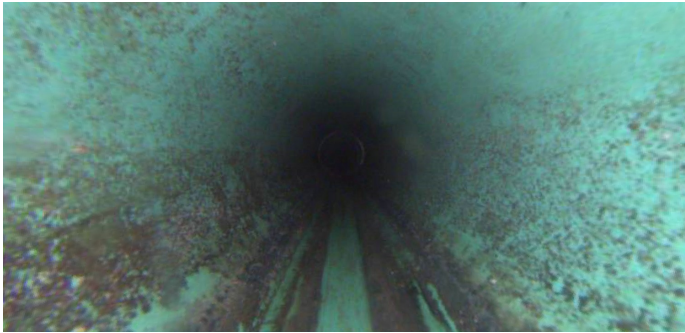
Code:	MWL
Description:	Water Level

Distance (ft):	.0
Structural Grade:	0
O&M Grade:	0
Clock Start/From:	
Clock To:	
1st Value:	
2nd Value:	
Value Percent:	5.000
Continuous Index:	
Within 8" of Joint:	NO
Remarks:

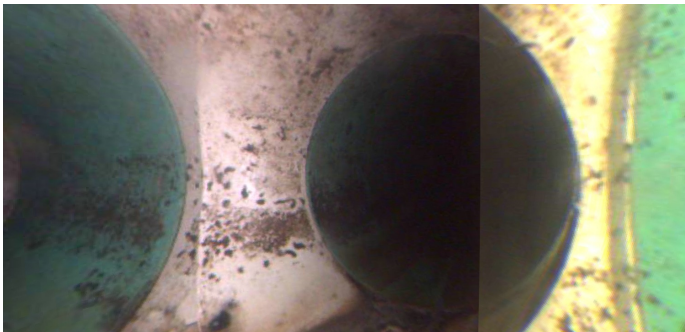
Code:	TF
Description:	Tap Factory

Distance (ft):	5.6
Structural Grade:	0
O&M Grade:	0
Clock Start/From:	3
Clock To:	
1st Value:	4.000
2nd Value:	
Value Percent:	
Continuous Index:	
Within 8" of Joint:	
Remarks:

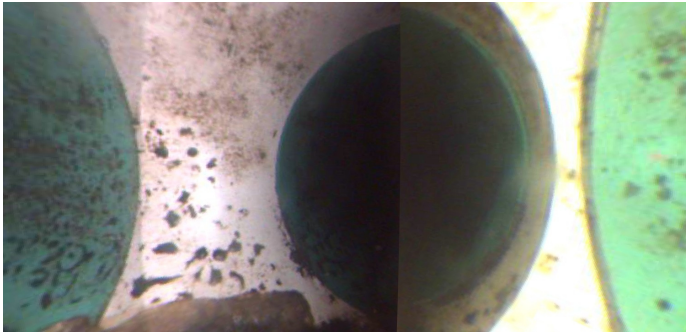
Code: **TF**
Description: **Tap Factory**

Distance (ft): **7.4**
Structural Grade: **0**
O&M Grade: **0**
Clock Start/From: **3**
Clock To:
1st Value: **4.000**
2nd Value:
Value Percent:
Continuous Index:
Within 8" of Joint:
Remarks:

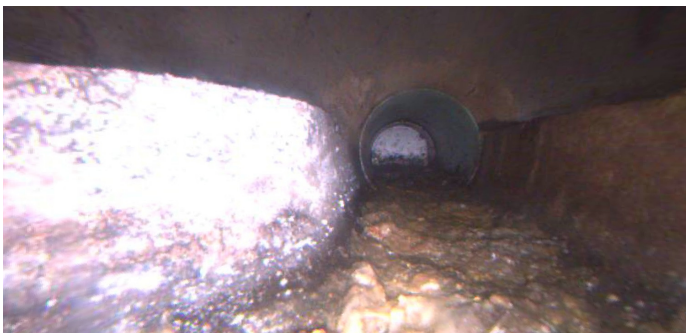
Code: **AMH**
Description: **Manhole**

Distance (ft): **60.7**
Structural Grade: **0**
O&M Grade: **0**
Clock Start/From:
Clock To:
1st Value:
2nd Value:
Value Percent:
Continuous Index:
Within 8" of Joint: **NO**
Remarks: **M-703-028**
