## Profile/Photo Observation Report

Street:	<b>W 40th ave</b>	Flow Control:	<b>Not Controlled</b>
City:	<b>Hobart, IN</b>	Year Renewed:	
Location:	<b>Other</b>	Tape/Media #:	
Purpose:	<b>Not Known</b>	Dia/Height:	<b>8"</b>
Use:	<b>Sanitary</b>	Material:	<b>PVC</b>
Drain Area:	<b>NA</b>	Lining:	
Category:	<b>NA</b>		
Comment:

Location Details:		Direction of Survey:	<b>Downstream</b>
US MH:	<b>M-703-029</b>	DS MH:	<b>M-703-028</b>
		Total Length Surveyed (ft):	<b>60.7</b>

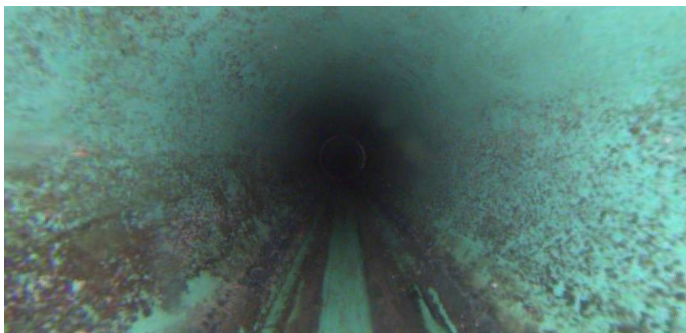
Code: **AMH**  
Description: **Manhole**

Distance (ft): **.0**  
Structural Grade: **0**  
O&M Grade: **0**  
Clock Start/From:  
Clock To:  
1st Value:  
2nd Value:  
Value Percent:  
Continuous Index:  
Within 8" of Joint: **NO**  
Remarks: **M-703-029**

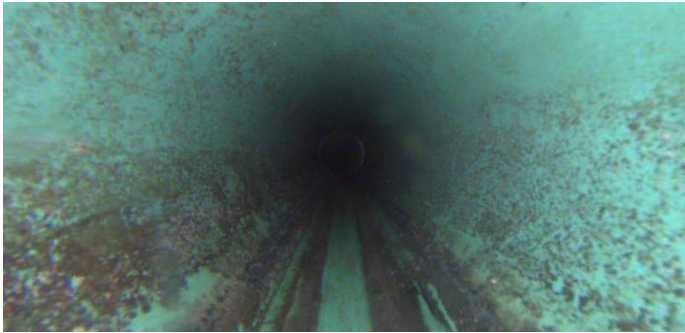
Code:	<b>MWL</b>
Description:	<b>Water Level</b>

Distance (ft):	<b>.0</b>
Structural Grade:	<b>0</b>
O&M Grade:	<b>0</b>
Clock Start/From:	
Clock To:	
1st Value:	
2nd Value:	
Value Percent:	<b>5.000</b>
Continuous Index:	
Within 8" of Joint:	<b>NO</b>
Remarks:

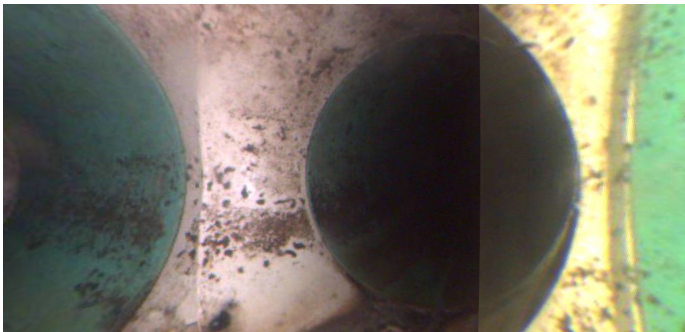
Code:	<b>TF</b>
Description:	<b>Tap Factory</b>

Distance (ft):	<b>5.6</b>
Structural Grade:	<b>0</b>
O&M Grade:	<b>0</b>
Clock Start/From:	<b>3</b>
Clock To:	
1st Value:	<b>4.000</b>
2nd Value:	
Value Percent:	
Continuous Index:	
Within 8" of Joint:	
Remarks:

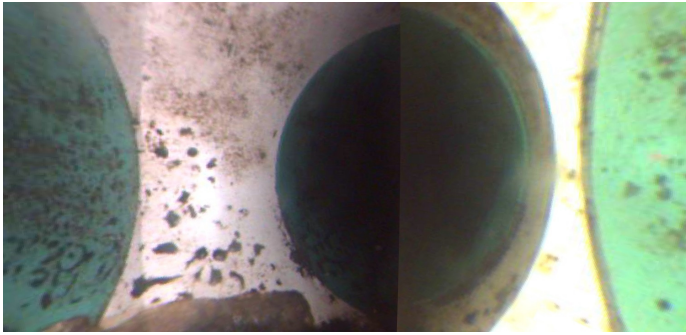
Code: **TF**  
Description: **Tap Factory**

Distance (ft): **7.4**  
Structural Grade: **0**  
O&M Grade: **0**  
Clock Start/From: **3**  
Clock To:  
1st Value: **4.000**  
2nd Value:  
Value Percent:  
Continuous Index:  
Within 8" of Joint:  
Remarks:

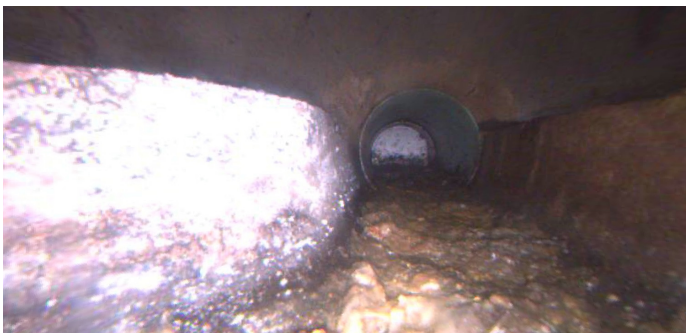
Code: **AMH**  
Description: **Manhole**

Distance (ft): **60.7**  
Structural Grade: **0**  
O&M Grade: **0**  
Clock Start/From:  
Clock To:  
1st Value:  
2nd Value:  
Value Percent:  
Continuous Index:  
Within 8" of Joint: **NO**  
Remarks: **M-703-028**
