## Profile/Photo Observation Report

Street:	<b>MANOR DR</b>	Flow Control:	<b>Not Controlled</b>
City:	<b>Hobart, IN</b>	Year Renewed:	
Location:	<b>Light Highway</b>	Tape/Media #:	
Purpose:	<b>Routine Assessment</b>	Dia/Height:	<b>8"</b>
Use:	<b>Sanitary</b>	Material:	<b>PVC</b>
Drain Area:	<b>NA</b>	Lining:	
Category:	<b>NA</b>		
Comment:

Location Details:		Direction of Survey:	<b>Downstream</b>
US MH:	<b>M-703-030</b>	DS MH:	<b>M-703-029</b>
		Total Length Surveyed (ft):	<b>115.8</b>

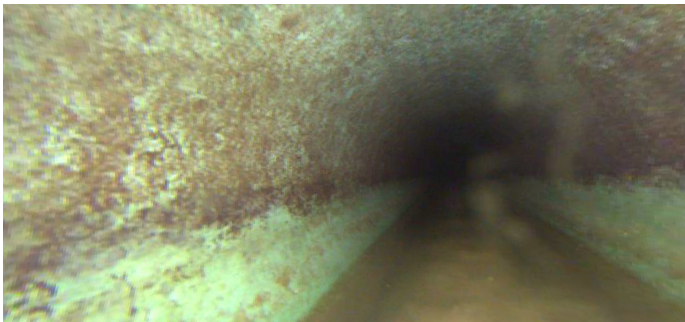
Code: **AMH**  
Description: **Manhole**

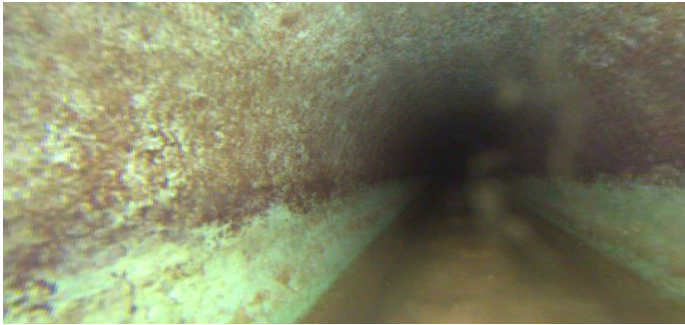
Code:	<b>MWL</b>
Description:	<b>Water Level</b>

Distance (ft):	<b>.0</b>
Structural Grade:	<b>0</b>
O&M Grade:	<b>0</b>
Clock Start/From:	
Clock To:	
1st Value:	
2nd Value:	
Value Percent:	<b>5.000</b>
Continuous Index:	
Within 8" of Joint:	<b>NO</b>
Remarks:

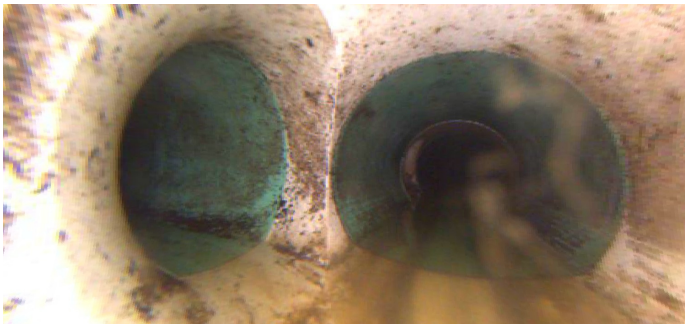
Code:	<b>TF</b>
Description:	<b>Tap Factory</b>

Distance (ft):	<b>48.5</b>
Structural Grade:	<b>0</b>
O&M Grade:	<b>0</b>
Clock Start/From:	<b>9</b>
Clock To:	
1st Value:	<b>4.000</b>
2nd Value:	
Value Percent:	
Continuous Index:	
Within 8" of Joint:	
Remarks:

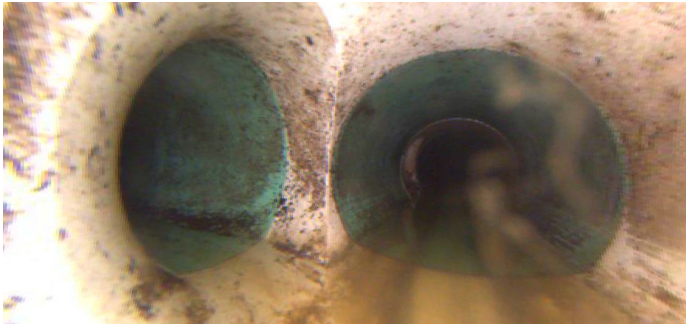
Code: **TF**  
Description: **Tap Factory**

Distance (ft): **48.5**  
Structural Grade: **0**  
O&M Grade: **0**  
Clock Start/From: **9**  
Clock To:  
1st Value: **4.000**  
2nd Value:  
Value Percent:  
Continuous Index:  
Within 8" of Joint:  
Remarks:

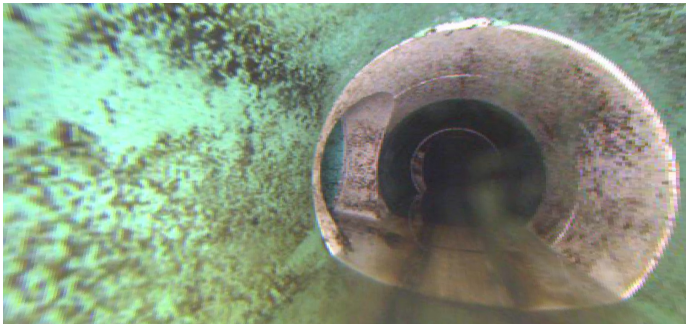
Code: **TF**  
Description: **Tap Factory**

Distance (ft): **106.6**  
Structural Grade: **0**  
O&M Grade: **0**  
Clock Start/From: **9**  
Clock To:  
1st Value: **4.000**  
2nd Value:  
Value Percent:  
Continuous Index:  
Within 8" of Joint:  
Remarks:

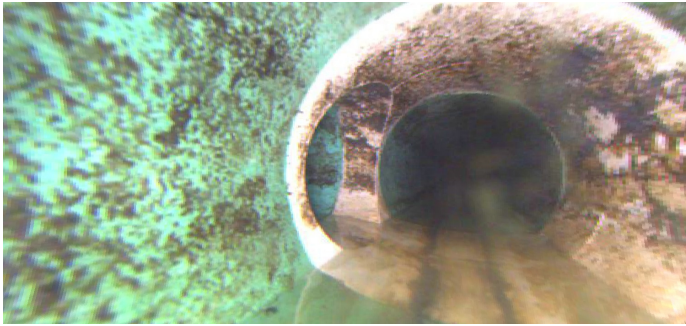
Code: **TF**  
Description: **Tap Factory**

Distance (ft): **108.4**  
Structural Grade: **0**  
O&M Grade: **0**  
Clock Start/From: **9**  
Clock To:  
1st Value: **4.000**  
2nd Value:  
Value Percent:  
Continuous Index:  
Within 8" of Joint:  
Remarks:

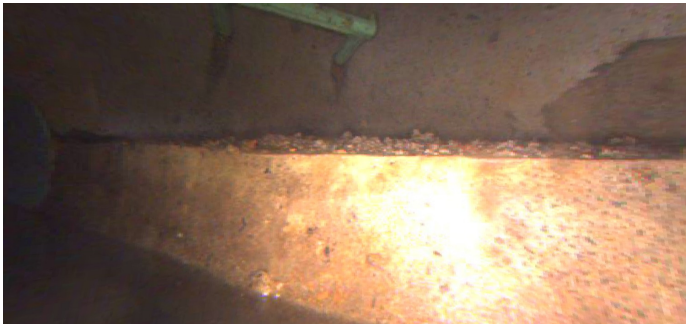
Code: **AMH**  
Description: **Manhole**

Distance (ft): **115.8**  
Structural Grade: **0**  
O&M Grade: **0**  
Clock Start/From:  
Clock To:  
1st Value:  
2nd Value:  
Value Percent:  
Continuous Index:  
Within 8" of Joint: **NO**  
Remarks: **M-703-029**
