Profile/Photo Observation Report

Street:	Manor Dr.	Flow Control:	Not Controlled
City:	Hobart, IN	Year Renewed:	
Location:	Light Highway	Tape/Media #:	
Purpose:	Routine Assessment	Dia/Height:	8"
Use:	Sanitary	Material:	PVC
Drain Area:	NA	Lining:	
Category:	NA		
Comment:

Location Details:		Direction of Survey:	Downstream
US MH:	M-703-030	DS MH:	M-703-029
		Total Length Surveyed (ft):	115.8

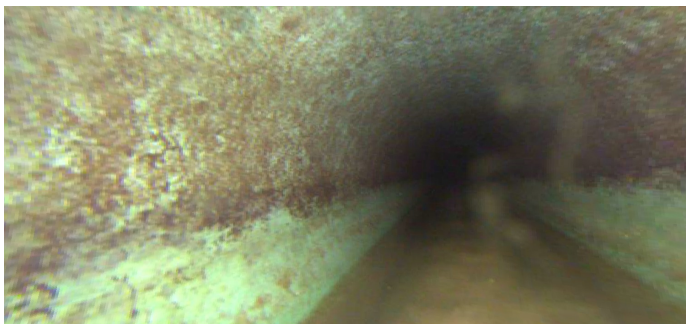
Code: **AMH**
Description: **Manhole**

Distance (ft): **.0**
Structural Grade: **0**
O&M Grade: **0**
Clock Start/From:
Clock To:
1st Value:
2nd Value:
Value Percent:
Continuous Index:
Within 8" of Joint: **NO**
Remarks: **M-703-030**

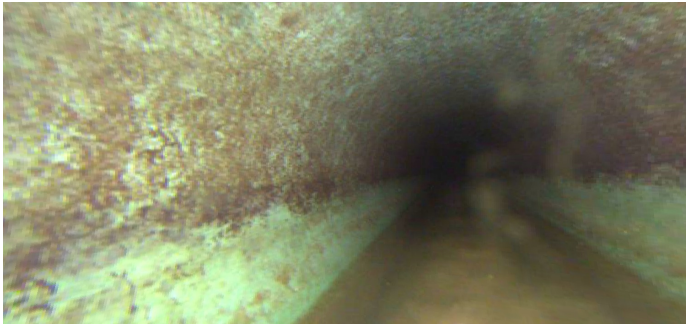
Code:	MWL
Description:	Water Level

Distance (ft):	.0
Structural Grade:	0
O&M Grade:	0
Clock Start/From:	
Clock To:	
1st Value:	
2nd Value:	
Value Percent:	5.000
Continuous Index:	
Within 8" of Joint:	NO
Remarks:

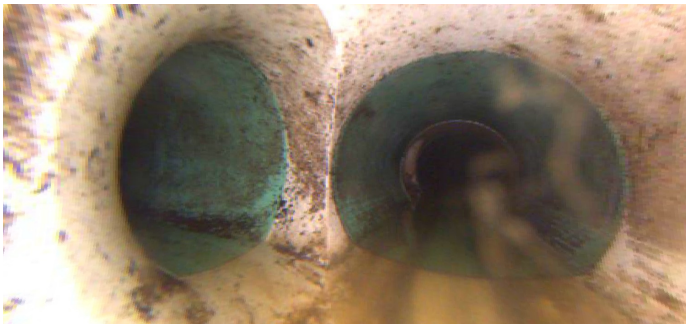
Code:	TF
Description:	Tap Factory

Distance (ft):	48.5
Structural Grade:	0
O&M Grade:	0
Clock Start/From:	9
Clock To:	
1st Value:	4.000
2nd Value:	
Value Percent:	
Continuous Index:	
Within 8" of Joint:	
Remarks:

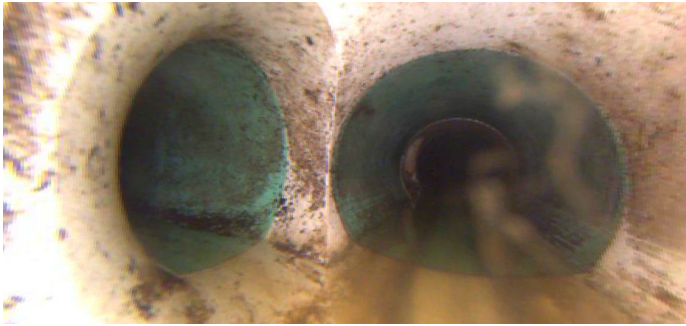
Code: **TF**
Description: **Tap Factory**

Distance (ft): **48.5**
Structural Grade: **0**
O&M Grade: **0**
Clock Start/From: **9**
Clock To:
1st Value: **4.000**
2nd Value:
Value Percent:
Continuous Index:
Within 8" of Joint:
Remarks:

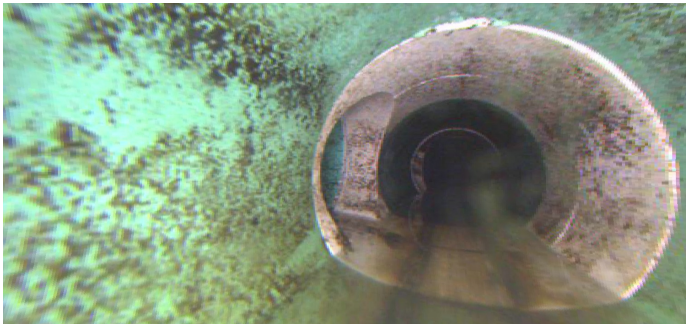
Code: **TF**
Description: **Tap Factory**

Distance (ft): **106.6**
Structural Grade: **0**
O&M Grade: **0**
Clock Start/From: **9**
Clock To:
1st Value: **4.000**
2nd Value:
Value Percent:
Continuous Index:
Within 8" of Joint:
Remarks:

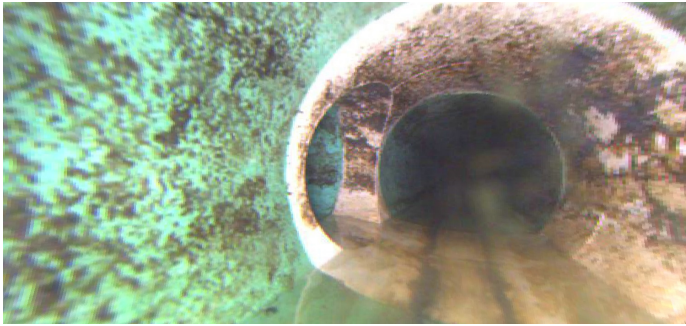
Code: **TF**
Description: **Tap Factory**

Distance (ft): **108.4**
Structural Grade: **0**
O&M Grade: **0**
Clock Start/From: **9**
Clock To:
1st Value: **4.000**
2nd Value:
Value Percent:
Continuous Index:
Within 8" of Joint:
Remarks:

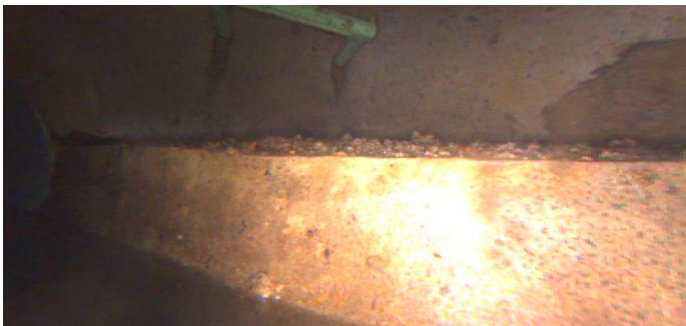
Code: **AMH**
Description: **Manhole**

Distance (ft): **115.8**
Structural Grade: **0**
O&M Grade: **0**
Clock Start/From:
Clock To:
1st Value:
2nd Value:
Value Percent:
Continuous Index:
Within 8" of Joint: **NO**
Remarks: **M-703-029**
