Profile/Photo Observation Report

Date:	03/27/2018	Weather:		Coding:	PACP 6.0
Pipe Length (ft):	71.4	Owner:	NA	Pre Clean:	Not Known
P.O.#:		Surveyor:	Jen Costello	PSR:	P-703-030-031
Customer:		Clean Date:	01/01/1900	Shape:	C

Street:	MANOR DR	Flow Control:	Not Controlled
City:	Hobart, IN	Year Renewed:	
Location:	Other	Tape/Media #:	
Purpose:	Not Known	Dia/Height:	10"
Use:	Sanitary	Material:	PVC
Drain Area:	NA	Lining:	
Category:	NA		
Comment:

Location Details:		Direction of Survey:	Upstream
US MH:	M-703-031	DS MH:	M-703-030
		Total Length Surveyed (ft):	67.0

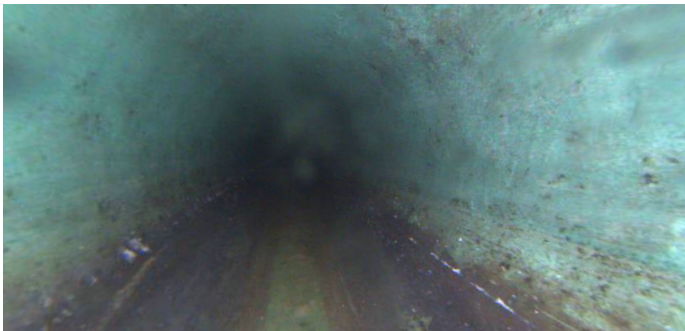
Code: **AMH**
Description: **Manhole**

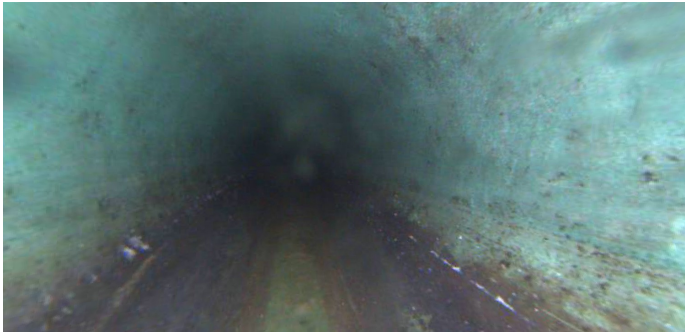
Code:	MWL
Description:	Water Level

Distance (ft):	.0
Structural Grade:	0
O&M Grade:	0
Clock Start/From:	
Clock To:	
1st Value:	
2nd Value:	
Value Percent:	5.000
Continuous Index:	
Within 8" of Joint:	NO
Remarks:

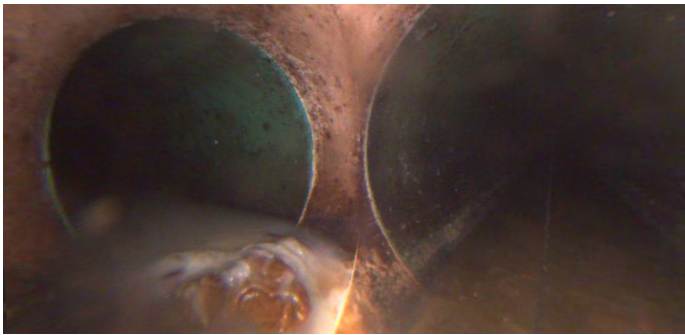
Code:	TFA
Description:	Tap Factory Active

Distance (ft):	25.3
Structural Grade:	0
O&M Grade:	0
Clock Start/From:	3
Clock To:	
1st Value:	4.000
2nd Value:	
Value Percent:	
Continuous Index:	
Within 8" of Joint:	
Remarks:

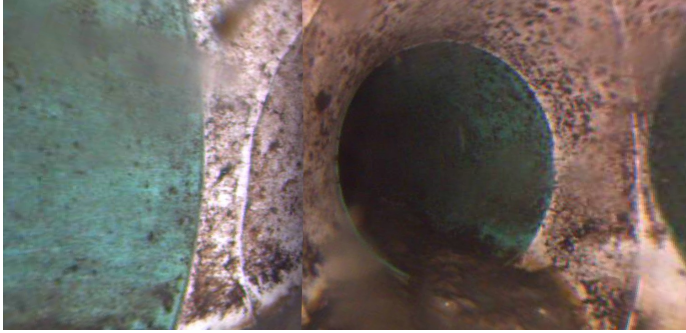
Code: **TFA**
Description: **Tap Factory Active**

Distance (ft): **26.8**
Structural Grade: **0**
O&M Grade: **0**
Clock Start/From: **3**
Clock To:
1st Value: **4.000**
2nd Value:
Value Percent:
Continuous Index:
Within 8" of Joint:
Remarks:

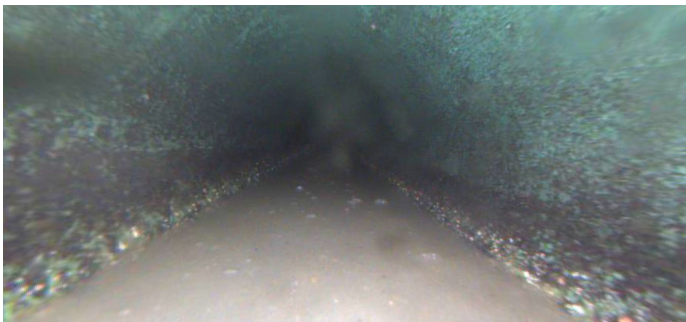
Code: **MWL**
Description: **Water Level**

Distance (ft): **60.1**
Structural Grade: **0**
O&M Grade: **0**
Clock Start/From:
Clock To:
1st Value:
2nd Value:
Value Percent: **20.000**
Continuous Index:
Within 8" of Joint: **NO**
Remarks:

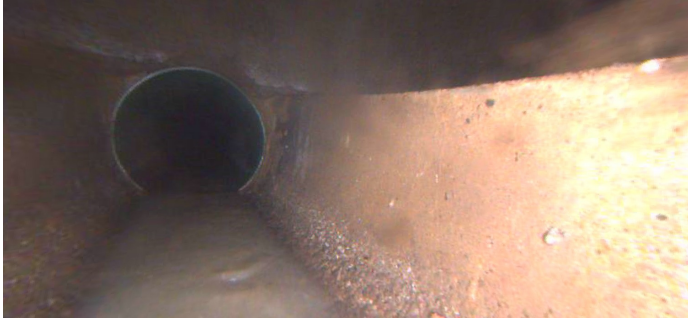
Code:	AMH
Description:	Manhole
Distance (ft):	67.0
Structural Grade:	0
O&M Grade:	0
Clock Start/From:	
Clock To:	
1st Value:	
2nd Value:	
Value Percent:	
Continuous Index:	
Within 8" of Joint:	NO
Remarks:	M-703-031
