## Profile/Photo Observation Report

Street:	<b>manor dr</b>	Flow Control:	<b>Not Controlled</b>
City:	<b>Hobart, IN</b>	Year Renewed:	
Location:	<b>Other</b>	Tape/Media #:	
Purpose:	<b>Not Known</b>	Dia/Height:	<b>10"</b>
Use:	<b>Sanitary</b>	Material:	<b>PVC</b>
Drain Area:	<b>NA</b>	Lining:	
Category:	<b>NA</b>		
Comment:

Location Details:		Direction of Survey:	<b>Upstream</b>
US MH:	<b>M-703-031</b>	DS MH:	<b>M-703-030</b>
		Total Length Surveyed (ft):	<b>67.0</b>

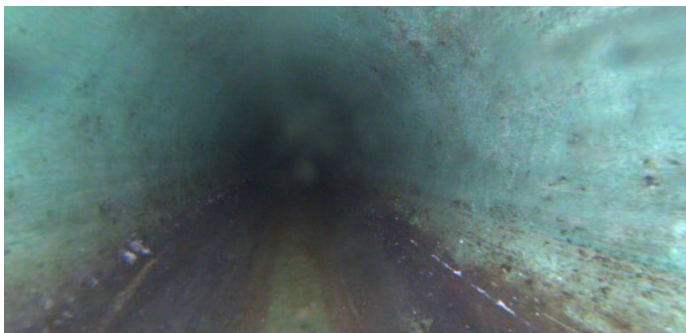
Code: **AMH**  
Description: **Manhole**

Distance (ft): **.0**  
Structural Grade: **0**  
O&M Grade: **0**  
Clock Start/From:  
Clock To:  
1st Value:  
2nd Value:  
Value Percent:  
Continuous Index:  
Within 8" of Joint: **NO**  
Remarks: **M-703-030**

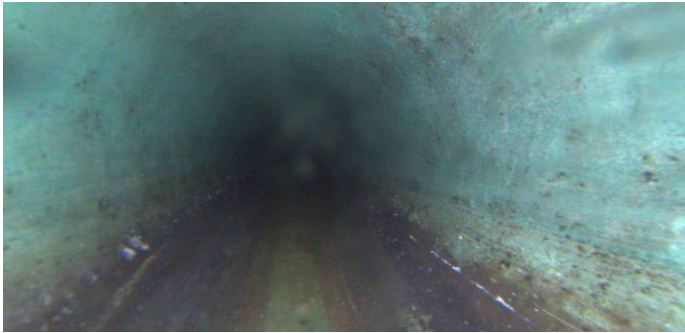
Code:	<b>MWL</b>
Description:	<b>Water Level</b>

Distance (ft):	<b>.0</b>
Structural Grade:	<b>0</b>
O&M Grade:	<b>0</b>
Clock Start/From:	
Clock To:	
1st Value:	
2nd Value:	
Value Percent:	<b>5.000</b>
Continuous Index:	
Within 8" of Joint:	<b>NO</b>
Remarks:

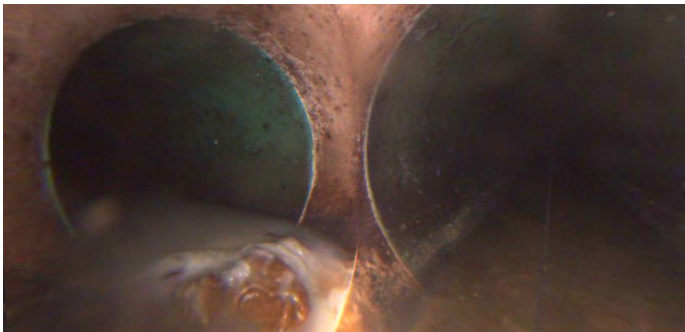
Code:	<b>TFA</b>
Description:	<b>Tap Factory Active</b>

Distance (ft):	<b>25.3</b>
Structural Grade:	<b>0</b>
O&M Grade:	<b>0</b>
Clock Start/From:	<b>3</b>
Clock To:	
1st Value:	<b>4.000</b>
2nd Value:	
Value Percent:	
Continuous Index:	
Within 8" of Joint:	
Remarks:

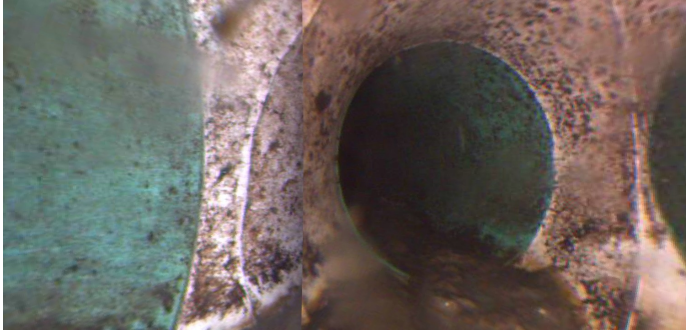
Code: **TFA**  
Description: **Tap Factory Active**

Distance (ft): **26.8**  
Structural Grade: **0**  
O&M Grade: **0**  
Clock Start/From: **3**  
Clock To:  
1st Value: **4.000**  
2nd Value:  
Value Percent:  
Continuous Index:  
Within 8" of Joint:  
Remarks:

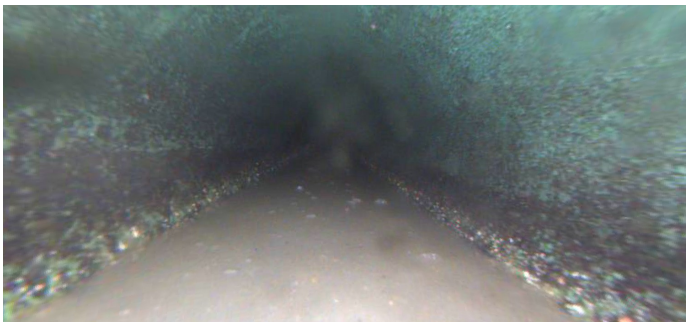
Code: **MWL**  
Description: **Water Level**

Distance (ft): **60.1**  
Structural Grade: **0**  
O&M Grade: **0**  
Clock Start/From:  
Clock To:  
1st Value:  
2nd Value:  
Value Percent: **20.000**  
Continuous Index:  
Within 8" of Joint: **NO**  
Remarks:

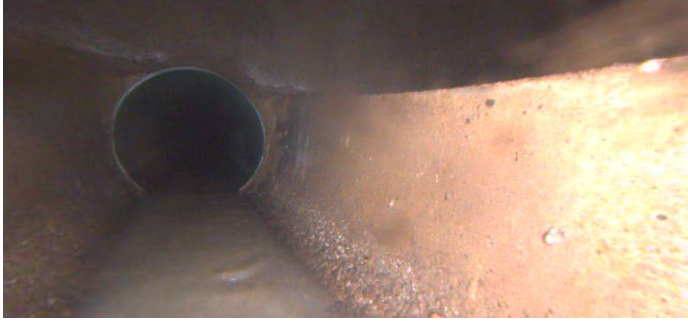
Code:	<b>AMH</b>
Description:	<b>Manhole</b>
Distance (ft):	<b>67.0</b>
Structural Grade:	<b>0</b>
O&M Grade:	<b>0</b>
Clock Start/From:	
Clock To:	
1st Value:	
2nd Value:	
Value Percent:	
Continuous Index:	
Within 8" of Joint:	<b>NO</b>
Remarks:	<b>M-703-031</b>
