Profile/Photo Observation Report

| Street: | MANOR DR | Flow Control: | Not Controlled |
| City: | Hobart, IN | Year Renewed: | |

| US MH: | M-703-032 | DS MH: | M-703-031 |

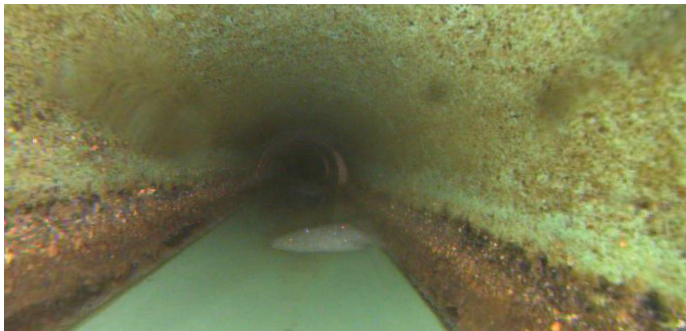
Code: **AMH**
Description: **Manhole**

Distance (ft): **.0**
Structural Grade: **0**
O&M Grade: **0**
Clock Start/From:
Clock To:
1st Value:
2nd Value:
Value Percent:
Continuous Index:
Within 8" of Joint: **NO**
Remarks: **M-703-032**

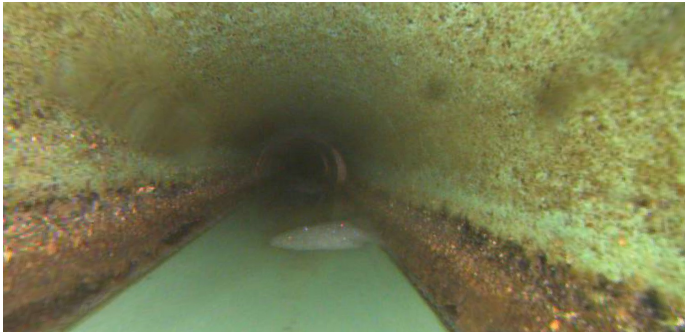
| Code: | MWL |
| Description: | Water Level |

| Distance (ft): | .0 |
| Value Percent: | 10.000 |

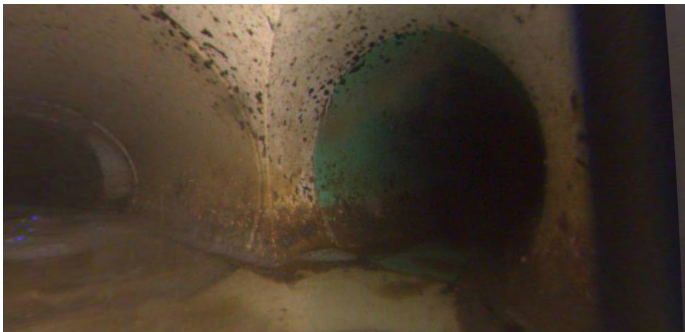
| Code: | TFA |
| Description: | Tap Factory Active |

| Distance (ft): | 3.4 |
| Clock Start/From: | 3 |

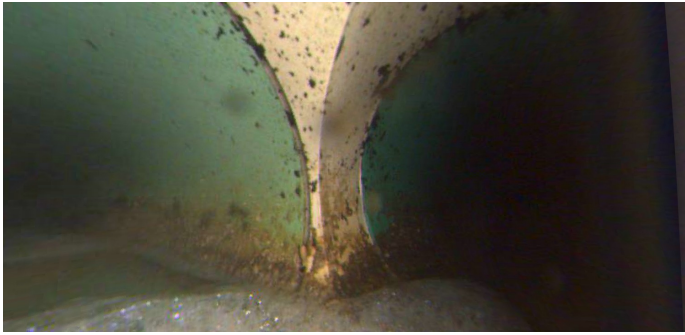
Code: **TFA**
Description: **Tap Factory Active**

Distance (ft): **5.2**
Structural Grade: **0**
O&M Grade: **0**
Clock Start/From: **3**
Clock To:
1st Value: **4.000**
2nd Value:
Value Percent:
Continuous Index:
Within 8" of Joint:
Remarks:

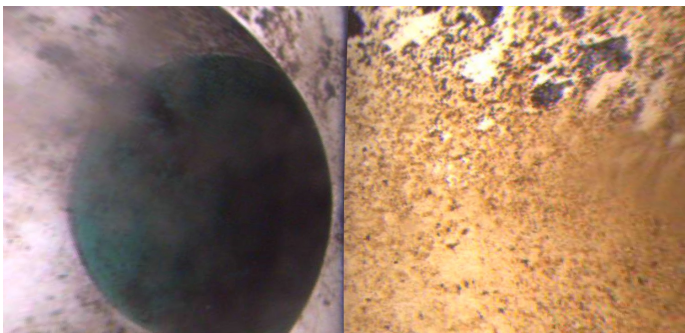
Code: **TF**
Description: **Tap Factory**

Distance (ft): **56.8**
Structural Grade: **0**
O&M Grade: **0**
Clock Start/From: **9**
Clock To:
1st Value: **4.000**
2nd Value:
Value Percent:
Continuous Index:
Within 8" of Joint:
Remarks:

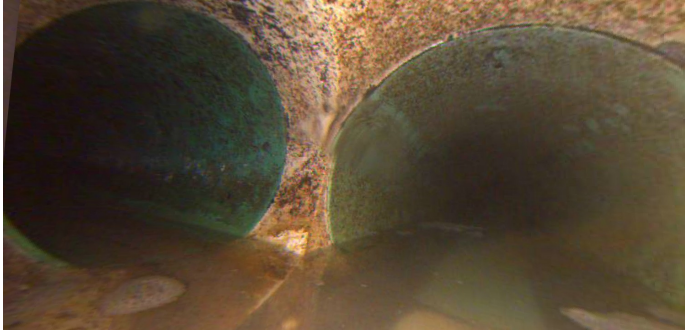
Code: **TFA**
Description: **Tap Factory Active**

Distance (ft): **57.9**
Structural Grade: **0**
O&M Grade: **0**
Clock Start/From: **9**
Clock To:
1st Value: **4.000**
2nd Value:
Value Percent:
Continuous Index:
Within 8" of Joint:
Remarks:

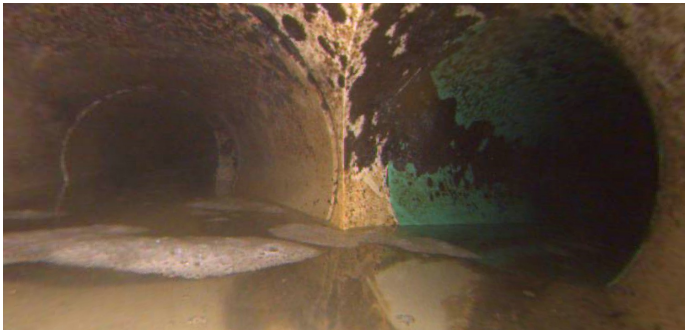
Code: **TFA**
Description: **Tap Factory Active**

Distance (ft): **88.8**
Structural Grade: **0**
O&M Grade: **0**
Clock Start/From: **3**
Clock To:
1st Value: **4.000**
2nd Value:
Value Percent:
Continuous Index:
Within 8" of Joint:
Remarks:

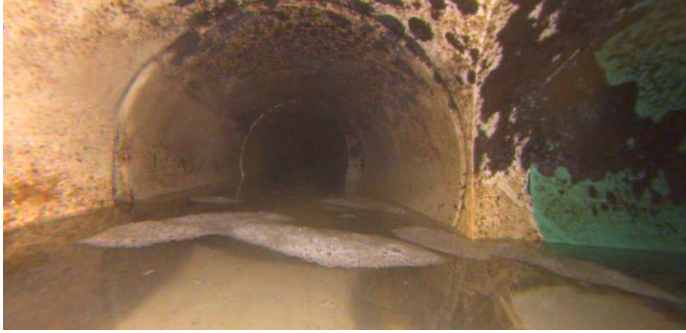
Code: **MWL**
Description: **Water Level**

Distance (ft): **88.8**
Structural Grade: **0**
O&M Grade: **0**
Clock Start/From:
Clock To:
1st Value:
2nd Value:
Value Percent: **30.000**
Continuous Index:
Within 8" of Joint: **NO**
Remarks:

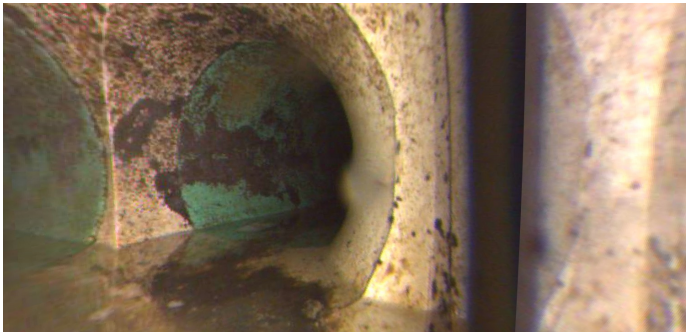
Code: **TFA**
Description: **Tap Factory Active**

Distance (ft): **90.3**
Structural Grade: **0**
O&M Grade: **0**
Clock Start/From: **3**
Clock To:
1st Value: **4.000**
2nd Value:
Value Percent:
Continuous Index:
Within 8" of Joint:
Remarks:

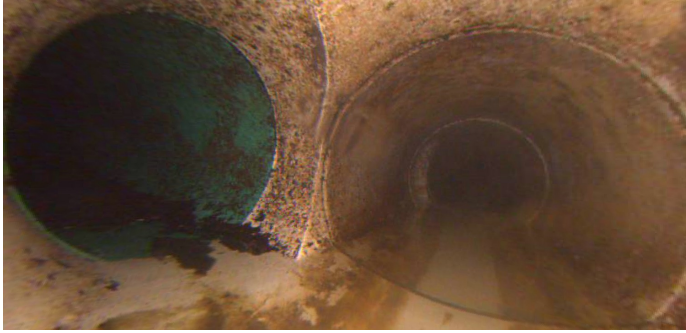
Code: **TFA**
Description: **Tap Factory Active**

Distance (ft): **135.3**
Structural Grade: **0**
O&M Grade: **0**
Clock Start/From: **9**
Clock To:
1st Value: **4.000**
2nd Value:
Value Percent:
Continuous Index:
Within 8" of Joint:
Remarks:

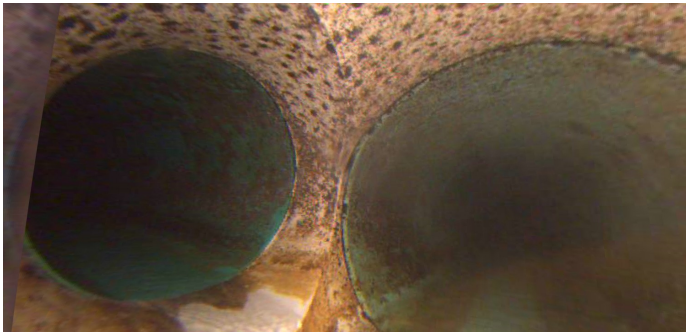
Code: **TFA**
Description: **Tap Factory Active**

Distance (ft): **137.1**
Structural Grade: **0**
O&M Grade: **0**
Clock Start/From: **9**
Clock To:
1st Value: **4.000**
2nd Value:
Value Percent:
Continuous Index:
Within 8" of Joint:
Remarks:

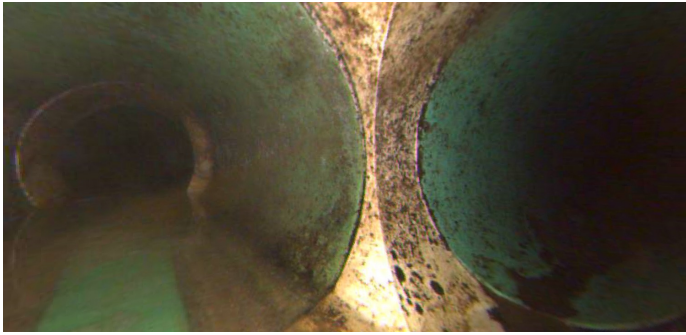
Code: **TF**
Description: **Tap Factory**

Distance (ft): **180.2**
Structural Grade: **0**
O&M Grade: **0**
Clock Start/From: **3**
Clock To:
1st Value: **4.000**
2nd Value:
Value Percent:
Continuous Index:
Within 8" of Joint:
Remarks:

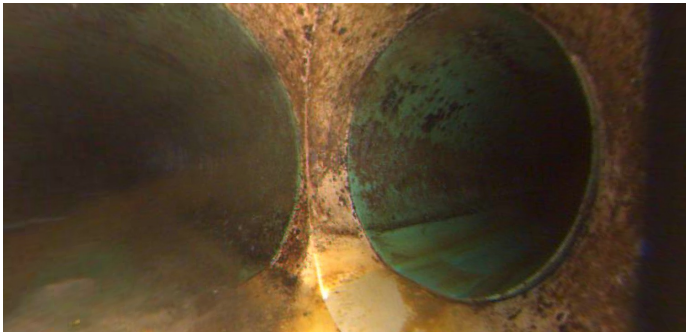
Code: **TF**
Description: **Tap Factory**

Distance (ft): **181.9**
Structural Grade: **0**
O&M Grade: **0**
Clock Start/From: **3**
Clock To:
1st Value: **4.000**
2nd Value:
Value Percent:
Continuous Index:
Within 8" of Joint:
Remarks:

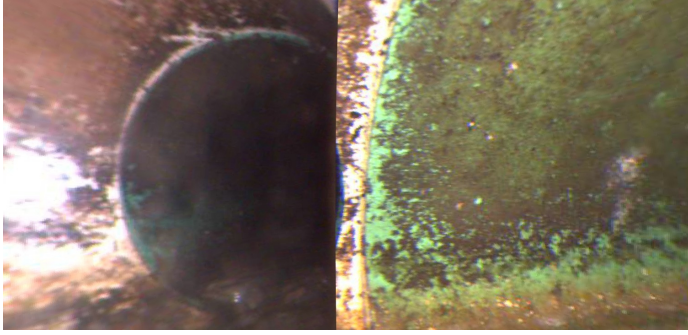
Code: **TFA**
Description: **Tap Factory Active**

Distance (ft): **213.9**
Structural Grade: **0**
O&M Grade: **0**
Clock Start/From: **9**
Clock To:
1st Value: **4.000**
2nd Value:
Value Percent:
Continuous Index:
Within 8" of Joint:
Remarks:

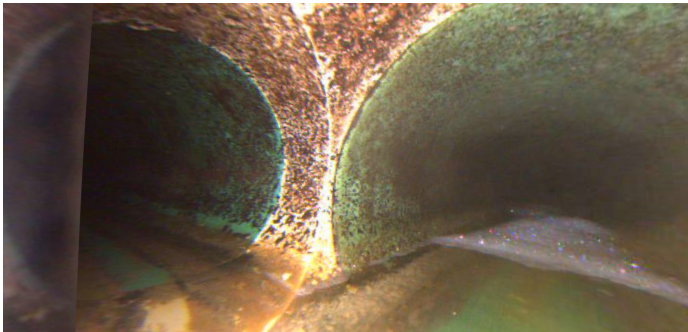
Code: **TFA**
Description: **Tap Factory Active**

Distance (ft): **215.2**
Structural Grade: **0**
O&M Grade: **0**
Clock Start/From: **9**
Clock To:
1st Value: **4.000**
2nd Value:
Value Percent:
Continuous Index:
Within 8" of Joint:
Remarks:

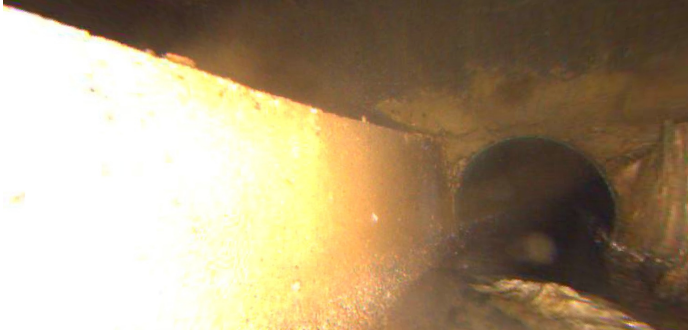
| Code: | AMH |
| Description: | Manhole |
| Distance (ft): | 238.7 |
| Remarks: | M-703-031 |
