Profile/Photo Observation Report

Date:	03/27/2018	Weather:		Coding:	PACP 6.0
Pipe Length (ft):	242.0	Owner:	NA	Pre Clean:	Not Known
P.O.#:		Surveyor:	Jen Costello	PSR:	P-703-031-032
Customer:		Clean Date:	01/01/1900	Shape:	C

Street:	manor dr	Flow Control:	Not Controlled
City:	Hobart, IN	Year Renewed:	
Location:	Other	Tape/Media #:	
Purpose:	Not Known	Dia/Height:	10"
Use:	Sanitary	Material:	PVC
Drain Area:	NA	Lining:	
Category:	NA		
Comment:

Location Details:		Direction of Survey:	Downstream
US MH:	M-703-032	DS MH:	M-703-031
		Total Length Surveyed (ft):	238.7

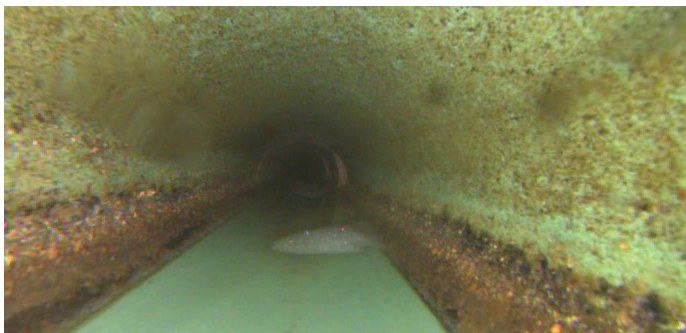
Code: **AMH**
Description: **Manhole**

Distance (ft): **.0**
Structural Grade: **0**
O&M Grade: **0**
Clock Start/From:
Clock To:
1st Value:
2nd Value:
Value Percent:
Continuous Index:
Within 8" of Joint: **NO**
Remarks: **M-703-032**

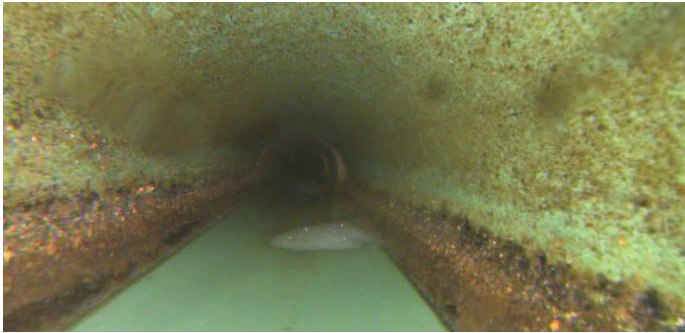
Code:	MWL
Description:	Water Level

Distance (ft):	.0
Structural Grade:	0
O&M Grade:	0
Clock Start/From:	
Clock To:	
1st Value:	
2nd Value:	
Value Percent:	10.000
Continuous Index:	
Within 8" of Joint:	NO
Remarks:

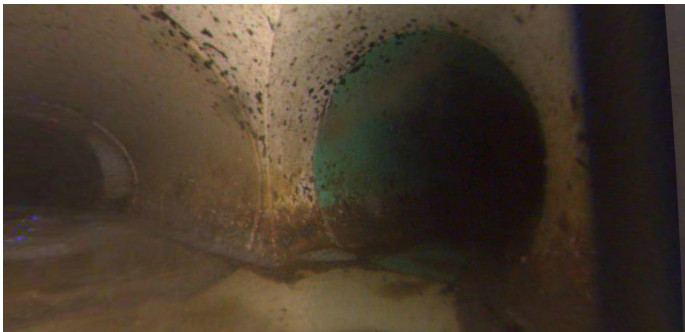
Code:	TFA
Description:	Tap Factory Active

Distance (ft):	3.4
Structural Grade:	0
O&M Grade:	0
Clock Start/From:	3
Clock To:	
1st Value:	4.000
2nd Value:	
Value Percent:	
Continuous Index:	
Within 8" of Joint:	
Remarks:

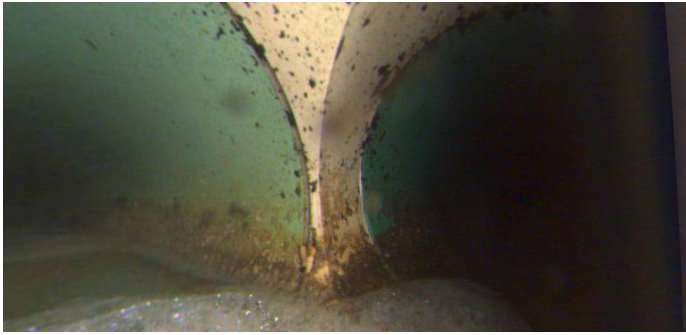
Code: **TFA**
Description: **Tap Factory Active**

Distance (ft): **5.2**
Structural Grade: **0**
O&M Grade: **0**
Clock Start/From: **3**
Clock To:
1st Value: **4.000**
2nd Value:
Value Percent:
Continuous Index:
Within 8" of Joint:
Remarks:

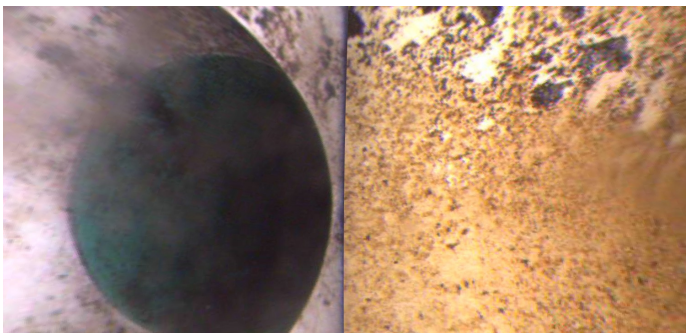
Code: **TF**
Description: **Tap Factory**

Distance (ft): **56.8**
Structural Grade: **0**
O&M Grade: **0**
Clock Start/From: **9**
Clock To:
1st Value: **4.000**
2nd Value:
Value Percent:
Continuous Index:
Within 8" of Joint:
Remarks:

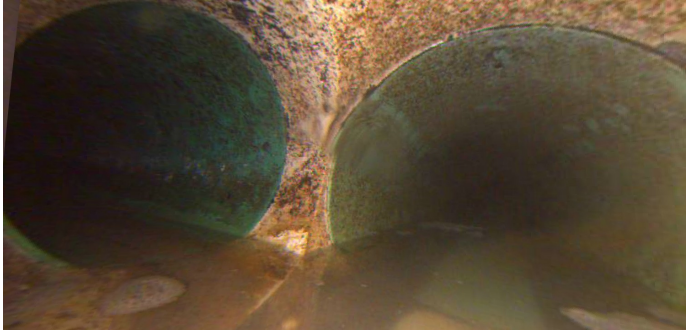
Code: **TFA**
Description: **Tap Factory Active**

Distance (ft): **57.9**
Structural Grade: **0**
O&M Grade: **0**
Clock Start/From: **9**
Clock To:
1st Value: **4.000**
2nd Value:
Value Percent:
Continuous Index:
Within 8" of Joint:
Remarks:

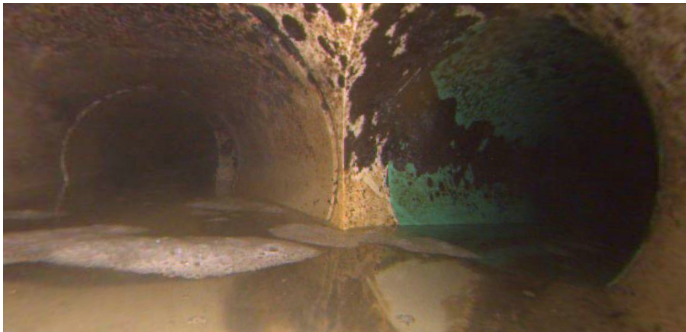
Code: **TFA**
Description: **Tap Factory Active**

Distance (ft): **88.8**
Structural Grade: **0**
O&M Grade: **0**
Clock Start/From: **3**
Clock To:
1st Value: **4.000**
2nd Value:
Value Percent:
Continuous Index:
Within 8" of Joint:
Remarks:

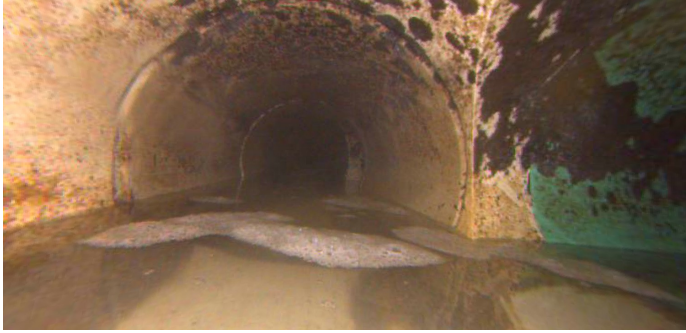
Code: **MWL**
Description: **Water Level**

Distance (ft): **88.8**
Structural Grade: **0**
O&M Grade: **0**
Clock Start/From:
Clock To:
1st Value:
2nd Value:
Value Percent: **30.000**
Continuous Index:
Within 8" of Joint: **NO**
Remarks:

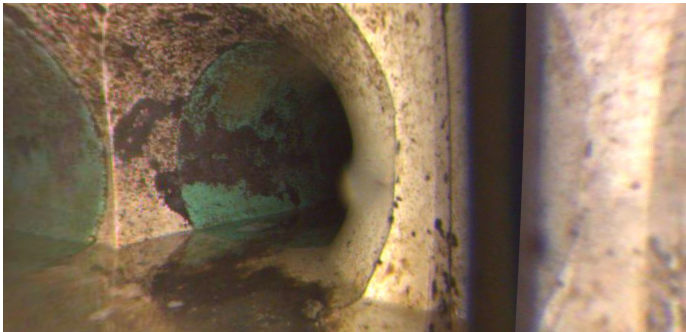
Code: **TFA**
Description: **Tap Factory Active**

Distance (ft): **90.3**
Structural Grade: **0**
O&M Grade: **0**
Clock Start/From: **3**
Clock To:
1st Value: **4.000**
2nd Value:
Value Percent:
Continuous Index:
Within 8" of Joint:
Remarks:

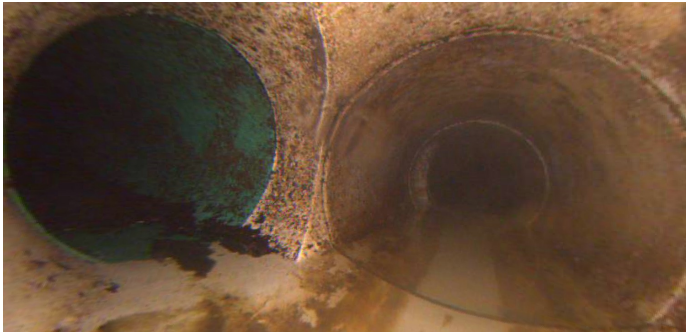
Code: **TFA**
Description: **Tap Factory Active**

Distance (ft): **135.3**
Structural Grade: **0**
O&M Grade: **0**
Clock Start/From: **9**
Clock To:
1st Value: **4.000**
2nd Value:
Value Percent:
Continuous Index:
Within 8" of Joint:
Remarks:

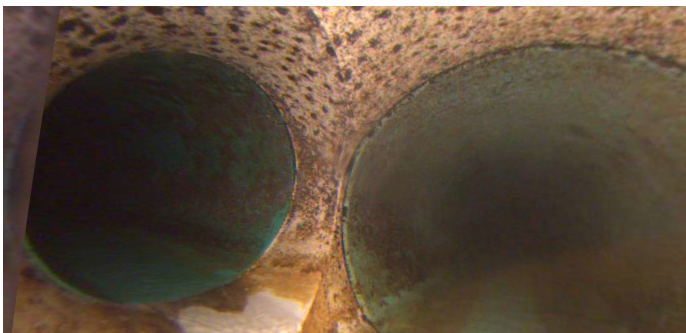
Code: **TFA**
Description: **Tap Factory Active**

Distance (ft): **137.1**
Structural Grade: **0**
O&M Grade: **0**
Clock Start/From: **9**
Clock To:
1st Value: **4.000**
2nd Value:
Value Percent:
Continuous Index:
Within 8" of Joint:
Remarks:

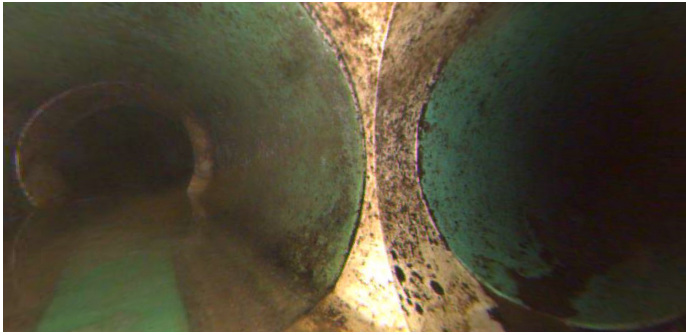
Code: **TF**
Description: **Tap Factory**

Distance (ft): **180.2**
Structural Grade: **0**
O&M Grade: **0**
Clock Start/From: **3**
Clock To:
1st Value: **4.000**
2nd Value:
Value Percent:
Continuous Index:
Within 8" of Joint:
Remarks:

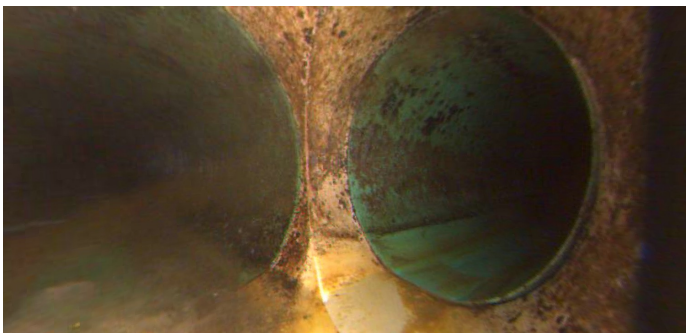
Code: **TF**
Description: **Tap Factory**

Distance (ft): **181.9**
Structural Grade: **0**
O&M Grade: **0**
Clock Start/From: **3**
Clock To:
1st Value: **4.000**
2nd Value:
Value Percent:
Continuous Index:
Within 8" of Joint:
Remarks:

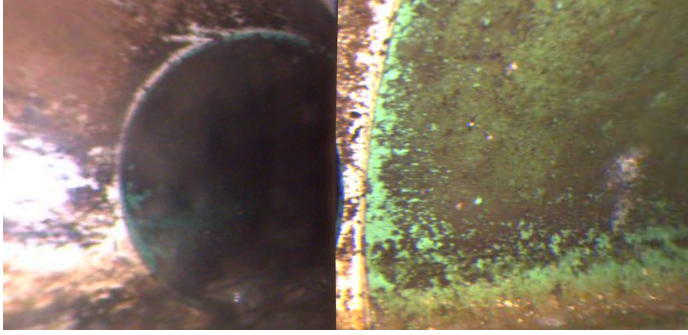
Code: **TFA**
Description: **Tap Factory Active**

Distance (ft): **213.9**
Structural Grade: **0**
O&M Grade: **0**
Clock Start/From: **9**
Clock To:
1st Value: **4.000**
2nd Value:
Value Percent:
Continuous Index:
Within 8" of Joint:
Remarks:

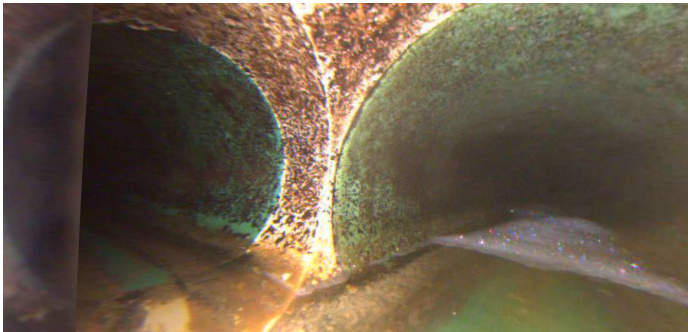
Code: **TFA**
Description: **Tap Factory Active**

Distance (ft): **215.2**
Structural Grade: **0**
O&M Grade: **0**
Clock Start/From: **9**
Clock To:
1st Value: **4.000**
2nd Value:
Value Percent:
Continuous Index:
Within 8" of Joint:
Remarks:

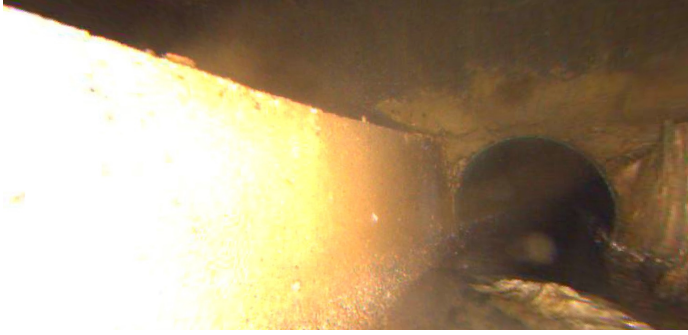
Code:	AMH
Description:	Manhole
Distance (ft):	238.7
Structural Grade:	0
O&M Grade:	0
Clock Start/From:	
Clock To:	
1st Value:	
2nd Value:	
Value Percent:	
Continuous Index:	
Within 8" of Joint:	NO
Remarks:	M-703-031
