## Profile/Photo Observation Report

Street:	<b>HIDDEN LAKE DR</b>	Flow Control:	<b>Not Controlled</b>
City:	<b>Hobart, IN</b>	Year Renewed:	
Location:	<b>Other</b>	Tape/Media #:	
Purpose:	<b>Not Known</b>	Dia/Height:	<b>10"</b>
Use:	<b>Sanitary</b>	Material:	<b>PVC</b>
Drain Area:	<b>NA</b>	Lining:	
Category:	<b>NA</b>		
Comment:

Location Details:		Direction of Survey:	<b>Upstream</b>
US MH:	<b>M-703-033</b>	DS MH:	<b>M-703-020</b>
		Total Length Surveyed (ft):	<b>103.9</b>

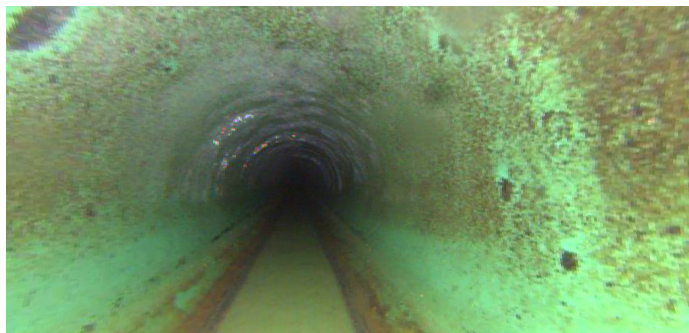
Code: **AMH**  
Description: **Manhole**

Distance (ft): **.0**  
Structural Grade: **0**  
O&M Grade: **0**  
Clock Start/From:  
Clock To:  
1st Value:  
2nd Value:  
Value Percent:  
Continuous Index:  
Within 8" of Joint: **NO**  
Remarks: **M-703-020**

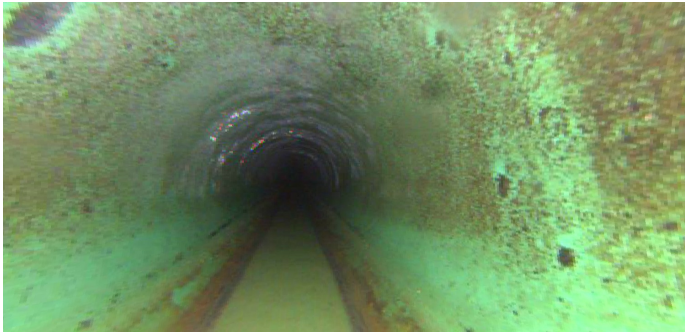
Code:	<b>MWL</b>
Description:	<b>Water Level</b>

Distance (ft):	<b>.0</b>
Structural Grade:	<b>0</b>
O&M Grade:	<b>0</b>
Clock Start/From:	
Clock To:	
1st Value:	
2nd Value:	
Value Percent:	<b>5.000</b>
Continuous Index:	
Within 8" of Joint:	<b>NO</b>
Remarks:

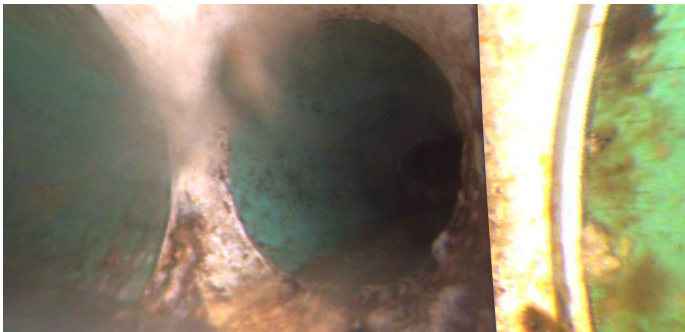
Code:	<b>TF</b>
Description:	<b>Tap Factory</b>

Distance (ft):	<b>58.5</b>
Structural Grade:	<b>0</b>
O&M Grade:	<b>0</b>
Clock Start/From:	<b>9</b>
Clock To:	
1st Value:	<b>4.000</b>
2nd Value:	
Value Percent:	
Continuous Index:	
Within 8" of Joint:	
Remarks:

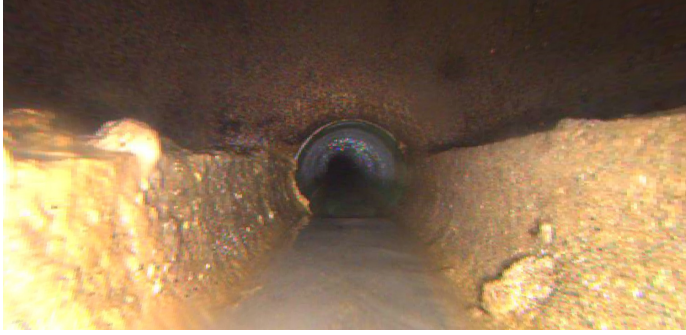
Code:	AMH
Description:	Manhole
Distance (ft):	103.9
Structural Grade:	0
O&M Grade:	0
Clock Start/From:	
Clock To:	
1st Value:	
2nd Value:	
Value Percent:	
Continuous Index:	
Within 8" of Joint:	NO
Remarks:	M-703-033
