Profile/Photo Observation Report

Street:	hidden lake dr	Flow Control:	Not Controlled
City:	Hobart, IN	Year Renewed:	
Location:	Other	Tape/Media #:	
Purpose:	Not Known	Dia/Height:	10"
Use:	Sanitary	Material:	PVC
Drain Area:	NA	Lining:	
Category:	NA		
Comment:

Location Details:		Direction of Survey:	Upstream
US MH:	M-703-033	DS MH:	M-703-020
		Total Length Surveyed (ft):	103.9

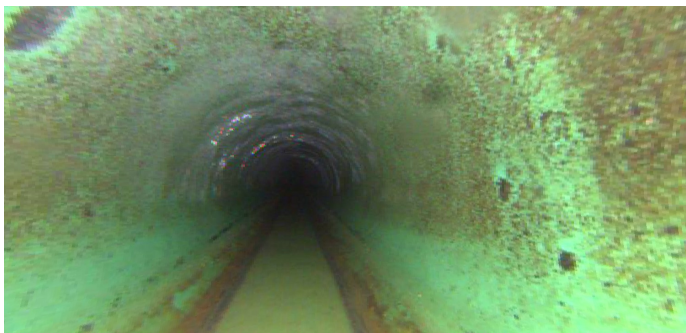
Code: **AMH**
Description: **Manhole**

Distance (ft): **.0**
Structural Grade: **0**
O&M Grade: **0**
Clock Start/From:
Clock To:
1st Value:
2nd Value:
Value Percent:
Continuous Index:
Within 8" of Joint: **NO**
Remarks: **M-703-020**

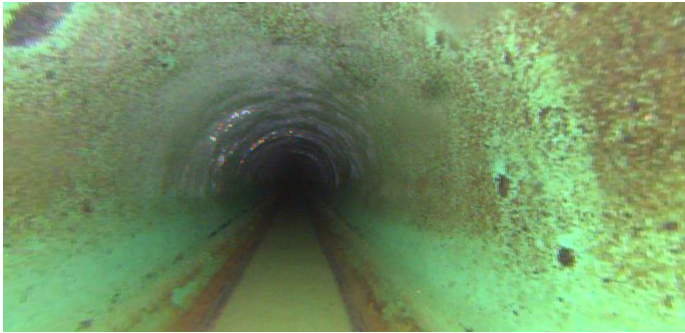
Code:	MWL
Description:	Water Level

Distance (ft):	.0
Structural Grade:	0
O&M Grade:	0
Clock Start/From:	
Clock To:	
1st Value:	
2nd Value:	
Value Percent:	5.000
Continuous Index:	
Within 8" of Joint:	NO
Remarks:

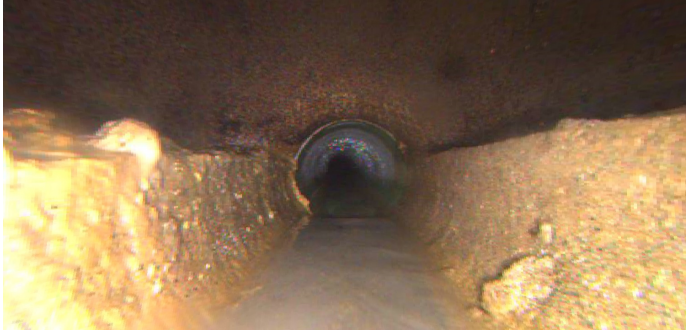
Code:	AMH
Description:	Manhole
Distance (ft):	103.9
Structural Grade:	0
O&M Grade:	0
Clock Start/From:	
Clock To:	
1st Value:	
2nd Value:	
Value Percent:	
Continuous Index:	
Within 8" of Joint:	NO
Remarks:	M-703-033
