Profile/Photo Observation Report

Street:	QUAIL DR & HIDDEN LAKE DR	Flow Control:	Not Controlled
City:	Hobart, IN	Year Renewed:	
Location:	Other	Tape/Media #:	
Purpose:	Not Known	Dia/Height:	10"
Use:	Sanitary	Material:	PVC
Drain Area:	NA	Lining:	
Category:	NA		
Comment:

Location Details:		Direction of Survey:	Downstream
US MH:	M-703-034	DS MH:	M-703-033
		Total Length Surveyed (ft):	331.0

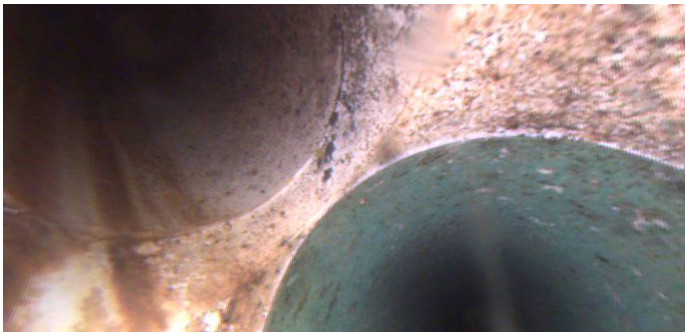
Code:	TF
Description:	Tap Factory

Distance (ft):	25.2
Structural Grade:	0
O&M Grade:	0
Clock Start/From:	10
Clock To:	
1st Value:	4.000
2nd Value:	
Value Percent:	
Continuous Index:	
Within 8" of Joint:	
Remarks:

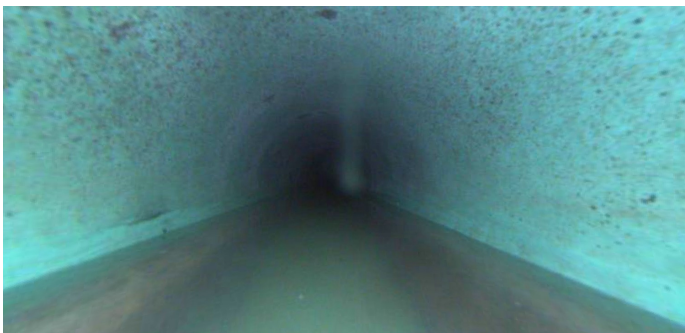
Code: **MWL**
Description: **Water Level**

Distance (ft): **67.1**
Structural Grade: **0**
O&M Grade: **0**
Clock Start/From:
Clock To:
1st Value:
2nd Value:
Value Percent: **40.000**
Continuous Index:
Within 8" of Joint: **NO**
Remarks:

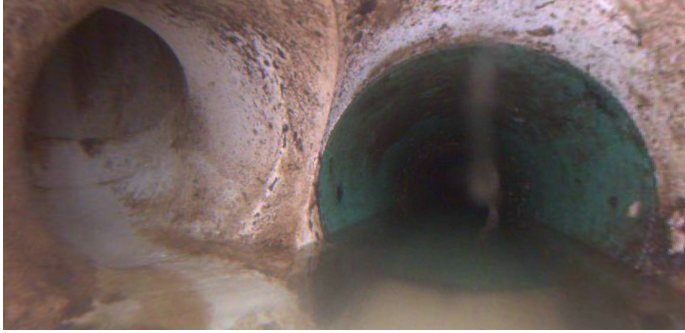
Code: **TFA**
Description: **Tap Factory Active**

Distance (ft): **110.4**
Structural Grade: **0**
O&M Grade: **0**
Clock Start/From: **9**
Clock To:
1st Value: **4.000**
2nd Value:
Value Percent:
Continuous Index:
Within 8" of Joint:
Remarks:

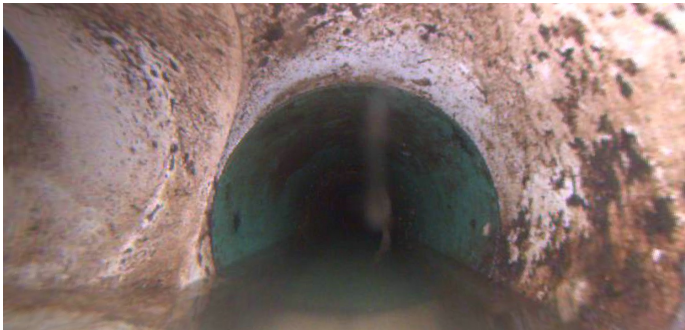
Code: **MWL**
Description: **Water Level**

Distance (ft): **110.4**
Structural Grade: **0**
O&M Grade: **0**
Clock Start/From:
Clock To:
1st Value:
2nd Value:
Value Percent: **30.000**
Continuous Index:
Within 8" of Joint: **NO**
Remarks:

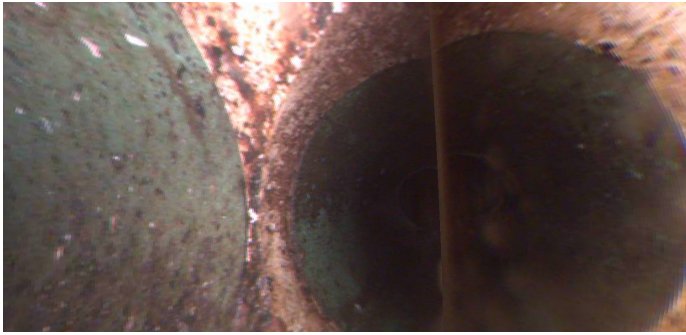
Code: **TF**
Description: **Tap Factory**

Distance (ft): **232.0**
Structural Grade: **0**
O&M Grade: **0**
Clock Start/From: **3**
Clock To:
1st Value: **4.000**
2nd Value:
Value Percent:
Continuous Index:
Within 8" of Joint:
Remarks:

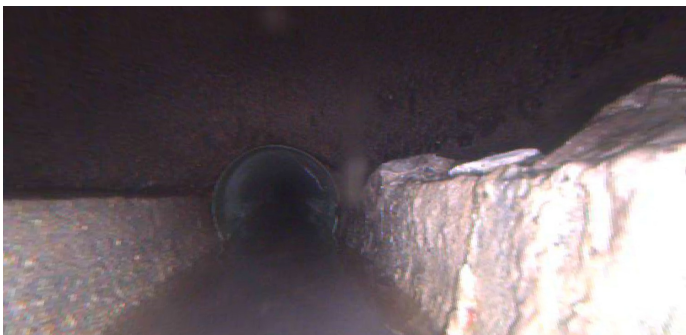
Code: **AMH**
Description: **Manhole**

Distance (ft): **331.0**
Structural Grade: **0**
O&M Grade: **0**
Clock Start/From:
Clock To:
1st Value:
2nd Value:
Value Percent:
Continuous Index:
Within 8" of Joint: **NO**
Remarks: **M-703-033**
