## Profile/Photo Observation Report

Street:	<b>EDGEWATER DR</b>	Flow Control:	<b>Not Controlled</b>
City:	<b>Hobart, IN</b>	Year Renewed:	
Location:	<b>Other</b>	Tape/Media #:	
Purpose:	<b>Not Known</b>	Dia/Height:	<b>10"</b>
Use:	<b>Sanitary</b>	Material:	<b>PVC</b>
Drain Area:	<b>NA</b>	Lining:	
Category:	<b>NA</b>		
Comment:

Location Details:		Direction of Survey:	<b>Upstream</b>
US MH:	<b>M-703-035</b>	DS MH:	<b>M-703-016</b>
		Total Length Surveyed (ft):	<b>302.7</b>

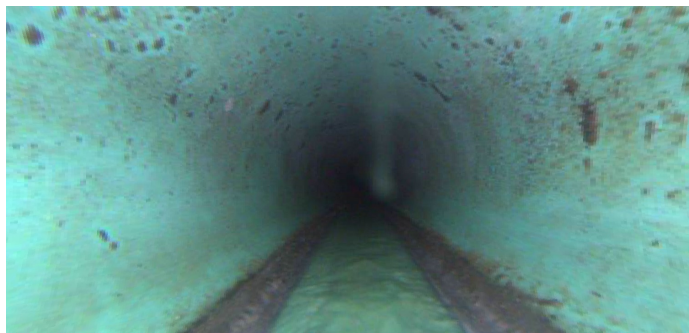
Code: **AMH**  
Description: **Manhole**

Distance (ft): **.0**  
Structural Grade: **0**  
O&M Grade: **0**  
Clock Start/From:  
Clock To:  
1st Value:  
2nd Value:  
Value Percent:  
Continuous Index:  
Within 8" of Joint: **NO**  
Remarks: **M-703-016**

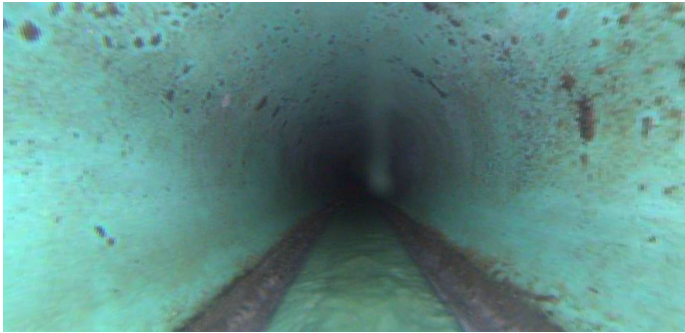
Code:	<b>MWL</b>
Description:	<b>Water Level</b>

Distance (ft):	<b>.0</b>
Structural Grade:	<b>0</b>
O&M Grade:	<b>0</b>
Clock Start/From:	
Clock To:	
1st Value:	
2nd Value:	
Value Percent:	<b>5.000</b>
Continuous Index:	
Within 8" of Joint:	<b>NO</b>
Remarks:

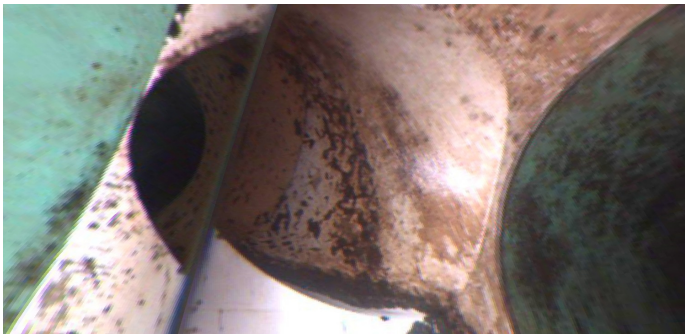
Code:	<b>TF</b>
Description:	<b>Tap Factory</b>

Distance (ft):	<b>83.9</b>
Structural Grade:	<b>0</b>
O&M Grade:	<b>0</b>
Clock Start/From:	<b>10</b>
Clock To:	
1st Value:	<b>4.000</b>
2nd Value:	
Value Percent:	
Continuous Index:	
Within 8" of Joint:	
Remarks:

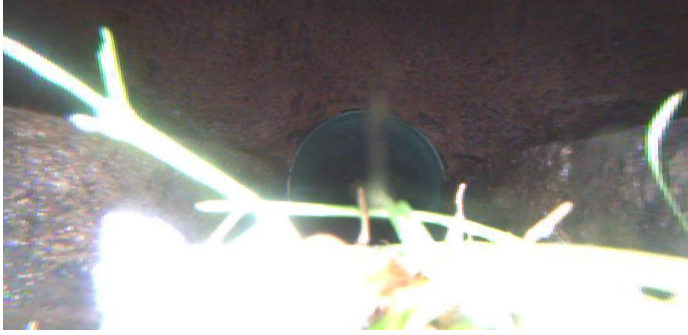
Code:	<b>AMH</b>
Description:	<b>Manhole</b>
Distance (ft):	<b>302.7</b>
Structural Grade:	<b>0</b>
O&M Grade:	<b>0</b>
Clock Start/From:	
Clock To:	
1st Value:	
2nd Value:	
Value Percent:	
Continuous Index:	
Within 8" of Joint:	<b>NO</b>
Remarks:	<b>M-703-035</b>
