## Profile/Photo Observation Report

Street:	<b>EDGEWATER DR &amp; HIDDEN LAKE DR</b>	Flow Control:	<b>Not Controlled</b>
City:	<b>Hobart, IN</b>	Year Renewed:	
Location:	<b>Other</b>	Tape/Media #:	
Purpose:	<b>Not Known</b>	Dia/Height:	<b>10"</b>
Use:	<b>Sanitary</b>	Material:	<b>PVC</b>
Drain Area:	<b>NA</b>	Lining:	
Category:	<b>NA</b>		
Comment:

Location Details:		Direction of Survey:	<b>Downstream</b>
US MH:	<b>M-703-035</b>	DS MH:	<b>M-703-034</b>
		Total Length Surveyed (ft):	<b>306.8</b>

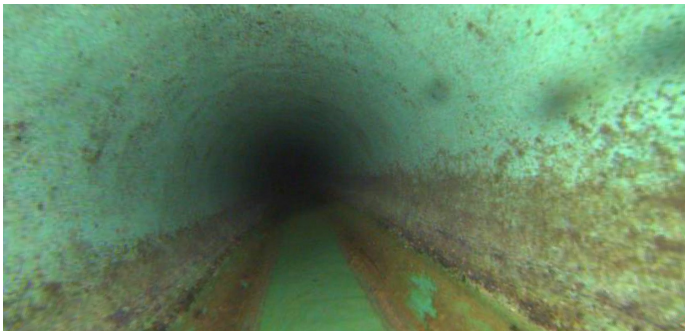
Code: **AMH**  
Description: **Manhole**

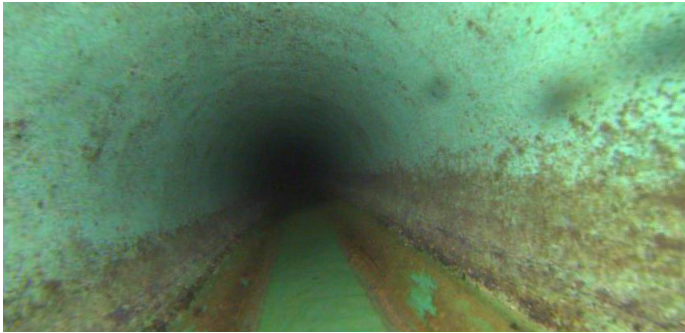
Code:	<b>MWL</b>
Description:	<b>Water Level</b>

Distance (ft):	<b>.0</b>
Structural Grade:	<b>0</b>
O&M Grade:	<b>0</b>
Clock Start/From:	
Clock To:	
1st Value:	
2nd Value:	
Value Percent:	<b>5.000</b>
Continuous Index:	
Within 8" of Joint:	<b>NO</b>
Remarks:

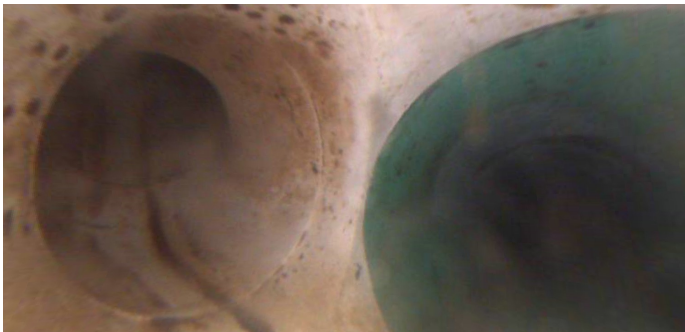
Code:	<b>TF</b>
Description:	<b>Tap Factory</b>

Distance (ft):	<b>43.1</b>
Structural Grade:	<b>0</b>
O&M Grade:	<b>0</b>
Clock Start/From:	<b>3</b>
Clock To:	
1st Value:	<b>4.000</b>
2nd Value:	
Value Percent:	
Continuous Index:	
Within 8" of Joint:	
Remarks:

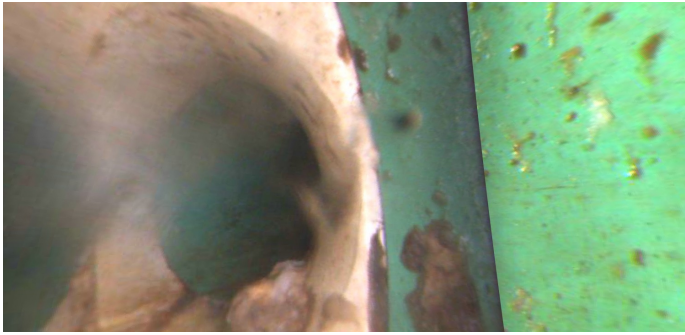
Code: **TF**  
Description: **Tap Factory**

Distance (ft): **45.5**  
Structural Grade: **0**  
O&M Grade: **0**  
Clock Start/From: **9**  
Clock To:  
1st Value: **4.000**  
2nd Value:  
Value Percent:  
Continuous Index:  
Within 8" of Joint:  
Remarks:

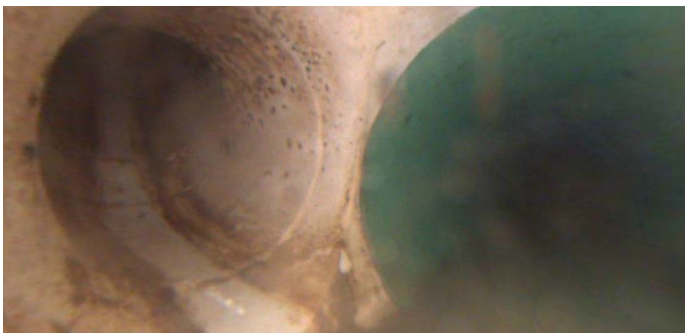
Code: **TFA**  
Description: **Tap Factory Active**

Distance (ft): **119.4**  
Structural Grade: **0**  
O&M Grade: **0**  
Clock Start/From: **3**  
Clock To:  
1st Value: **4.000**  
2nd Value:  
Value Percent:  
Continuous Index:  
Within 8" of Joint:  
Remarks:

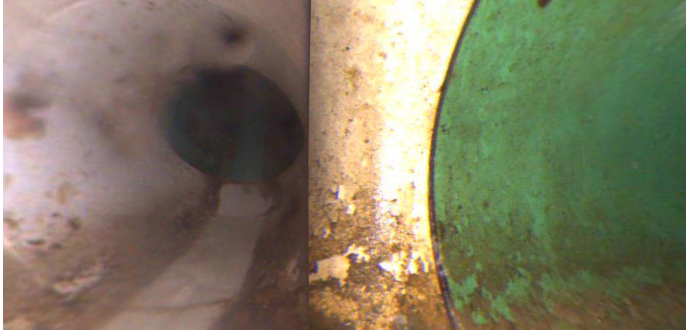
Code: **TFA**  
Description: **Tap Factory Active**

Distance (ft): **121.4**  
Structural Grade: **0**  
O&M Grade: **0**  
Clock Start/From: **9**  
Clock To:  
1st Value: **4.000**  
2nd Value:  
Value Percent:  
Continuous Index:  
Within 8" of Joint:  
Remarks:

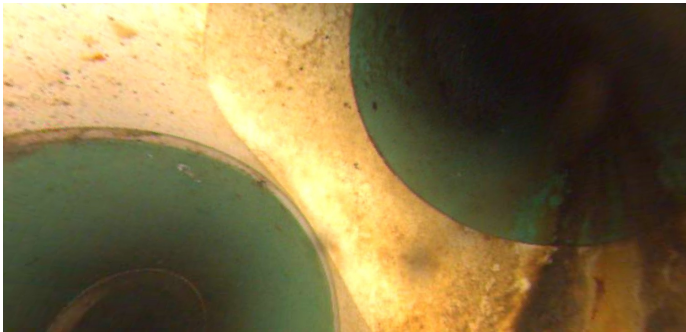
Code: **TF**  
Description: **Tap Factory**

Distance (ft): **205.4**  
Structural Grade: **0**  
O&M Grade: **0**  
Clock Start/From: **2**  
Clock To:  
1st Value: **4.000**  
2nd Value:  
Value Percent:  
Continuous Index:  
Within 8" of Joint:  
Remarks:

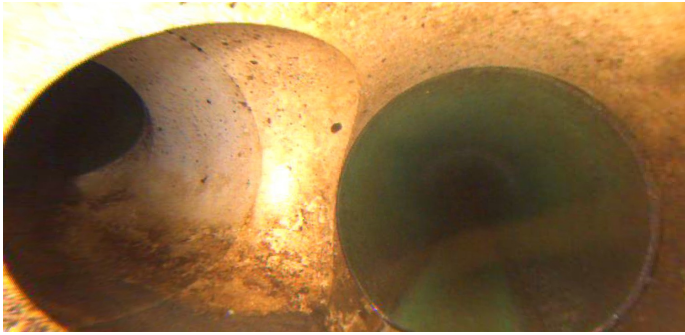
Code: **TFA**  
Description: **Tap Factory Active**

Distance (ft): **207.3**  
Structural Grade: **0**  
O&M Grade: **0**  
Clock Start/From: **9**  
Clock To:  
1st Value: **4.000**  
2nd Value:  
Value Percent:  
Continuous Index:  
Within 8" of Joint:  
Remarks:

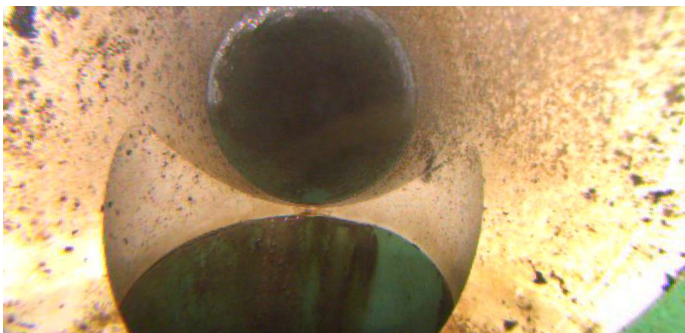
Code: **TF**  
Description: **Tap Factory**

Distance (ft): **303.7**  
Structural Grade: **0**  
O&M Grade: **0**  
Clock Start/From: **6**  
Clock To:  
1st Value: **6.000**  
2nd Value:  
Value Percent:  
Continuous Index:  
Within 8" of Joint:  
Remarks: **DROP CONNECTION**

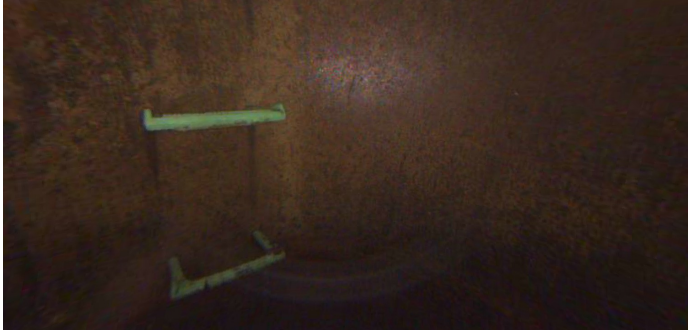
Code:	AMH
Description:	Manhole
Distance (ft):	306.8
Structural Grade:	0
O&M Grade:	0
Clock Start/From:	
Clock To:	
1st Value:	
2nd Value:	
Value Percent:	
Continuous Index:	
Within 8" of Joint:	NO
Remarks:	M-703-034
