Profile/Photo Observation Report

Street:	hidden lake dr	Flow Control:	Not Controlled
City:	Hobart, IN	Year Renewed:	
Location:	Other	Tape/Media #:	
Purpose:	Not Known	Dia/Height:	10"
Use:	Sanitary	Material:	PVC
Drain Area:	NA	Lining:	
Category:	NA		
Comment:

Location Details:		Direction of Survey:	Downstream
US MH:	M-703-035	DS MH:	M-703-034
		Total Length Surveyed (ft):	306.8

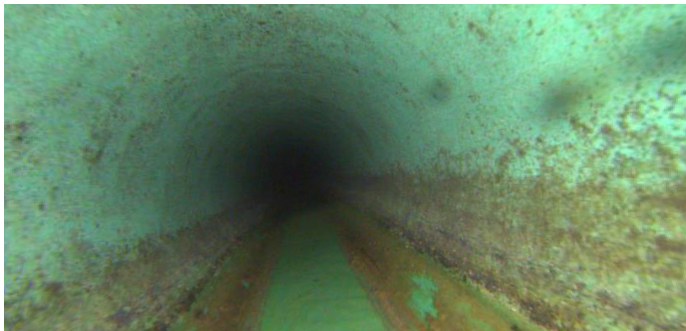
Code: **AMH**
Description: **Manhole**

Distance (ft): **.0**
Structural Grade: **0**
O&M Grade: **0**
Clock Start/From:
Clock To:
1st Value:
2nd Value:
Value Percent:
Continuous Index:
Within 8" of Joint: **NO**
Remarks: **M-703-035**

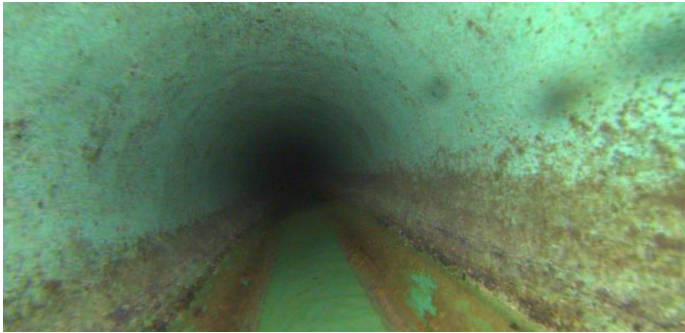
Code:	MWL
Description:	Water Level

Distance (ft):	.0
Structural Grade:	0
O&M Grade:	0
Clock Start/From:	
Clock To:	
1st Value:	
2nd Value:	
Value Percent:	5.000
Continuous Index:	
Within 8" of Joint:	NO
Remarks:

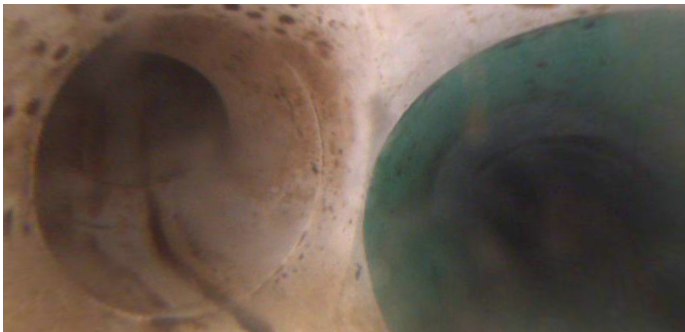
Code:	TF
Description:	Tap Factory

Distance (ft):	43.1
Structural Grade:	0
O&M Grade:	0
Clock Start/From:	3
Clock To:	
1st Value:	4.000
2nd Value:	
Value Percent:	
Continuous Index:	
Within 8" of Joint:	
Remarks:

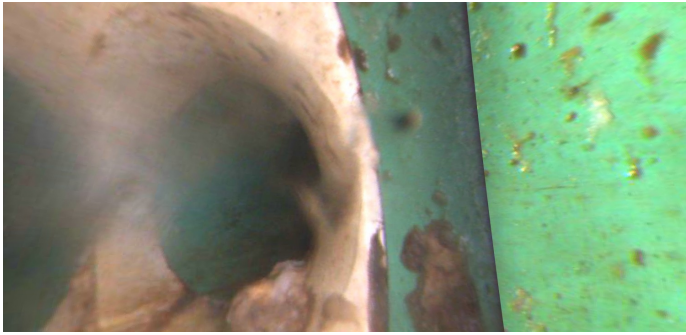
Code: **TF**
Description: **Tap Factory**

Distance (ft): **45.5**
Structural Grade: **0**
O&M Grade: **0**
Clock Start/From: **9**
Clock To:
1st Value: **4.000**
2nd Value:
Value Percent:
Continuous Index:
Within 8" of Joint:
Remarks:

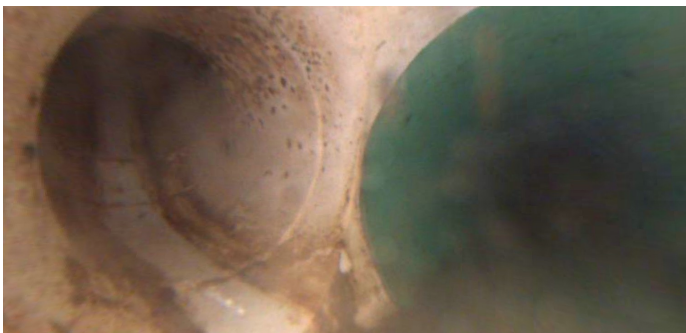
Code: **TFA**
Description: **Tap Factory Active**

Distance (ft): **119.4**
Structural Grade: **0**
O&M Grade: **0**
Clock Start/From: **3**
Clock To:
1st Value: **4.000**
2nd Value:
Value Percent:
Continuous Index:
Within 8" of Joint:
Remarks:

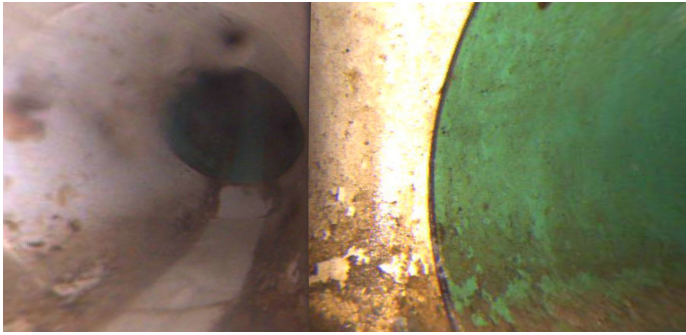
Code: **TFA**
Description: **Tap Factory Active**

Distance (ft): **121.4**
Structural Grade: **0**
O&M Grade: **0**
Clock Start/From: **9**
Clock To:
1st Value: **4.000**
2nd Value:
Value Percent:
Continuous Index:
Within 8" of Joint:
Remarks:

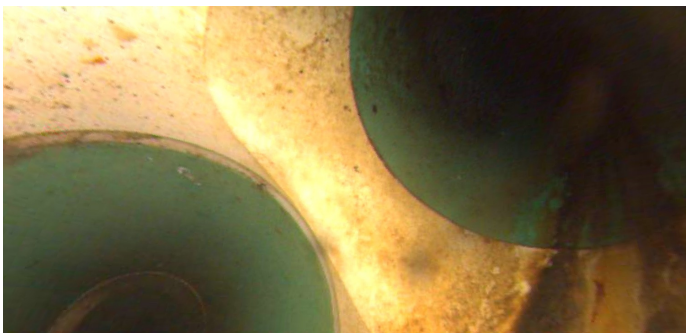
Code: **TF**
Description: **Tap Factory**

Distance (ft): **205.4**
Structural Grade: **0**
O&M Grade: **0**
Clock Start/From: **2**
Clock To:
1st Value: **4.000**
2nd Value:
Value Percent:
Continuous Index:
Within 8" of Joint:
Remarks:

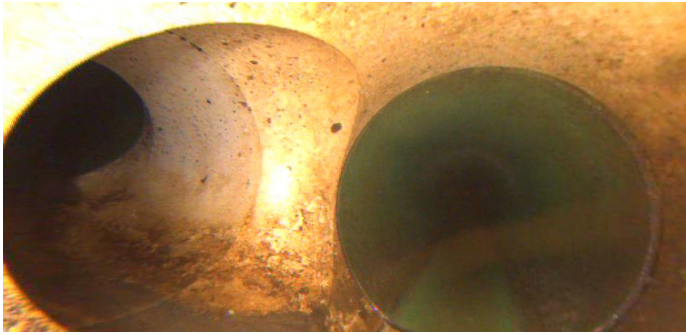
Code: **TFA**
Description: **Tap Factory Active**

Distance (ft): **207.3**
Structural Grade: **0**
O&M Grade: **0**
Clock Start/From: **9**
Clock To:
1st Value: **4.000**
2nd Value:
Value Percent:
Continuous Index:
Within 8" of Joint:
Remarks:

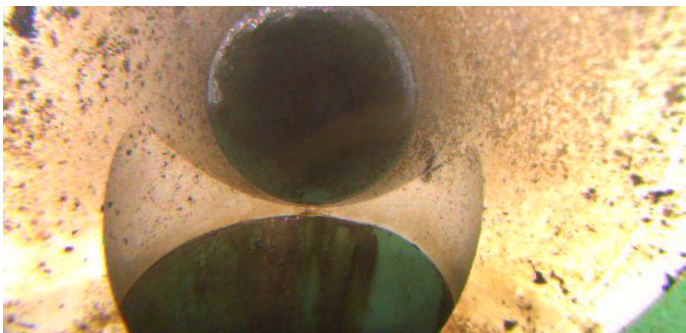
Code: **TF**
Description: **Tap Factory**

Distance (ft): **303.7**
Structural Grade: **0**
O&M Grade: **0**
Clock Start/From: **6**
Clock To:
1st Value: **6.000**
2nd Value:
Value Percent:
Continuous Index:
Within 8" of Joint:
Remarks: **DROP CONNECTION**

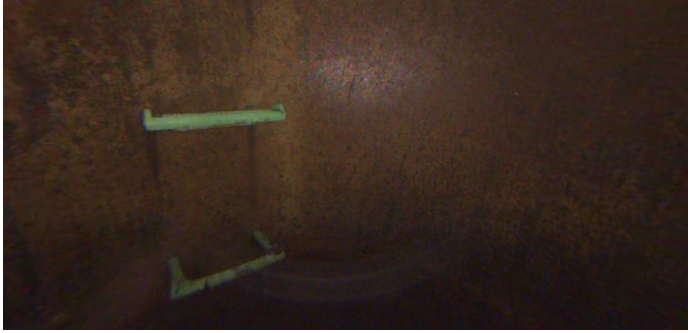
Code:	AMH
Description:	Manhole
Distance (ft):	306.8
Structural Grade:	0
O&M Grade:	0
Clock Start/From:	
Clock To:	
1st Value:	
2nd Value:	
Value Percent:	
Continuous Index:	
Within 8" of Joint:	NO
Remarks:	M-703-034
