Profile/Photo Observation Report

Date:	03/27/2018	Weather:		Coding:	PACP 6.0
Pipe Length (ft):	103.1	Owner:	NA	Pre Clean:	Not Known
P.O.#:		Surveyor:	Jen Costello	PSR:	P-703-035-036
Customer:		Clean Date:	01/01/1900	Shape:	C

Street:	EDGEWATER DR & DEERPATH CT	Flow Control:	Not Controlled
City:	Hobart, IN	Year Renewed:	
Location:	Other	Tape/Media #:	
Purpose:	Not Known	Dia/Height:	10"
Use:	Sanitary	Material:	PVC
Drain Area:	NA	Lining:	
Category:	NA		
Comment:

Location Details:		Direction of Survey:	Upstream
US MH:	M-703-036	DS MH:	M-703-035
		Total Length Surveyed (ft):	99.9

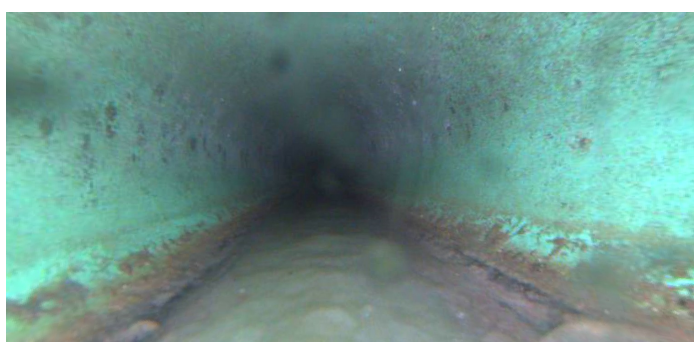
Code: **AMH**
Description: **Manhole**

Distance (ft): **.0**
Structural Grade: **0**
O&M Grade: **0**
Clock Start/From:
Clock To:
1st Value:
2nd Value:
Value Percent:
Continuous Index:
Within 8" of Joint: **NO**
Remarks: **M-703-035**

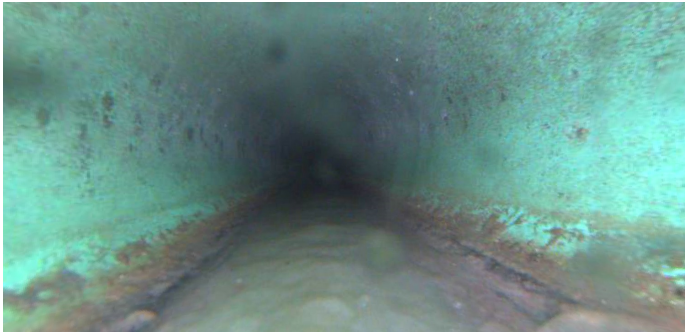
Code:	MWL
Description:	Water Level

Distance (ft):	.0
Structural Grade:	0
O&M Grade:	0
Clock Start/From:	
Clock To:	
1st Value:	
2nd Value:	
Value Percent:	10.000
Continuous Index:	
Within 8" of Joint:	NO
Remarks:

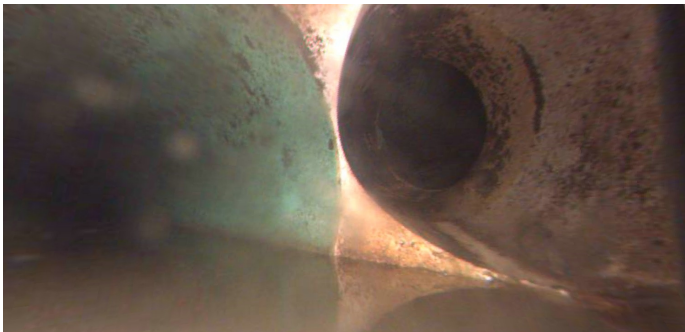
Code:	TFA
Description:	Tap Factory Active

Distance (ft):	89.5
Structural Grade:	0
O&M Grade:	0
Clock Start/From:	9
Clock To:	
1st Value:	4.000
2nd Value:	
Value Percent:	
Continuous Index:	
Within 8" of Joint:	
Remarks:

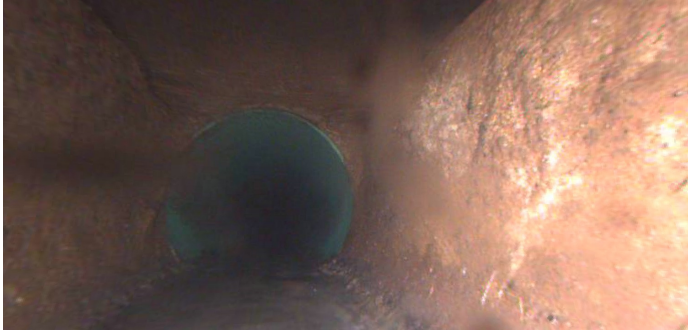
Code:	AMH
Description:	Manhole
Distance (ft):	99.9
Structural Grade:	0
O&M Grade:	0
Clock Start/From:	
Clock To:	
1st Value:	
2nd Value:	
Value Percent:	
Continuous Index:	
Within 8" of Joint:	NO
Remarks:	M-703-036
