## Profile/Photo Observation Report

Street:	<b>hidden lake dr</b>	Flow Control:	<b>Not Controlled</b>
City:	<b>Hobart, IN</b>	Year Renewed:	
Location:	<b>Other</b>	Tape/Media #:	
Purpose:	<b>Not Known</b>	Dia/Height:	<b>10"</b>
Use:	<b>Sanitary</b>	Material:	<b>PVC</b>
Drain Area:	<b>NA</b>	Lining:	
Category:	<b>NA</b>		
Comment:

Location Details:		Direction of Survey:	<b>Upstream</b>
US MH:	<b>M-703-036</b>	DS MH:	<b>M-703-035</b>
		Total Length Surveyed (ft):	<b>99.9</b>

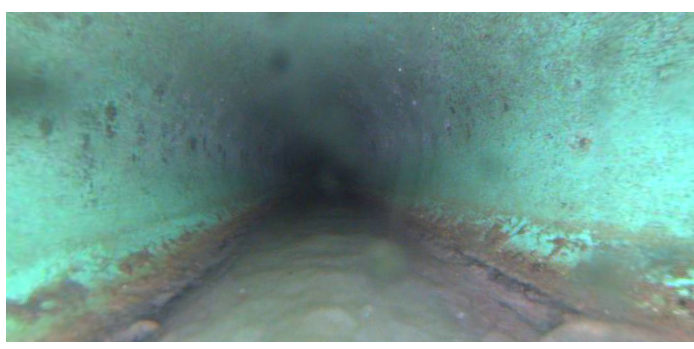
Code: **AMH**  
Description: **Manhole**

Distance (ft): **.0**  
Structural Grade: **0**  
O&M Grade: **0**  
Clock Start/From:  
Clock To:  
1st Value:  
2nd Value:  
Value Percent:  
Continuous Index:  
Within 8" of Joint: **NO**  
Remarks: **M-703-035**

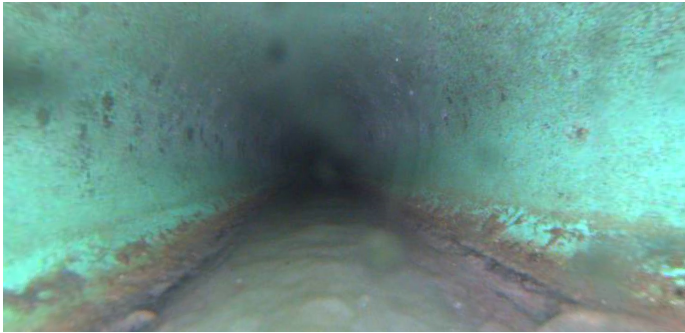
Code:	<b>MWL</b>
Description:	<b>Water Level</b>

Distance (ft):	<b>.0</b>
Structural Grade:	<b>0</b>
O&M Grade:	<b>0</b>
Clock Start/From:	
Clock To:	
1st Value:	
2nd Value:	
Value Percent:	<b>10.000</b>
Continuous Index:	
Within 8" of Joint:	<b>NO</b>
Remarks:

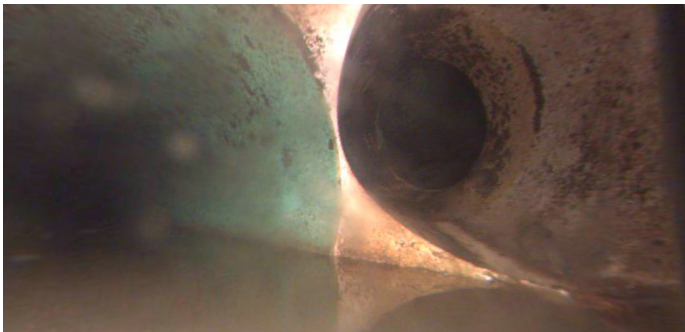
Code:	<b>TFA</b>
Description:	<b>Tap Factory Active</b>

Distance (ft):	<b>89.5</b>
Structural Grade:	<b>0</b>
O&M Grade:	<b>0</b>
Clock Start/From:	<b>9</b>
Clock To:	
1st Value:	<b>4.000</b>
2nd Value:	
Value Percent:	
Continuous Index:	
Within 8" of Joint:	
Remarks:

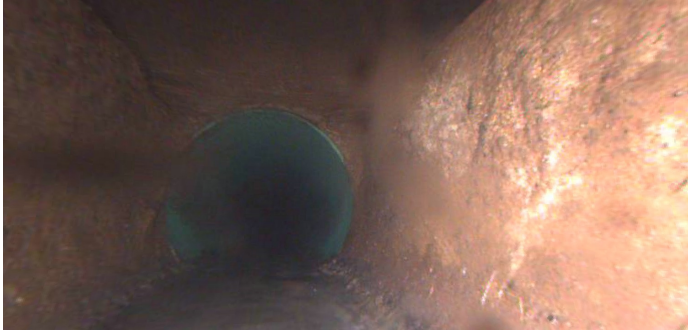
Code:	<b>AMH</b>
Description:	<b>Manhole</b>
Distance (ft):	<b>99.9</b>
Structural Grade:	<b>0</b>
O&M Grade:	<b>0</b>
Clock Start/From:	
Clock To:	
1st Value:	
2nd Value:	
Value Percent:	
Continuous Index:	
Within 8" of Joint:	<b>NO</b>
Remarks:	<b>M-703-036</b>
