## Profile/Photo Observation Report

Street:	<b>EDGEWATER DR</b>	Flow Control:	<b>Not Controlled</b>
City:	<b>Hobart, IN</b>	Year Renewed:	
Location:	<b>Other</b>	Tape/Media #:	
Purpose:	<b>Not Known</b>	Dia/Height:	<b>10"</b>
Use:	<b>Sanitary</b>	Material:	<b>PVC</b>
Drain Area:	<b>NA</b>	Lining:	
Category:	<b>NA</b>		
Comment:

Location Details:		Direction of Survey:	<b>Downstream</b>
US MH:	<b>M-703-037</b>	DS MH:	<b>M-703-036</b>
		Total Length Surveyed (ft):	<b>249.9</b>

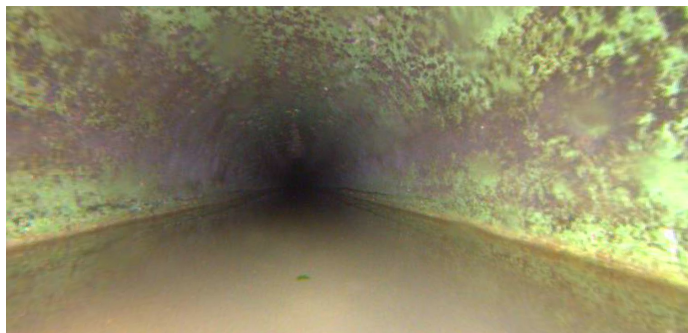
Code: **AMH**  
Description: **Manhole**

Distance (ft): **.0**  
Structural Grade: **0**  
O&M Grade: **0**  
Clock Start/From:  
Clock To:  
1st Value:  
2nd Value:  
Value Percent:  
Continuous Index:  
Within 8" of Joint: **NO**  
Remarks: **M-703-037**

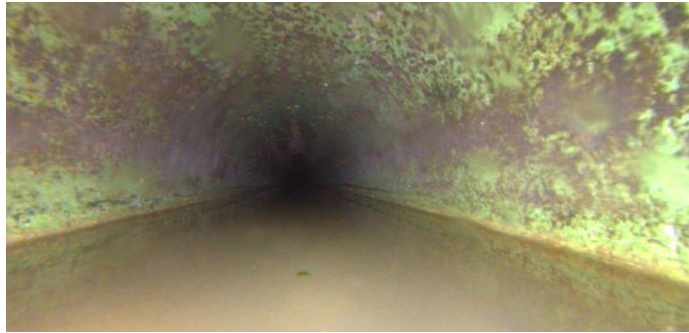
Code: **MWL**  
Description: **Water Level**

Distance (ft): **.0**  
Structural Grade: **0**  
O&M Grade: **0**  
Clock Start/From:  
Clock To:  
1st Value:  
2nd Value:  
Value Percent: **40.000**  
Continuous Index:  
Within 8" of Joint: **NO**  
Remarks:

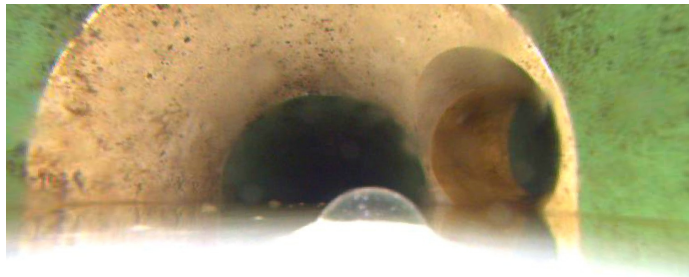
Code: **TFA**  
Description: **Tap Factory Active**

Distance (ft): **66.7**  
Structural Grade: **0**  
O&M Grade: **0**  
Clock Start/From: **3**  
Clock To:  
1st Value: **4.000**  
2nd Value:  
Value Percent:  
Continuous Index:  
Within 8" of Joint:  
Remarks:

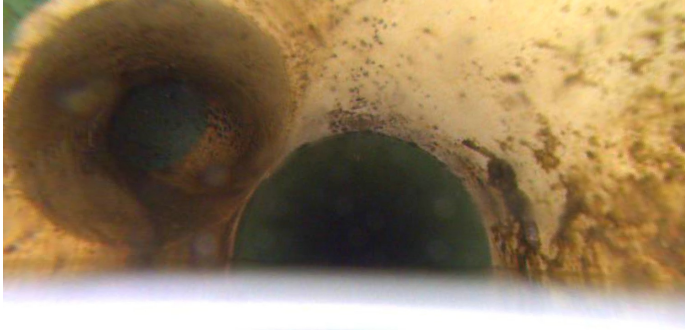
Code: **TF**  
Description: **Tap Factory**

Distance (ft): **89.2**  
Structural Grade: **0**  
O&M Grade: **0**  
Clock Start/From: **10**  
Clock To:  
1st Value: **4.000**  
2nd Value:  
Value Percent:  
Continuous Index:  
Within 8" of Joint:  
Remarks:

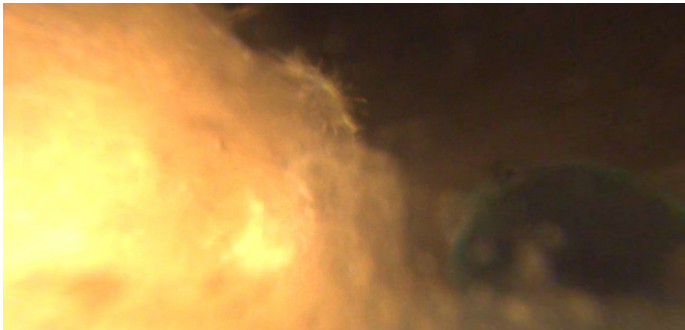
Code: **AMH**  
Description: **Manhole**

Distance (ft): **249.9**  
Structural Grade: **0**  
O&M Grade: **0**  
Clock Start/From:  
Clock To:  
1st Value:  
2nd Value:  
Value Percent:  
Continuous Index:  
Within 8" of Joint: **NO**  
Remarks: **M-703-036**
