Profile/Photo Observation Report

Street:	EDGEWATER DR	Flow Control:	Not Controlled
City:	Hobart, IN	Year Renewed:	
Location:	Other	Tape/Media #:	
Purpose:	Not Known	Dia/Height:	10"
Use:	Sanitary	Material:	PVC
Drain Area:	NA	Lining:	
Category:	NA		
Comment:

Location Details:		Direction of Survey:	Downstream
US MH:	M-703-037	DS MH:	M-703-036
		Total Length Surveyed (ft):	249.9

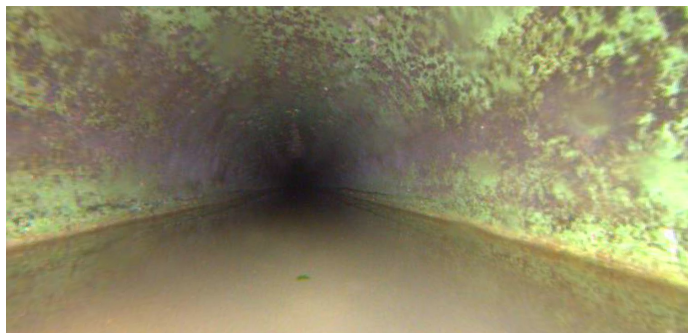
Code: **AMH**
 Description: **Manhole**

Distance (ft): **.0**
 Structural Grade: **0**
 O&M Grade: **0**
 Clock Start/From:
 Clock To:
 1st Value:
 2nd Value:
 Value Percent:
 Continuous Index:
 Within 8" of Joint: **NO**
 Remarks: **M-703-037**

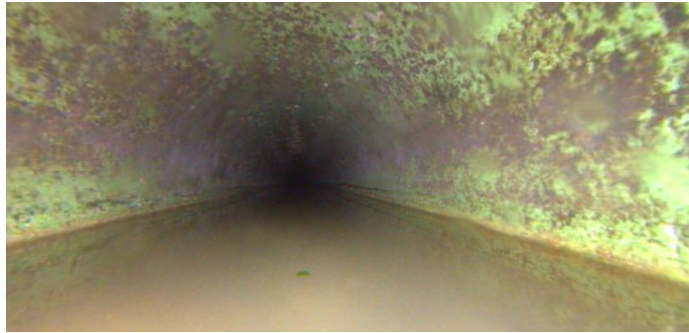
Code: **MWL**
Description: **Water Level**

Distance (ft): **.0**
Structural Grade: **0**
O&M Grade: **0**
Clock Start/From:
Clock To:
1st Value:
2nd Value:
Value Percent: **40.000**
Continuous Index:
Within 8" of Joint: **NO**
Remarks:

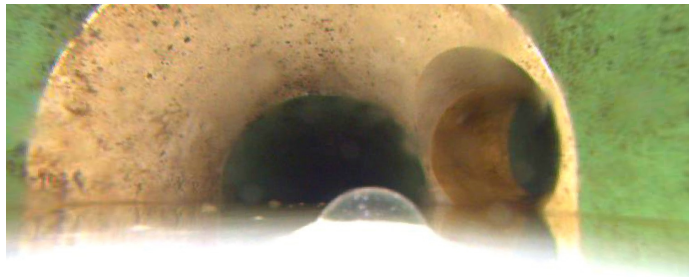
Code: **TFA**
Description: **Tap Factory Active**

Distance (ft): **66.7**
Structural Grade: **0**
O&M Grade: **0**
Clock Start/From: **3**
Clock To:
1st Value: **4.000**
2nd Value:
Value Percent:
Continuous Index:
Within 8" of Joint:
Remarks:

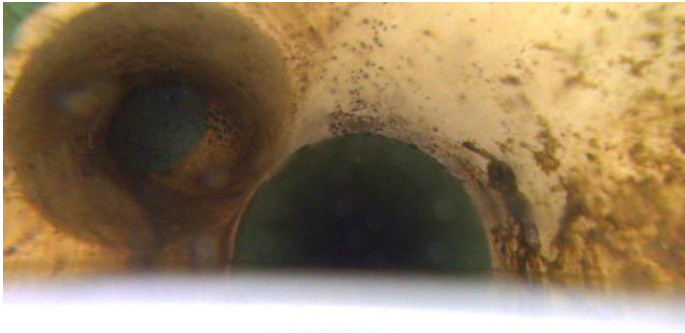
Code: **TF**
Description: **Tap Factory**

Distance (ft): **89.2**
Structural Grade: **0**
O&M Grade: **0**
Clock Start/From: **10**
Clock To:
1st Value: **4.000**
2nd Value:
Value Percent:
Continuous Index:
Within 8" of Joint:
Remarks:

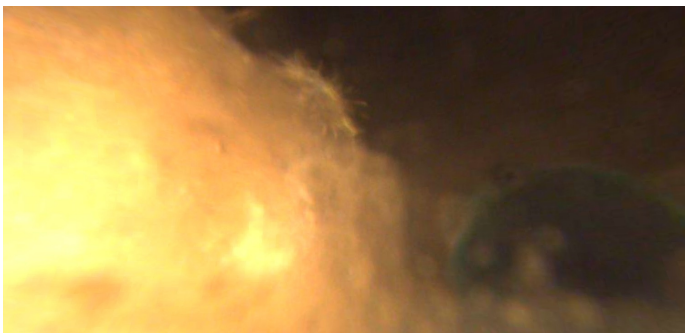
Code: **AMH**
Description: **Manhole**

Distance (ft): **249.9**
Structural Grade: **0**
O&M Grade: **0**
Clock Start/From:
Clock To:
1st Value:
2nd Value:
Value Percent:
Continuous Index:
Within 8" of Joint: **NO**
Remarks: **M-703-036**
