Profile/Photo Observation Report

Street:	EDGEWATER DR	Flow Control:	Not Controlled
City:	Hobart, IN	Year Renewed:	
Location:	Other	Tape/Media #:	
Purpose:	Not Known	Dia/Height:	8"
Use:	Sanitary	Material:	PVC
Drain Area:	NA	Lining:	
Category:	NA		
Comment:

Location Details:		Direction of Survey:	Upstream
US MH:	M-703-037	DS MH:	M-704-067
		Total Length Surveyed (ft):	363.6

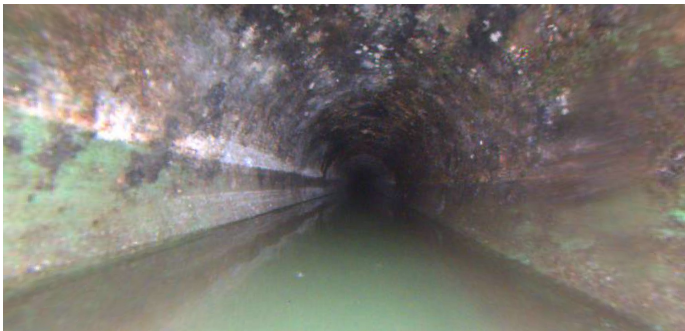
Code:	DAGS
Description:	Deposits Attached Grease

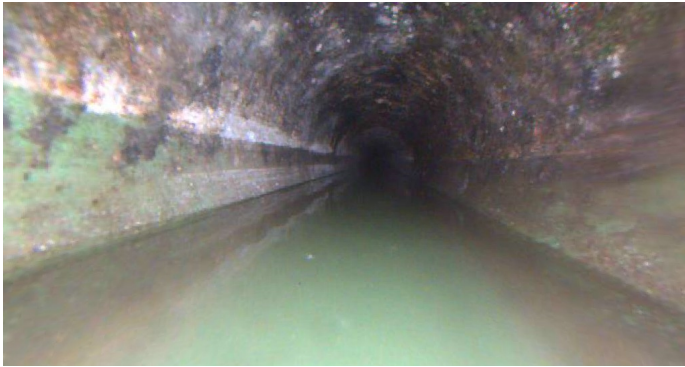
Code:	AMH
Description:	Manhole

Distance (ft):	.0
Structural Grade:	0
O&M Grade:	0
Clock Start/From:	
Clock To:	
1st Value:	
2nd Value:	
Value Percent:	
Continuous Index:	
Within 8" of Joint:	NO
Remarks:	M-704-067

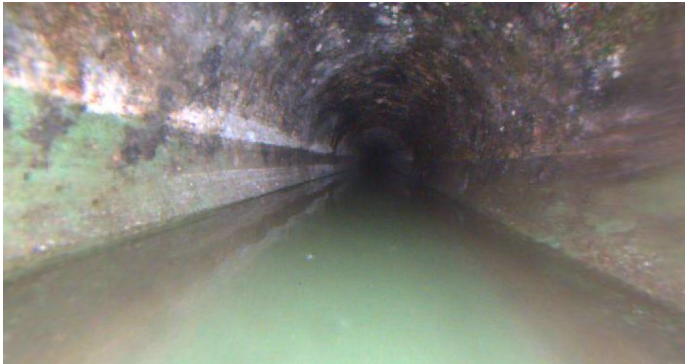
Code:	MWL
Description:	Water Level

Distance (ft):	.0
Structural Grade:	0
O&M Grade:	0
Clock Start/From:	
Clock To:	
1st Value:	
2nd Value:	
Value Percent:	10.000
Continuous Index:	
Within 8" of Joint:	NO
Remarks:

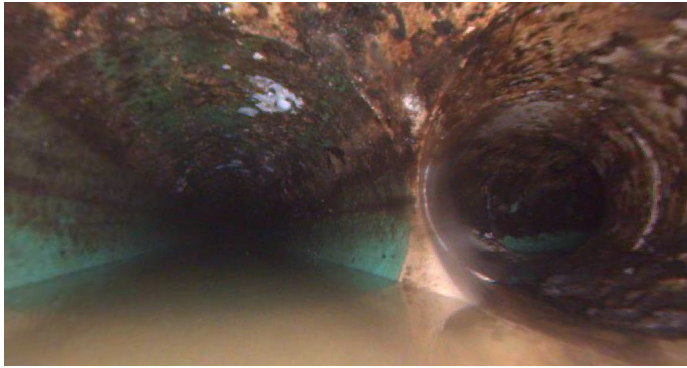
Code: **TF**
Description: **Tap Factory**

Distance (ft): **63.3**
Structural Grade: **0**
O&M Grade: **0**
Clock Start/From: **4**
Clock To:
1st Value: **4.000**
2nd Value:
Value Percent:
Continuous Index:
Within 8" of Joint:
Remarks:

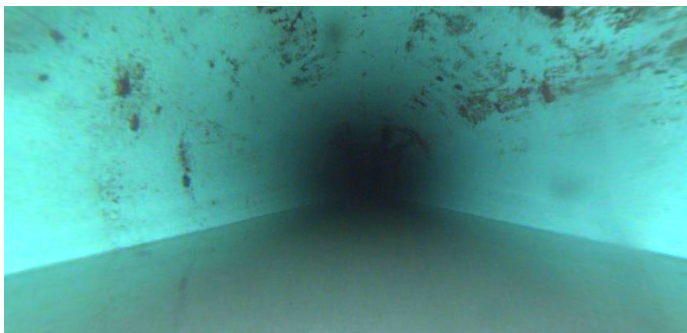
Code: **DAGS**
Description: **Deposits Attached Grease**

Distance (ft): **117.7**
Structural Grade: **0**
O&M Grade: **2**
Clock Start/From: **8**
Clock To: **4**
1st Value:
2nd Value:
Value Percent: **5.000**
Continuous Index: **F01**
Within 8" of Joint: **NO**
Remarks:

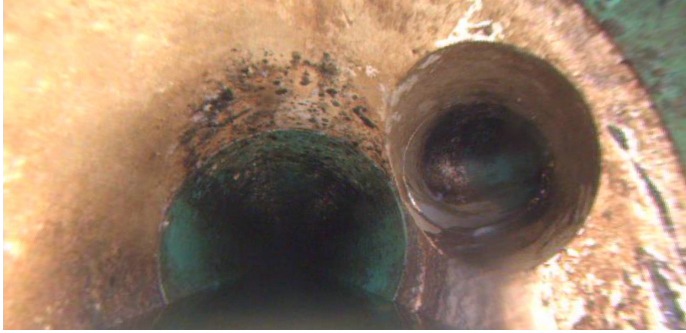
Code: **TF**
Description: **Tap Factory**

Distance (ft): **147.2**
Structural Grade: **0**
O&M Grade: **0**
Clock Start/From: **2**
Clock To:
1st Value: **4.000**
2nd Value:
Value Percent:
Continuous Index:
Within 8" of Joint:
Remarks:

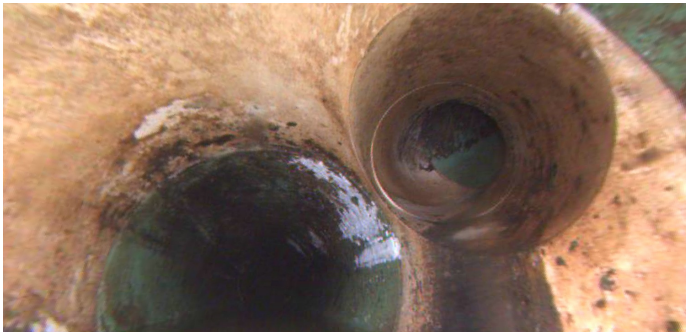
Code: **TF**
Description: **Tap Factory**

Distance (ft): **238.7**
Structural Grade: **0**
O&M Grade: **0**
Clock Start/From: **2**
Clock To:
1st Value: **4.000**
2nd Value:
Value Percent:
Continuous Index:
Within 8" of Joint:
Remarks:

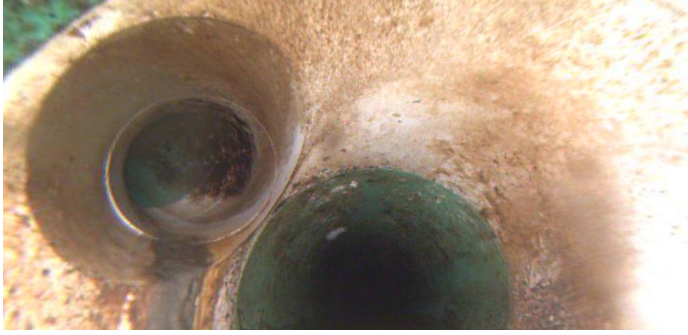
Code: **TF**
Description: **Tap Factory**

Distance (ft): **250.6**
Structural Grade: **0**
O&M Grade: **0**
Clock Start/From: **10**
Clock To:
1st Value: **4.000**
2nd Value:
Value Percent:
Continuous Index:
Within 8" of Joint:
Remarks:

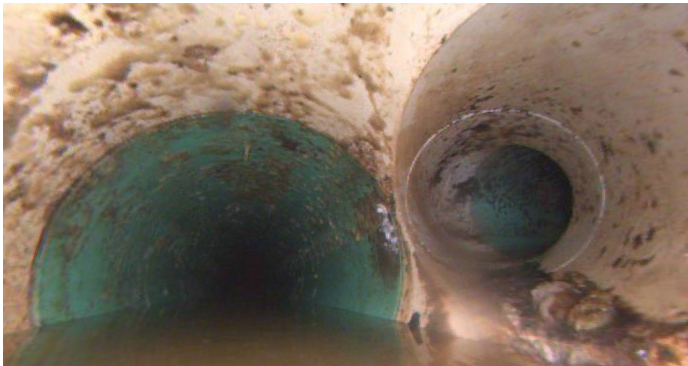
Code: **TF**
Description: **Tap Factory**

Distance (ft): **323.1**
Structural Grade: **0**
O&M Grade: **0**
Clock Start/From: **4**
Clock To:
1st Value: **4.000**
2nd Value:
Value Percent:
Continuous Index:
Within 8" of Joint:
Remarks:

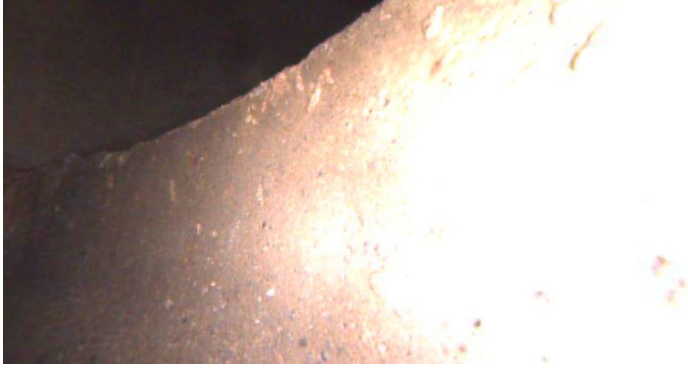
Code:	AMH
Description:	Manhole
Distance (ft):	363.6
Structural Grade:	0
O&M Grade:	0
Clock Start/From:	
Clock To:	
1st Value:	
2nd Value:	
Value Percent:	
Continuous Index:	
Within 8" of Joint:	NO
Remarks:	M-703-037
