Profile/Photo Observation Report

Street:	Edgewater Dr.	Flow Control:	Not Controlled
City:	Hobart, IN	Year Renewed:	
Location:	Other	Tape/Media #:	
Purpose:	Not Known	Dia/Height:	8"
Use:	Sanitary	Material:	PVC
Drain Area:	NA	Lining:	
Category:	NA		
Comment:

Location Details:		Direction of Survey:	Upstream
US MH:	M-703-037	DS MH:	M-704-067
		Total Length Surveyed (ft):	363.6

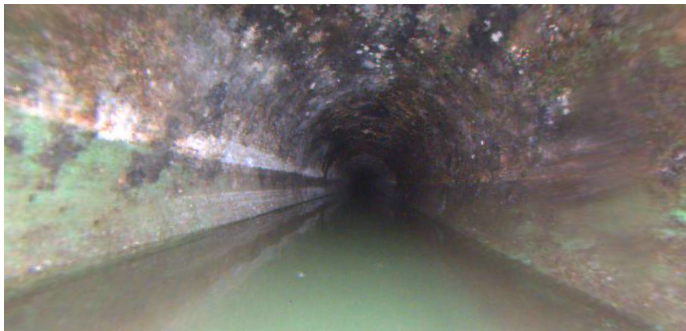
Code: **DAGS**
Description: **Deposits Attached Grease**

Distance (ft): **.0**
Structural Grade: **0**
O&M Grade: **2**
Clock Start/From: **8**
Clock To: **4**
1st Value:
2nd Value:
Value Percent: **5.000**
Continuous Index: **S01**
Within 8" of Joint: **NO**
Remarks:

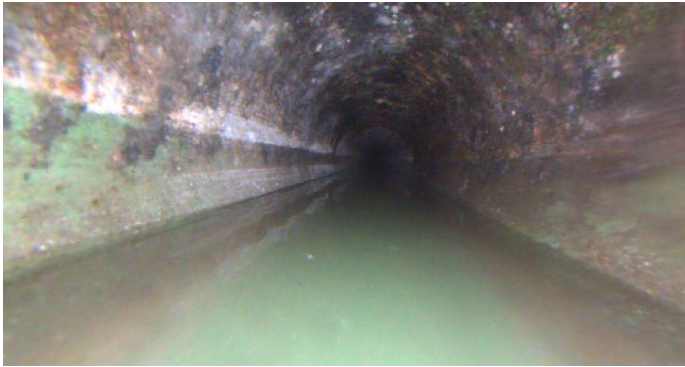
Code: **AMH**
Description: **Manhole**

Distance (ft): **.0**
Structural Grade: **0**
O&M Grade: **0**
Clock Start/From:
Clock To:
1st Value:
2nd Value:
Value Percent:
Continuous Index:
Within 8" of Joint: **NO**
Remarks: **M-704-067**

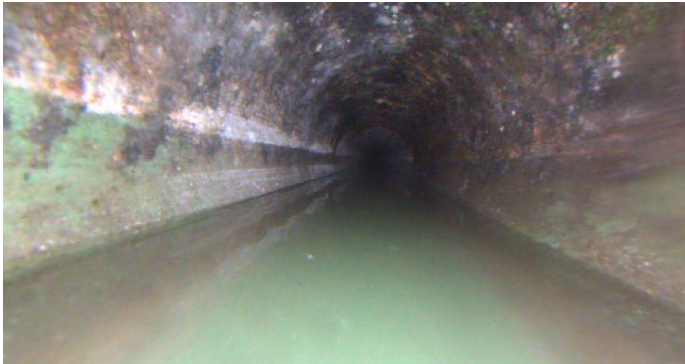
Code: **MWL**
Description: **Water Level**

Distance (ft): **.0**
Structural Grade: **0**
O&M Grade: **0**
Clock Start/From:
Clock To:
1st Value:
2nd Value:
Value Percent: **10.000**
Continuous Index:
Within 8" of Joint: **NO**
Remarks:

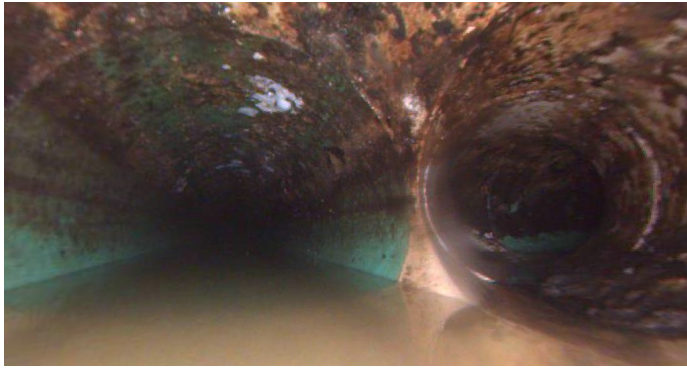
Code: **TF**
Description: **Tap Factory**

Distance (ft): **63.3**
Structural Grade: **0**
O&M Grade: **0**
Clock Start/From: **4**
Clock To:
1st Value: **4.000**
2nd Value:
Value Percent:
Continuous Index:
Within 8" of Joint:
Remarks:

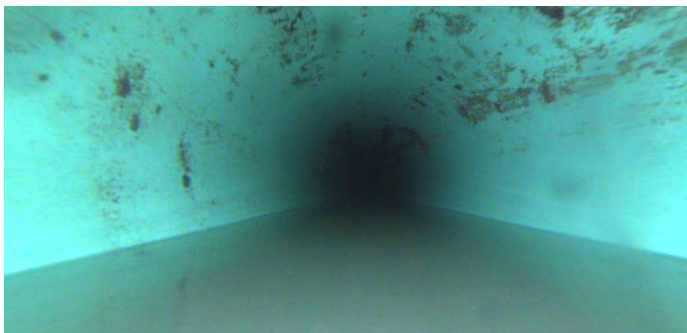
Code: **DAGS**
Description: **Deposits Attached Grease**

Distance (ft): **117.7**
Structural Grade: **0**
O&M Grade: **2**
Clock Start/From: **8**
Clock To: **4**
1st Value:
2nd Value:
Value Percent: **5.000**
Continuous Index: **F01**
Within 8" of Joint: **NO**
Remarks:

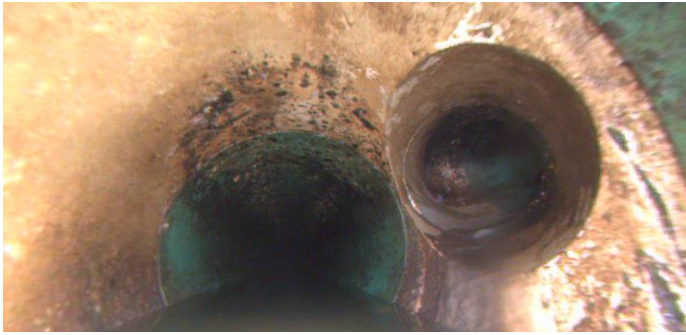
Code: **TF**
Description: **Tap Factory**

Distance (ft): **147.2**
Structural Grade: **0**
O&M Grade: **0**
Clock Start/From: **2**
Clock To:
1st Value: **4.000**
2nd Value:
Value Percent:
Continuous Index:
Within 8" of Joint:
Remarks:

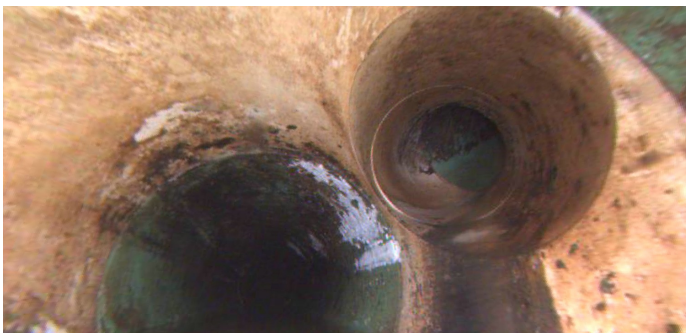
Code: **TF**
Description: **Tap Factory**

Distance (ft): **238.7**
Structural Grade: **0**
O&M Grade: **0**
Clock Start/From: **2**
Clock To:
1st Value: **4.000**
2nd Value:
Value Percent:
Continuous Index:
Within 8" of Joint:
Remarks:

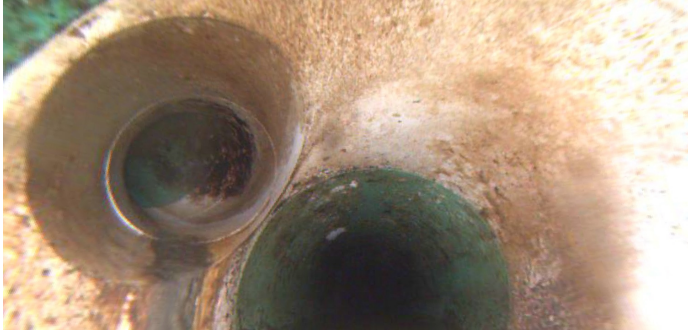
Code: **TF**
Description: **Tap Factory**

Distance (ft): **250.6**
Structural Grade: **0**
O&M Grade: **0**
Clock Start/From: **10**
Clock To:
1st Value: **4.000**
2nd Value:
Value Percent:
Continuous Index:
Within 8" of Joint:
Remarks:

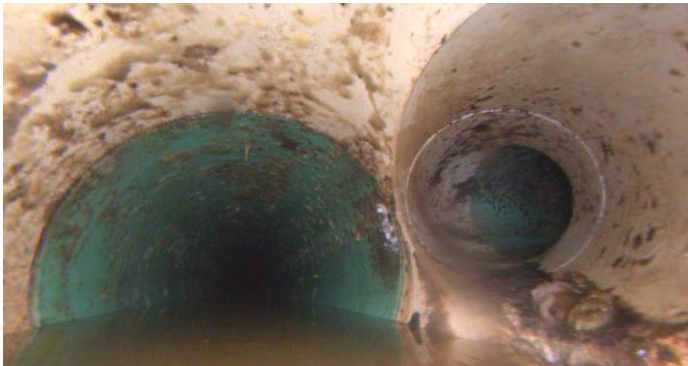
Code: **TF**
Description: **Tap Factory**

Distance (ft): **323.1**
Structural Grade: **0**
O&M Grade: **0**
Clock Start/From: **4**
Clock To:
1st Value: **4.000**
2nd Value:
Value Percent:
Continuous Index:
Within 8" of Joint:
Remarks:

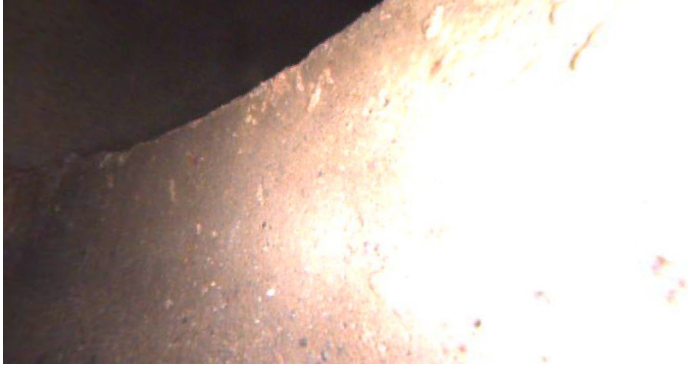
Code:	AMH
Description:	Manhole
Distance (ft):	363.6
Structural Grade:	0
O&M Grade:	0
Clock Start/From:	
Clock To:	
1st Value:	
2nd Value:	
Value Percent:	
Continuous Index:	
Within 8" of Joint:	NO
Remarks:	M-703-037
