Profile/Photo Observation Report

Street:	OFF NERINGA LN	Flow Control:	Not Controlled
City:	Hobart, IN	Year Renewed:	
Location:	Other	Tape/Media #:	
Purpose:	Not Known	Dia/Height:	8"
Use:	Sanitary	Material:	PVC
Drain Area:	NA	Lining:	
Category:	NA		
Comment:

Location Details:		Direction of Survey:	Upstream
US MH:	M-703-039	DS MH:	M-703-038
		Total Length Surveyed (ft):	132.2

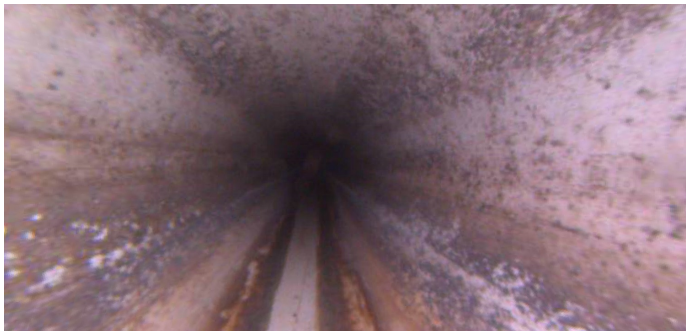
Code: **AMH**
Description: **Manhole**

Distance (ft): **.0**
Structural Grade: **0**
O&M Grade: **0**
Clock Start/From:
Clock To:
1st Value:
2nd Value:
Value Percent:
Continuous Index:
Within 8" of Joint: **NO**
Remarks: **M-703-038**

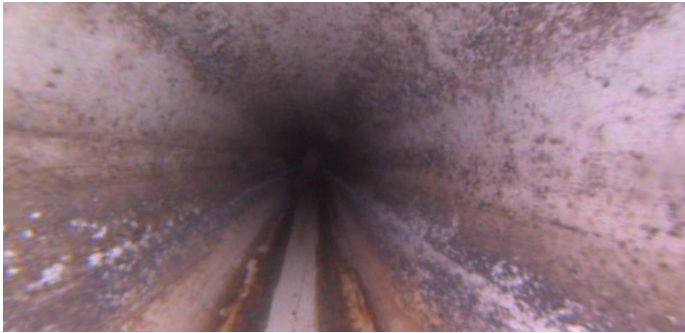
Code:	MWL
Description:	Water Level

Distance (ft):	.0
Structural Grade:	0
O&M Grade:	0
Clock Start/From:	
Clock To:	
1st Value:	
2nd Value:	
Value Percent:	5.000
Continuous Index:	
Within 8" of Joint:	NO
Remarks:

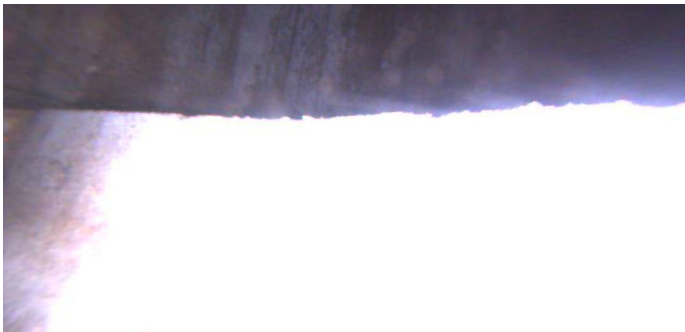
Code:	AMH
Description:	Manhole

Distance (ft):	132.2
Structural Grade:	0
O&M Grade:	0
Clock Start/From:	
Clock To:	
1st Value:	
2nd Value:	
Value Percent:	
Continuous Index:	
Within 8" of Joint:	NO
Remarks:	M-703-039
