Profile/Photo Observation Report

Street:	Fox Trail Ct.	Flow Control:	Not Controlled
City:	Hobart, IN	Year Renewed:	
Location:	Other	Tape/Media #:	
Purpose:	Not Known	Dia/Height:	8"
Use:	Sanitary	Material:	PVC
Drain Area:	NA	Lining:	
Category:	NA		
Comment:

Location Details:		Direction of Survey:	Upstream
US MH:	M-703-039	DS MH:	M-703-038
		Total Length Surveyed (ft):	132.2

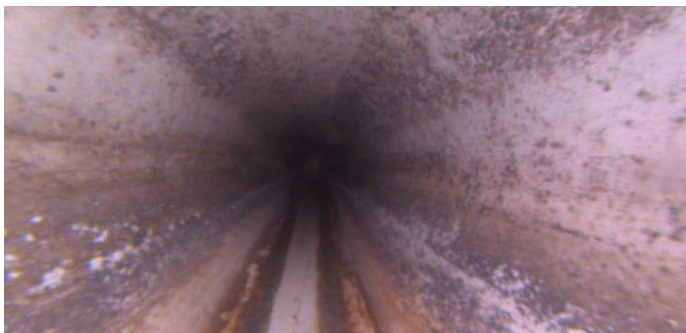
Code: **AMH**
Description: **Manhole**

Distance (ft): **.0**
Structural Grade: **0**
O&M Grade: **0**
Clock Start/From:
Clock To:
1st Value:
2nd Value:
Value Percent:
Continuous Index:
Within 8" of Joint: **NO**
Remarks: **M-703-038**

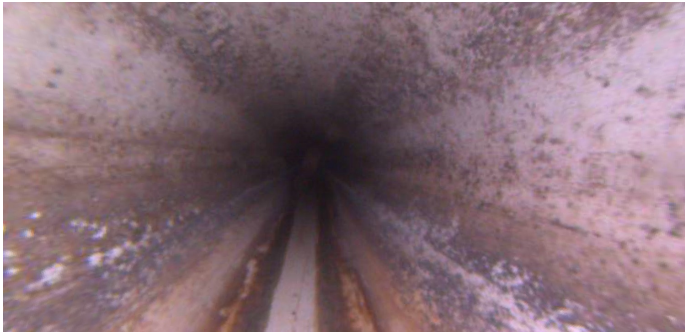
Code:	MWL
Description:	Water Level

Distance (ft):	.0
Structural Grade:	0
O&M Grade:	0
Clock Start/From:	
Clock To:	
1st Value:	
2nd Value:	
Value Percent:	5.000
Continuous Index:	
Within 8" of Joint:	NO
Remarks:

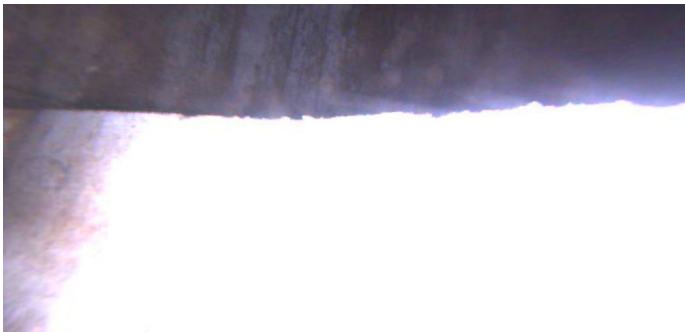
Code:	AMH
Description:	Manhole

Distance (ft):	132.2
Structural Grade:	0
O&M Grade:	0
Clock Start/From:	
Clock To:	
1st Value:	
2nd Value:	
Value Percent:	
Continuous Index:	
Within 8" of Joint:	NO
Remarks:	M-703-039
