## Profile/Photo Observation Report

Street:	<b>NERINGA LN</b>	Flow Control:	<b>Not Controlled</b>
City:	<b>Hobart, IN</b>	Year Renewed:	
Location:	<b>Light Highway</b>	Tape/Media #:	
Purpose:	<b>Routine Assessment</b>	Dia/Height:	<b>8"</b>
Use:	<b>Sanitary</b>	Material:	<b>PVC</b>
Drain Area:	<b>NA</b>	Lining:	
Category:	<b>NA</b>		
Comment:

Location Details:		Direction of Survey:	<b>Upstream</b>
US MH:	<b>M-703-040</b>	DS MH:	<b>M-703-039</b>
		Total Length Surveyed (ft):	<b>182.9</b>

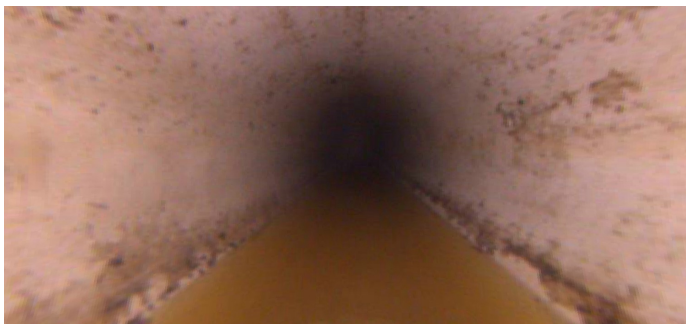
Code: **AMH**  
Description: **Manhole**

Distance (ft): **.0**  
Structural Grade: **0**  
O&M Grade: **0**  
Clock Start/From:  
Clock To:  
1st Value:  
2nd Value:  
Value Percent:  
Continuous Index:  
Within 8" of Joint: **NO**  
Remarks: **M-703-039**

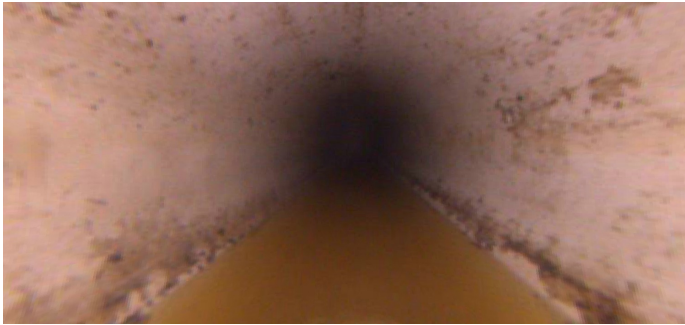
Code:	<b>MWL</b>
Description:	<b>Water Level</b>

Distance (ft):	<b>.0</b>
Structural Grade:	<b>0</b>
O&M Grade:	<b>0</b>
Clock Start/From:	
Clock To:	
1st Value:	
2nd Value:	
Value Percent:	<b>5.000</b>
Continuous Index:	
Within 8" of Joint:	<b>NO</b>
Remarks:

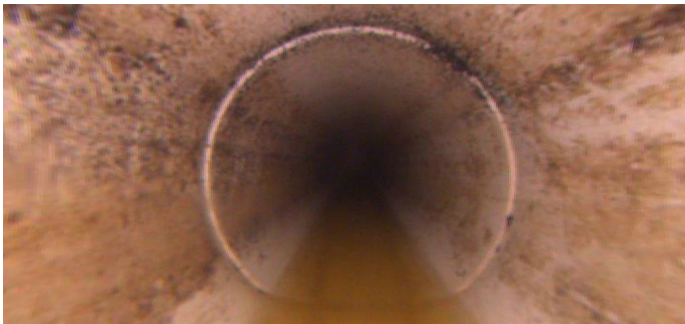
Code:	<b>RFJ</b>
Description:	<b>Roots Fine Joint</b>

Distance (ft):	<b>11.8</b>
Structural Grade:	<b>0</b>
O&M Grade:	<b>1</b>
Clock Start/From:	<b>11</b>
Clock To:	<b>2</b>
1st Value:	
2nd Value:	
Value Percent:	
Continuous Index:	
Within 8" of Joint:	<b>YES</b>
Remarks:

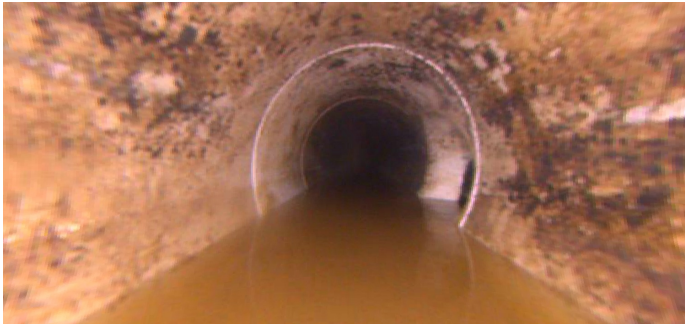
Code: **TF**  
Description: **Tap Factory**

Distance (ft): **57.7**  
Structural Grade: **0**  
O&M Grade: **0**  
Clock Start/From: **3**  
Clock To:  
1st Value: **4.000**  
2nd Value:  
Value Percent:  
Continuous Index:  
Within 8" of Joint:  
Remarks:

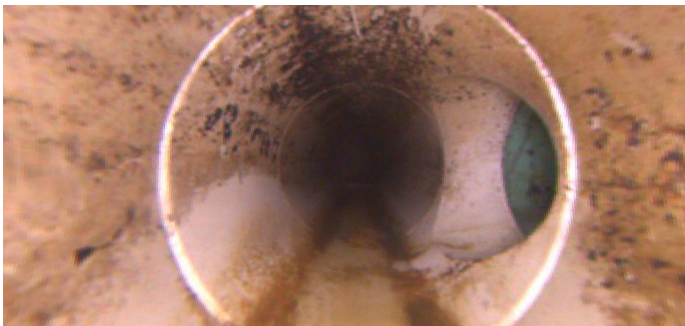
Code: **TF**  
Description: **Tap Factory**

Distance (ft): **137.7**  
Structural Grade: **0**  
O&M Grade: **0**  
Clock Start/From: **3**  
Clock To:  
1st Value: **4.000**  
2nd Value:  
Value Percent:  
Continuous Index:  
Within 8" of Joint:  
Remarks:

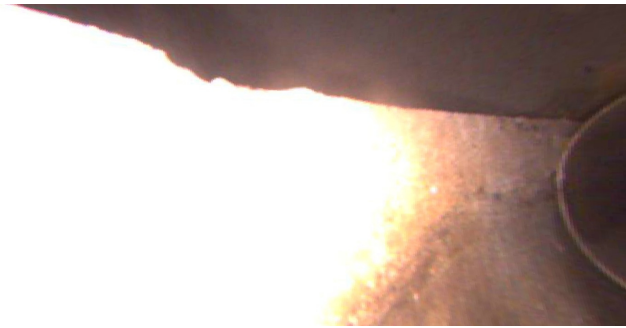
Code: **AMH**  
Description: **Manhole**

Distance (ft): **182.9**  
Structural Grade: **0**  
O&M Grade: **0**  
Clock Start/From:  
Clock To:  
1st Value:  
2nd Value:  
Value Percent:  
Continuous Index:  
Within 8" of Joint: **NO**  
Remarks: **M-703-040**
