Profile/Photo Observation Report

Street:	Fox Trail Ct.	Flow Control:	Not Controlled
City:	Hobart, IN	Year Renewed:	
Location:	Light Highway	Tape/Media #:	
Purpose:	Routine Assessment	Dia/Height:	8"
Use:	Sanitary	Material:	PVC
Drain Area:	NA	Lining:	
Category:	NA		
Comment:

Location Details:		Direction of Survey:	Upstream
US MH:	M-703-040	DS MH:	M-703-039
		Total Length Surveyed (ft):	182.9

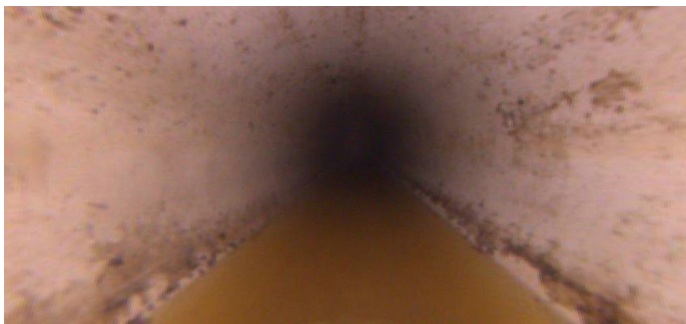
Code: **AMH**
Description: **Manhole**

Distance (ft): **.0**
Structural Grade: **0**
O&M Grade: **0**
Clock Start/From:
Clock To:
1st Value:
2nd Value:
Value Percent:
Continuous Index:
Within 8" of Joint: **NO**
Remarks: **M-703-039**

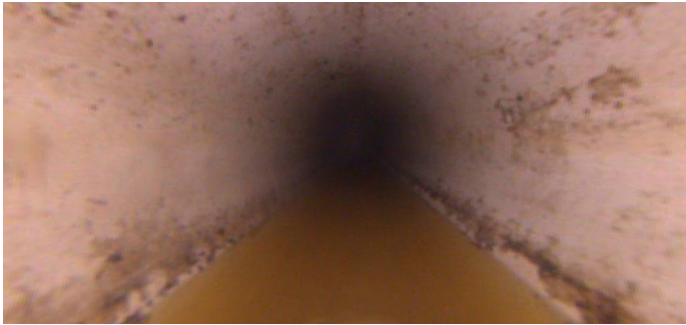
Code:	MWL
Description:	Water Level

Distance (ft):	.0
Structural Grade:	0
O&M Grade:	0
Clock Start/From:	
Clock To:	
1st Value:	
2nd Value:	
Value Percent:	5.000
Continuous Index:	
Within 8" of Joint:	NO
Remarks:

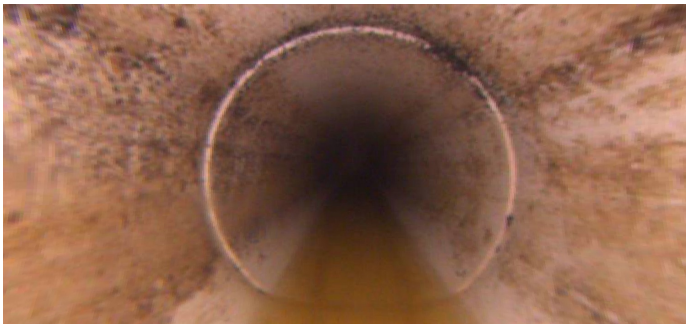
Code:	RFJ
Description:	Roots Fine Joint

Distance (ft):	11.8
Structural Grade:	0
O&M Grade:	1
Clock Start/From:	11
Clock To:	2
1st Value:	
2nd Value:	
Value Percent:	
Continuous Index:	
Within 8" of Joint:	YES
Remarks:

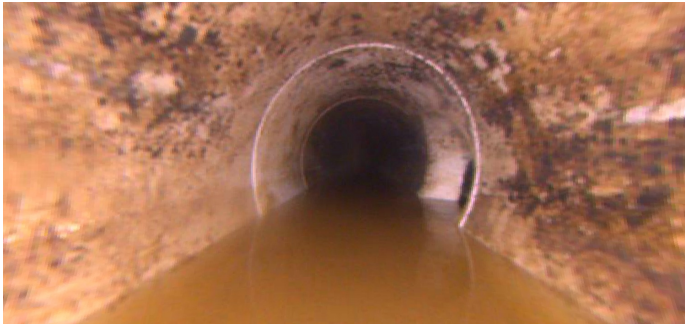
Code: **TF**
Description: **Tap Factory**

Distance (ft): **57.7**
Structural Grade: **0**
O&M Grade: **0**
Clock Start/From: **3**
Clock To:
1st Value: **4.000**
2nd Value:
Value Percent:
Continuous Index:
Within 8" of Joint:
Remarks:

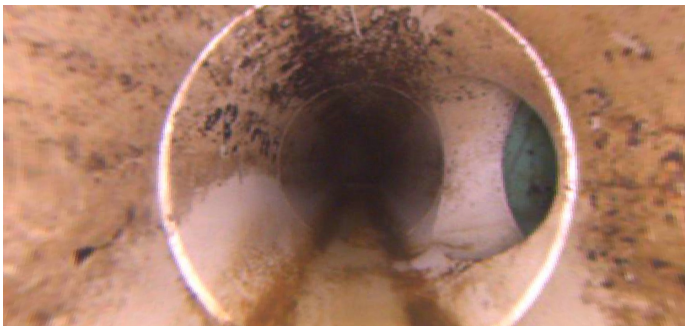
Code: **TF**
Description: **Tap Factory**

Distance (ft): **137.7**
Structural Grade: **0**
O&M Grade: **0**
Clock Start/From: **3**
Clock To:
1st Value: **4.000**
2nd Value:
Value Percent:
Continuous Index:
Within 8" of Joint:
Remarks:

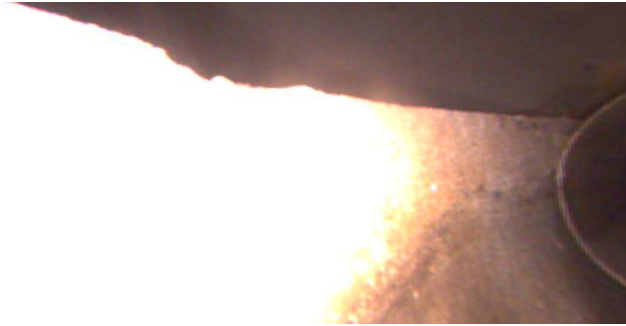
Code: **AMH**
Description: **Manhole**

Distance (ft): **182.9**
Structural Grade: **0**
O&M Grade: **0**
Clock Start/From:
Clock To:
1st Value:
2nd Value:
Value Percent:
Continuous Index:
Within 8" of Joint: **NO**
Remarks: **M-703-040**
