Profile/Photo Observation Report

Date:	04/25/2018	Weather:		Coding:	PACP 4.2
Pipe Length (ft):	300.1	Owner:	City of Hobart	Pre Clean:	No Pre-Cleaning
P.O.#:	2004	Surveyor:	SAN	PSR:	P-703-042-035
Customer:	Red Zone	Clean Date:		Shape:	C

Street:	504 Deerpath Ct	Flow Control:	Not Controlled
City:	Hobart In	Year Renewed:	
Location:	Yard	Tape/Media #:	Deliverable 1
Purpose:	Routine Assessment	Dia/Height:	8"
Use:	Sanitary	Material:	PVC
Drain Area:	Northeast	Lining:	
Category:	NA		
Comment:	434-1/DSMH # on video is incorrect due to a manhole that was not shown on mapping.		
Location Details:	Edge of street	Direction of Survey:	Downstream
US MH:	M-703-042	DS MH:	M-703-042A
		Total Length Surveyed (ft):	300.1

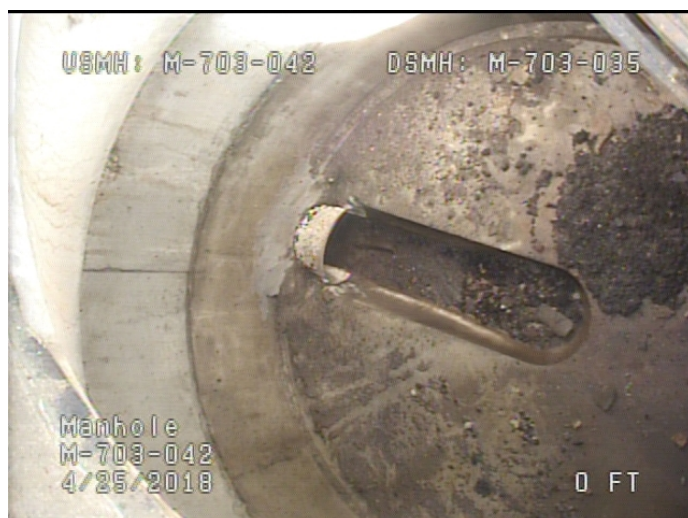
Code: **AMH**
Description: **Manhole**

Distance (ft): **.0**
Structural Grade: **0**
O&M Grade: **0**
Clock Start/From:
Clock To:
1st Value:
2nd Value:
Value Percent:
Continuous Index:
Within 8" of Joint: **NO**
Remarks: **M-703-042**

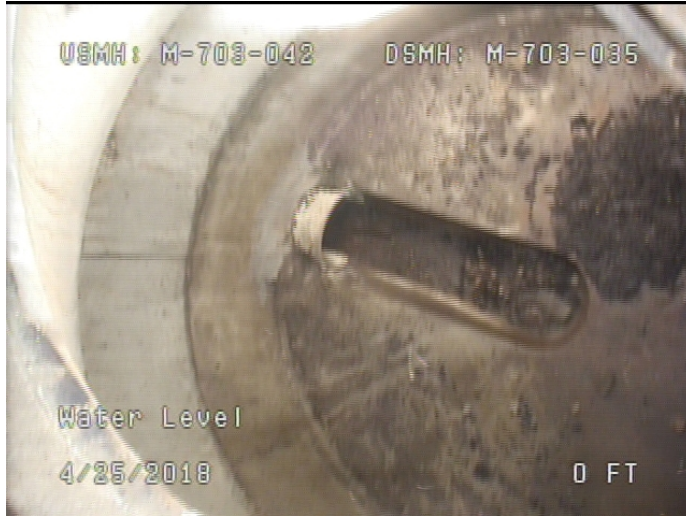
Code:	MWL
Description:	Water Level
Distance (ft):	.0
Structural Grade:	0
O&M Grade:	0
Clock Start/From:	
Clock To:	
1st Value:	
2nd Value:	
Value Percent:	0.000
Continuous Index:	
Within 8" of Joint:	NO
Remarks:

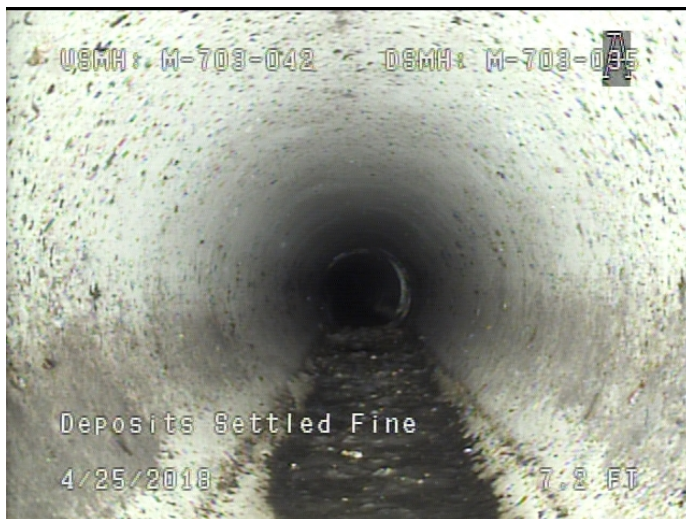
Code:	DSF
Description:	Deposits Settled Fine
Distance (ft):	7.2
Structural Grade:	0
O&M Grade:	2
Clock Start/From:	6
Clock To:	
1st Value:	
2nd Value:	
Value Percent:	10.000
Continuous Index:	
Within 8" of Joint:	NO
Remarks:

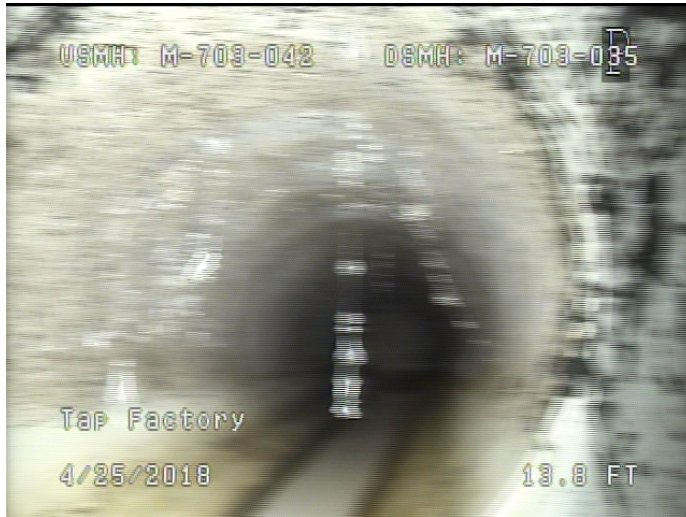
Code:	TF
Description:	Tap Factory
Distance (ft):	13.8
Structural Grade:	0
O&M Grade:	0
Clock Start/From:	3
Clock To:	
1st Value:	4.000
2nd Value:	
Value Percent:	
Continuous Index:	
Within 8" of Joint:	NO
Remarks:

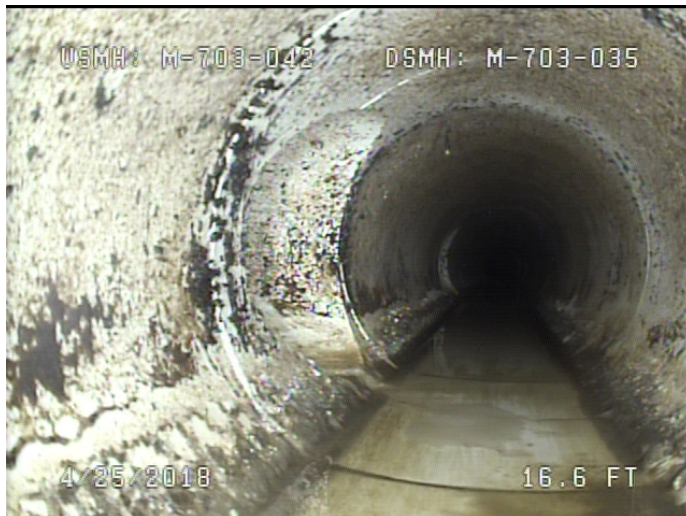
Code:	TF
Description:	Tap Factory
Distance (ft):	16.6
Structural Grade:	0
O&M Grade:	0
Clock Start/From:	9
Clock To:	
1st Value:	4.000
2nd Value:	
Value Percent:	
Continuous Index:	
Within 8" of Joint:	NO
Remarks:

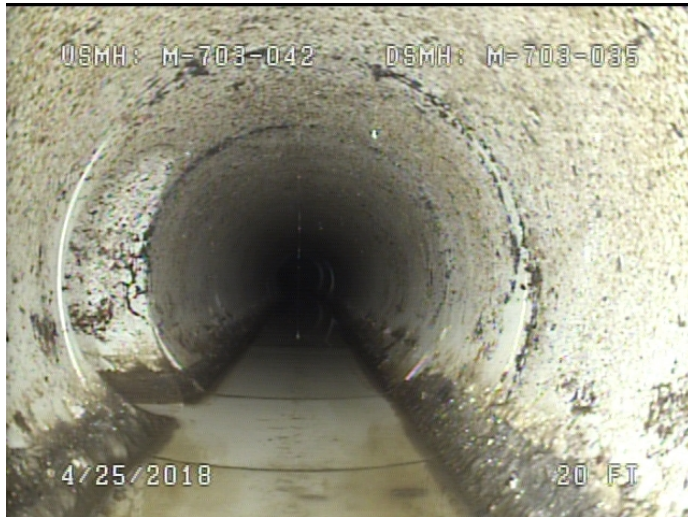
Code: **TF**
 Description: **Tap Factory**

Distance (ft): **20.0**
 Structural Grade: **0**
 O&M Grade: **0**
 Clock Start/From: **9**
 Clock To:
 1st Value: **4.000**
 2nd Value:
 Value Percent:
 Continuous Index:
 Within 8" of Joint: **NO**
 Remarks:

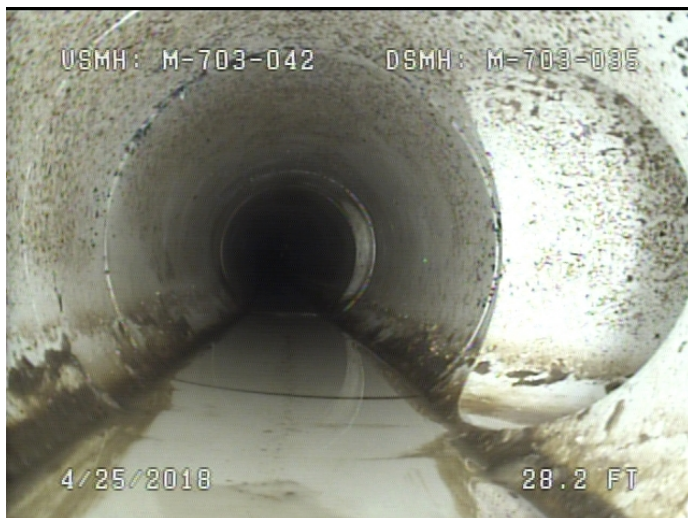
Code: **TF**
 Description: **Tap Factory**

Distance (ft): **28.2**
 Structural Grade: **0**
 O&M Grade: **0**
 Clock Start/From: **3**
 Clock To:
 1st Value: **4.000**
 2nd Value:
 Value Percent:
 Continuous Index:
 Within 8" of Joint: **NO**
 Remarks:

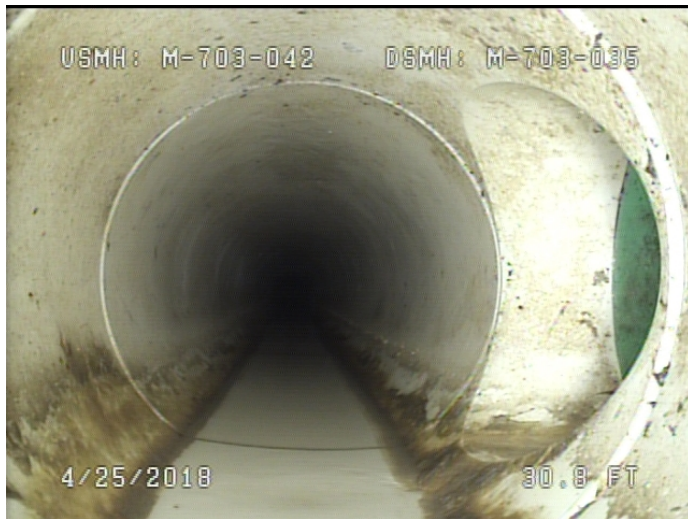
Code: **TF**
 Description: **Tap Factory**

Distance (ft): **30.8**
 Structural Grade: **0**
 O&M Grade: **0**
 Clock Start/From: **3**
 Clock To:
 1st Value: **4.000**
 2nd Value:
 Value Percent:
 Continuous Index:
 Within 8" of Joint: **NO**
 Remarks:

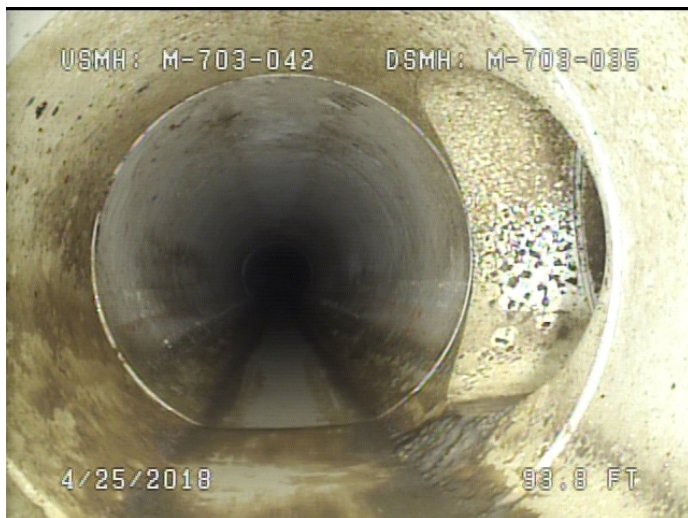
Code: **TF**
 Description: **Tap Factory**

Distance (ft): **93.8**
 Structural Grade: **0**
 O&M Grade: **0**
 Clock Start/From: **3**
 Clock To:
 1st Value: **4.000**
 2nd Value:
 Value Percent:
 Continuous Index:
 Within 8" of Joint: **NO**
 Remarks:

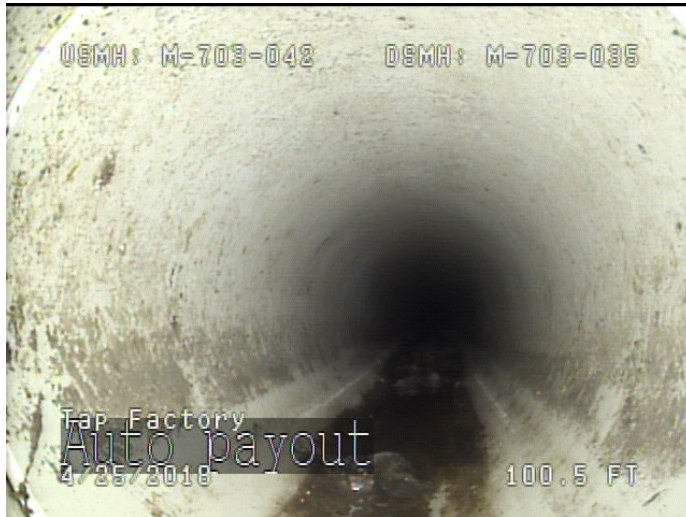
Code:	TF
Description:	Tap Factory
Distance (ft):	100.5
Structural Grade:	0
O&M Grade:	0
Clock Start/From:	9
Clock To:	
1st Value:	4.000
2nd Value:	
Value Percent:	
Continuous Index:	
Within 8" of Joint:	NO
Remarks:

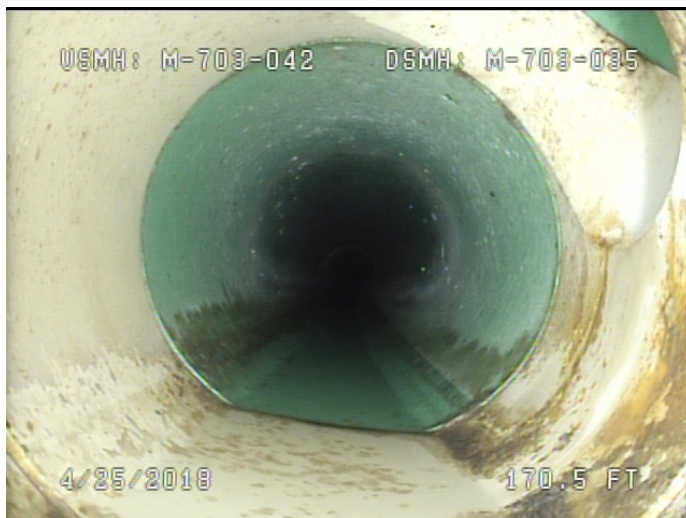
Code:	TF
Description:	Tap Factory
Distance (ft):	170.5
Structural Grade:	0
O&M Grade:	0
Clock Start/From:	1
Clock To:	
1st Value:	4.000
2nd Value:	
Value Percent:	
Continuous Index:	
Within 8" of Joint:	NO
Remarks:

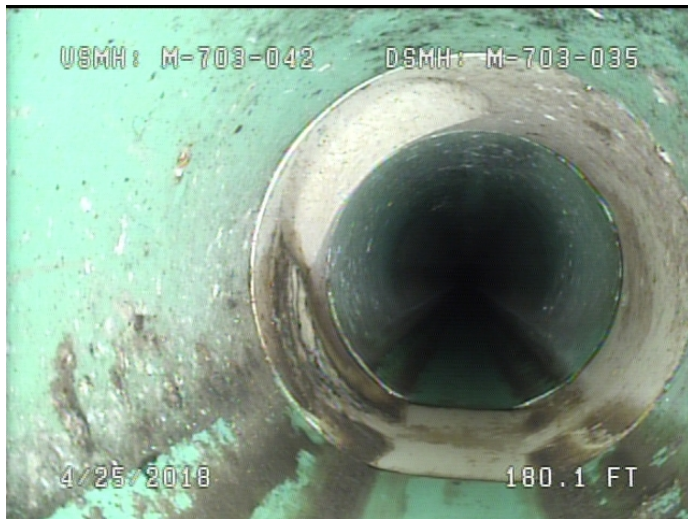
Code: **TF**
 Description: **Tap Factory**

Distance (ft): **180.1**
 Structural Grade: **0**
 O&M Grade: **0**
 Clock Start/From: **10**
 Clock To:
 1st Value: **4.000**
 2nd Value:
 Value Percent:
 Continuous Index:
 Within 8" of Joint: **NO**
 Remarks:

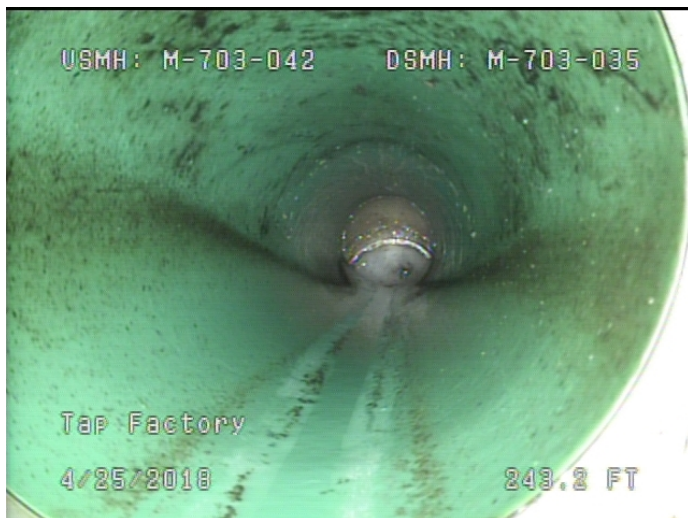
Code: **TF**
 Description: **Tap Factory**

Distance (ft): **243.2**
 Structural Grade: **0**
 O&M Grade: **0**
 Clock Start/From: **11**
 Clock To:
 1st Value: **4.000**
 2nd Value:
 Value Percent:
 Continuous Index:
 Within 8" of Joint: **NO**
 Remarks:

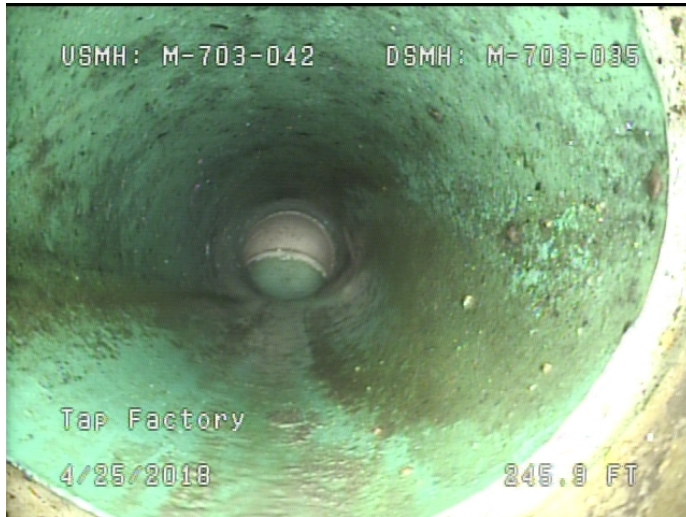
Code: **TF**
 Description: **Tap Factory**

Distance (ft): **245.9**
 Structural Grade: **0**
 O&M Grade: **0**
 Clock Start/From: **1**
 Clock To:
 1st Value: **4.000**
 2nd Value:
 Value Percent:
 Continuous Index:
 Within 8" of Joint: **NO**
 Remarks:

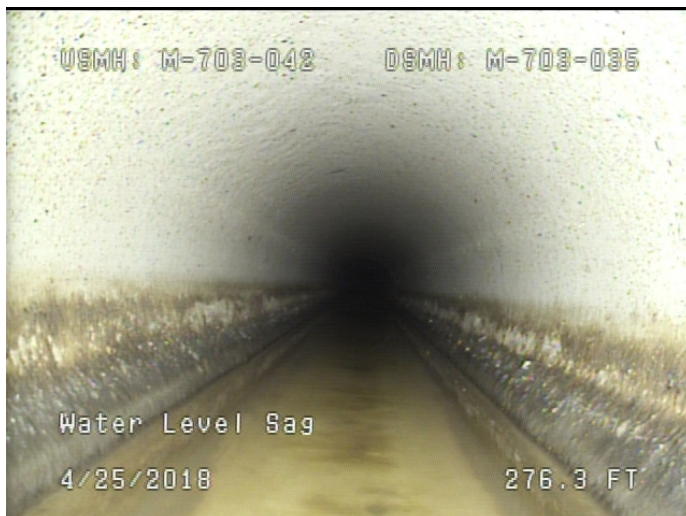
Code: **MWLS**
 Description: **Water Level Sag**

Distance (ft): **276.3**
 Structural Grade: **2**
 O&M Grade: **3**
 Clock Start/From:
 Clock To:
 1st Value:
 2nd Value:
 Value Percent: **15.000**
 Continuous Index: **S02**
 Within 8" of Joint: **NO**
 Remarks:

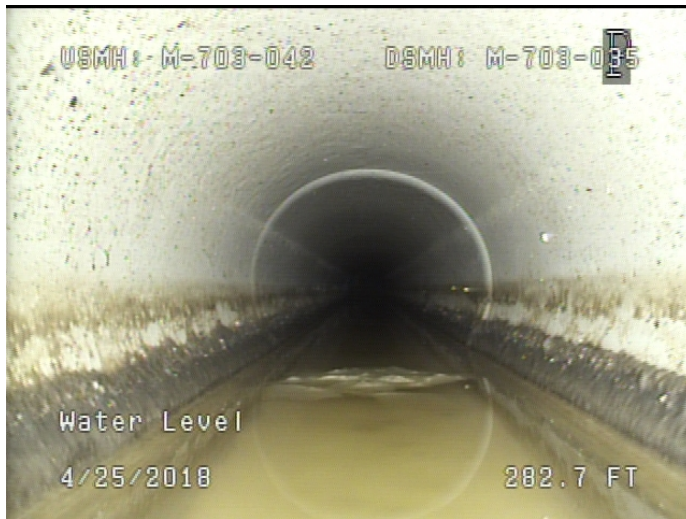
Code: **MWL**
Description: **Water Level**

Distance (ft): **282.7**
Structural Grade: **0**
O&M Grade: **0**
Clock Start/From:
Clock To:
1st Value:
2nd Value:
Value Percent: **25.000**
Continuous Index:
Within 8" of Joint: **NO**
Remarks:

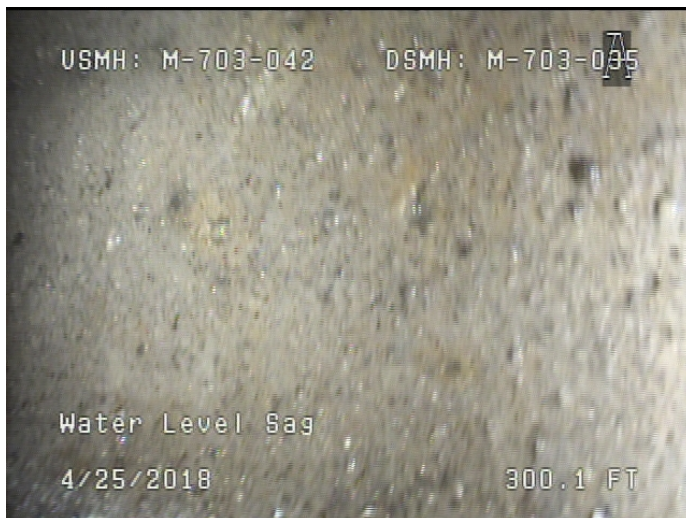
Code: **MWLS**
Description: **Water Level Sag**

Distance (ft): **300.1**
Structural Grade: **2**
O&M Grade: **3**
Clock Start/From:
Clock To:
1st Value:
2nd Value:
Value Percent: **15.000**
Continuous Index: **F02**
Within 8" of Joint: **NO**
Remarks:

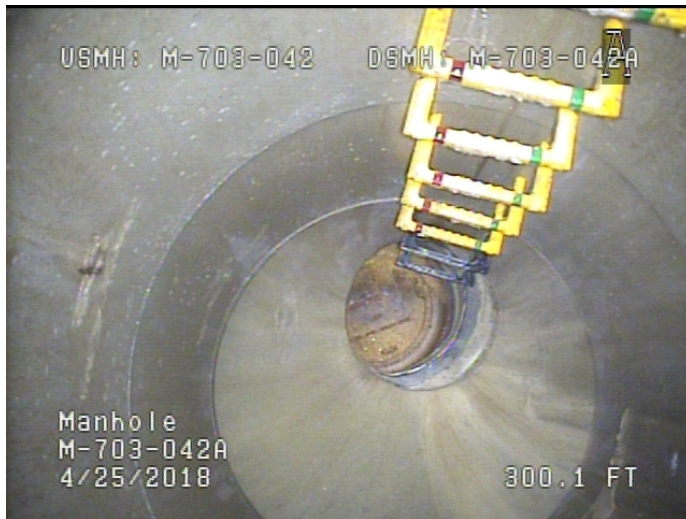
Code:	AMH
Description:	Manhole
Distance (ft):	300.1
Structural Grade:	0
O&M Grade:	0
Clock Start/From:	
Clock To:	
1st Value:	
2nd Value:	
Value Percent:	
Continuous Index:	
Within 8" of Joint:	NO
Remarks:	M-703-042A
