Profile/Photo Observation Report

Street:	Front Street	Flow Control:	
City:	Hobart, IN	Year Renewed:	
Location:	Light Highway	Tape/Media #:	844
Purpose:	Routine Assessment	Dia/Height:	24"
Use:	Sanitary	Material:	RCP
Drain Area:		Lining:

US MH: **M-704-10** DS MH: **M-705-9** Total Length Surveyed (ft): **431.4**

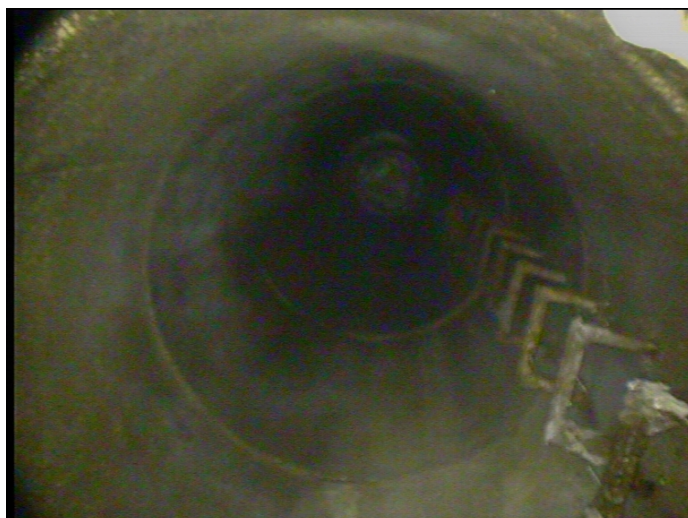
Code: **AMH**
 Description: **Manhole**

Distance (ft): **.0**
 Structural Grade: **0**
 O&M Grade: **0**
 Clock Start/From:
 Clock To:
 1st Value:
 2nd Value:
 Value Percent:
 Continuous Index:
 Within 8" of Joint: **NO**
 Remarks: **M-704-10**

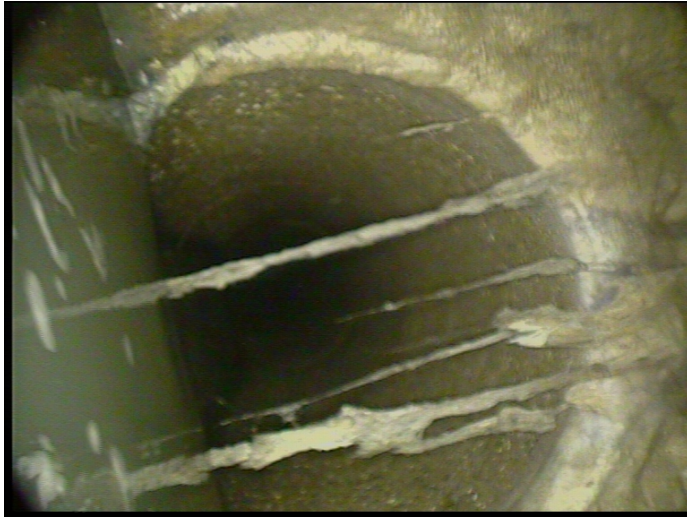
Code: **MWL**
Description: **Water Level**

Distance (ft): **.0**
Structural Grade: **0**
O&M Grade: **0**
Clock Start/From:
Clock To:
1st Value:
2nd Value:
Value Percent: **10.000**
Continuous Index:
Within 8" of Joint: **NO**
Remarks:

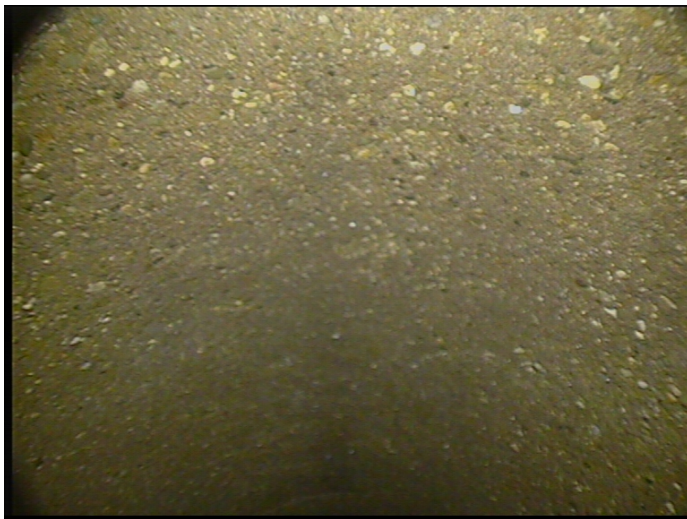
Code: **SAV**
Description: **Surface Aggregate Visible**

Distance (ft): **9.6**
Structural Grade: **3**
O&M Grade: **0**
Clock Start/From: **8**
Clock To: **4**
1st Value:
2nd Value:
Value Percent:
Continuous Index: **S01**
Within 8" of Joint: **YES**
Remarks:

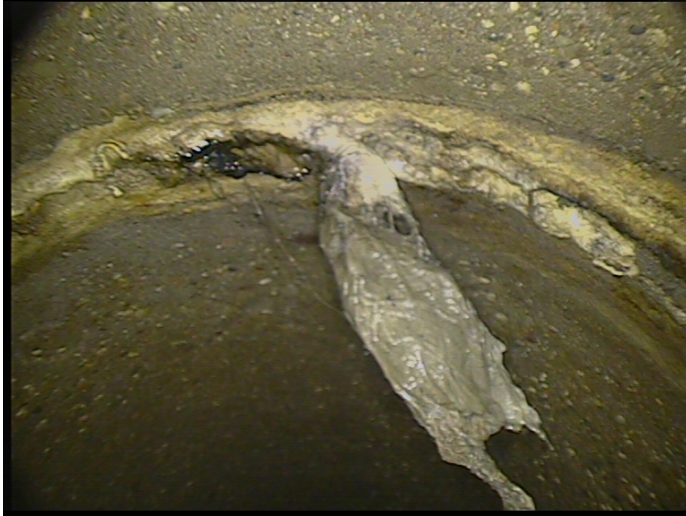
Code:	ID
Description:	Infil Dripper
Distance (ft):	222.5
Structural Grade:	0
O&M Grade:	3
Clock Start/From:	1
Clock To:	
1st Value:	
2nd Value:	
Value Percent:	
Continuous Index:	
Within 8" of Joint:	YES
Remarks:

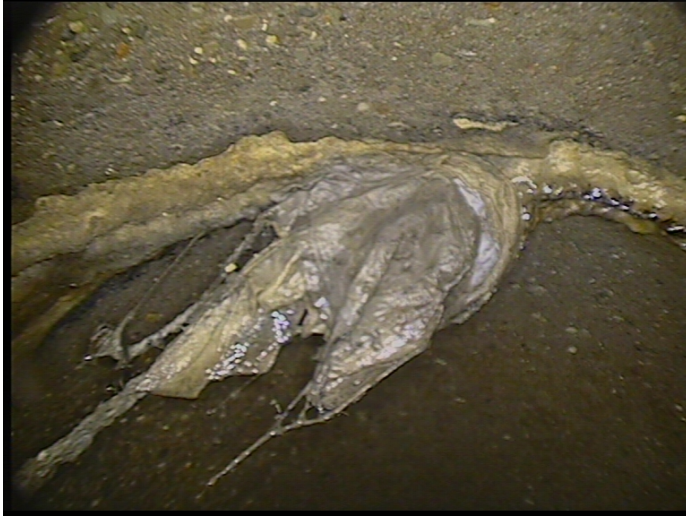
Code:	DAR
Description:	Deposits Attached Ragging
Distance (ft):	275.7
Structural Grade:	0
O&M Grade:	2
Clock Start/From:	11
Clock To:	
1st Value:	
2nd Value:	
Value Percent:	5.000
Continuous Index:	
Within 8" of Joint:	YES
Remarks:

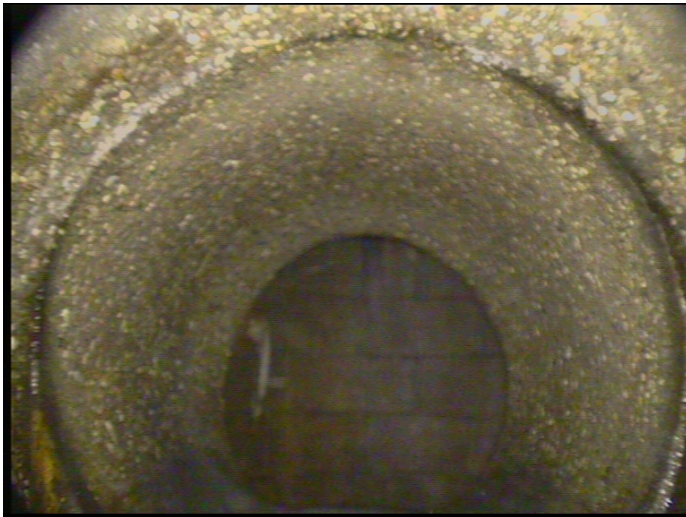
Code:	SAV
Description:	Surface Aggregate Visible
Distance (ft):	429.3
Structural Grade:	3
O&M Grade:	0
Clock Start/From:	8
Clock To:	4
1st Value:	
2nd Value:	
Value Percent:	
Continuous Index:	F01
Within 8" of Joint:	NO
Remarks:

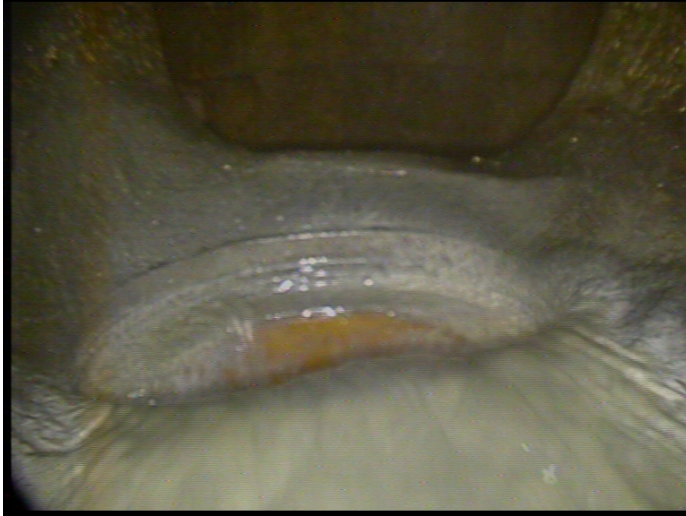
Code:	TFA
Description:	Tap Factory Active
Distance (ft):	431.4
Structural Grade:	0
O&M Grade:	0
Clock Start/From:	6
Clock To:	
1st Value:	8.000
2nd Value:	
Value Percent:	
Continuous Index:	
Within 8" of Joint:	NO
Remarks:	drop connection

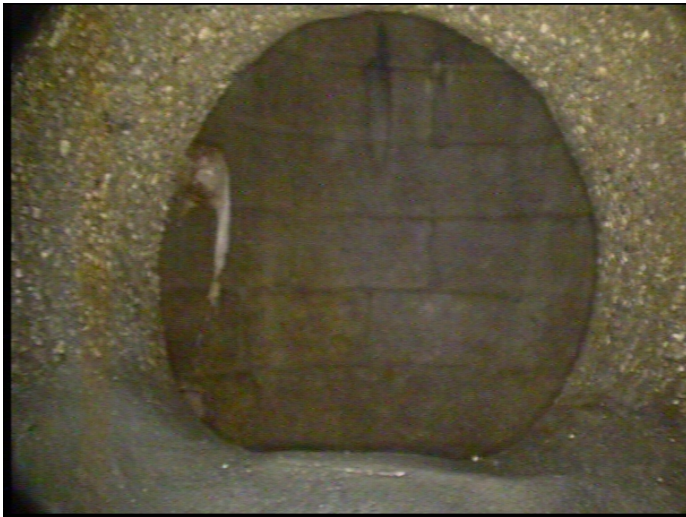
Code:	AMH
Description:	Manhole
Distance (ft):	431.4
Structural Grade:	0
O&M Grade:	0
Clock Start/From:	
Clock To:	
1st Value:	
2nd Value:	
Value Percent:	
Continuous Index:	
Within 8" of Joint:	NO
Remarks:	M-705-9
