Profile/Photo Observation Report

Street:	N MICHIGAN AVE & E HOME AVE	Flow Control:	Not Controlled
City:	Hobart, IN	Year Renewed:	
Location:	Other	Tape/Media #:	
Purpose:	Not Known	Dia/Height:	12"
Use:	Sanitary	Material:	VCP
Drain Area:	NA	Lining:	
Category:	NA		
Comment:

Location Details:		Direction of Survey:	Upstream
US MH:	M-704-014	DS MH:	M-704-015
		Total Length Surveyed (ft):	190.8

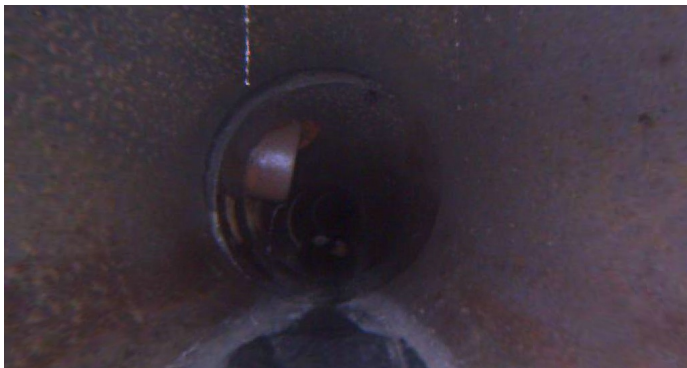
Code: **MWL**
Description: **Water Level**

Distance (ft): **.0**
Structural Grade: **0**
O&M Grade: **0**
Clock Start/From:
Clock To:
1st Value:
2nd Value:
Value Percent: **10.000**
Continuous Index:
Within 8" of Joint: **NO**
Remarks:

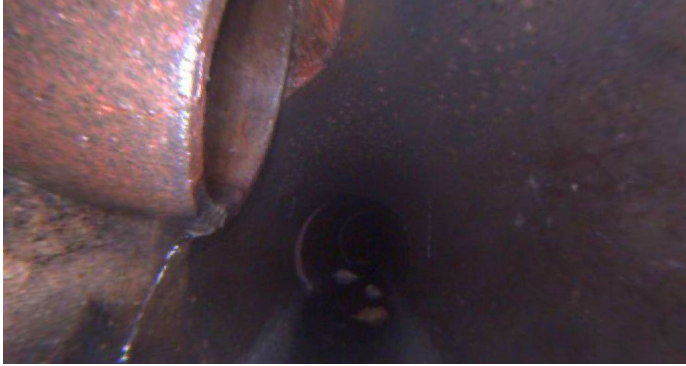
Code: **TBI**
Description: **Tap Break-in Intruding**

Distance (ft): **1.7**
Structural Grade: **0**
O&M Grade: **2**
Clock Start/From: **10**
Clock To:
1st Value: **4.000**
2nd Value: **3.000**
Value Percent:
Continuous Index:
Within 8" of Joint:
Remarks:

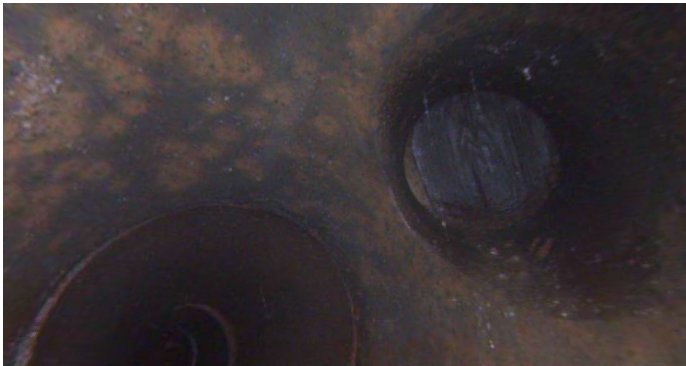
Code: **TFC**
Description: **Tap Factory Capped**

Distance (ft): **21.2**
Structural Grade: **0**
O&M Grade: **0**
Clock Start/From: **10**
Clock To:
1st Value: **4.000**
2nd Value:
Value Percent:
Continuous Index:
Within 8" of Joint:
Remarks:

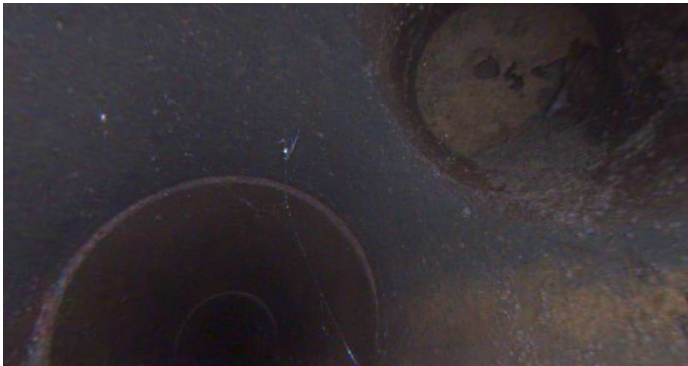
Code: **TFC**
Description: **Tap Factory Capped**

Distance (ft): **49.0**
Structural Grade: **0**
O&M Grade: **0**
Clock Start/From: **10**
Clock To:
1st Value: **4.000**
2nd Value:
Value Percent:
Continuous Index:
Within 8" of Joint:
Remarks:

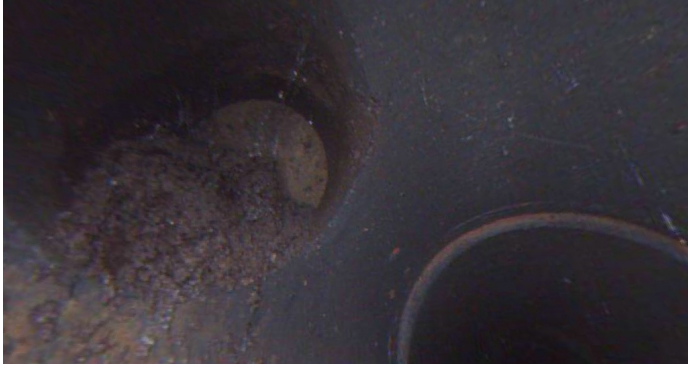
Code: **TFC**
Description: **Tap Factory Capped**

Distance (ft): **52.0**
Structural Grade: **0**
O&M Grade: **0**
Clock Start/From: **3**
Clock To:
1st Value: **4.000**
2nd Value:
Value Percent:
Continuous Index:
Within 8" of Joint:
Remarks:

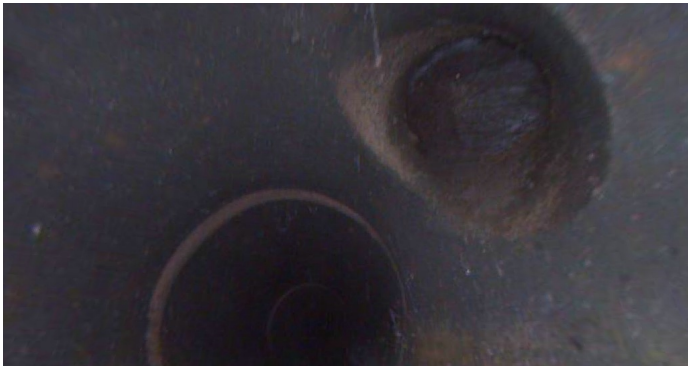
Code: **TFC**
Description: **Tap Factory Capped**

Distance (ft): **73.7**
Structural Grade: **0**
O&M Grade: **0**
Clock Start/From: **10**
Clock To:
1st Value: **4.000**
2nd Value:
Value Percent:
Continuous Index:
Within 8" of Joint:
Remarks:

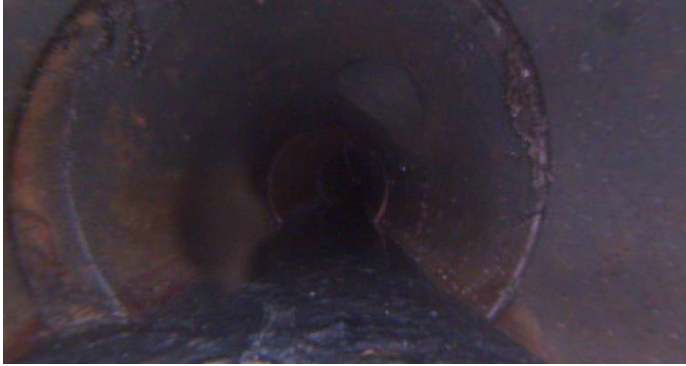
Code: **RFJ**
Description: **Roots Fine Joint**

Distance (ft): **73.7**
Structural Grade: **0**
O&M Grade: **1**
Clock Start/From: **7**
Clock To: **5**
1st Value:
2nd Value:
Value Percent:
Continuous Index:
Within 8" of Joint: **YES**
Remarks:

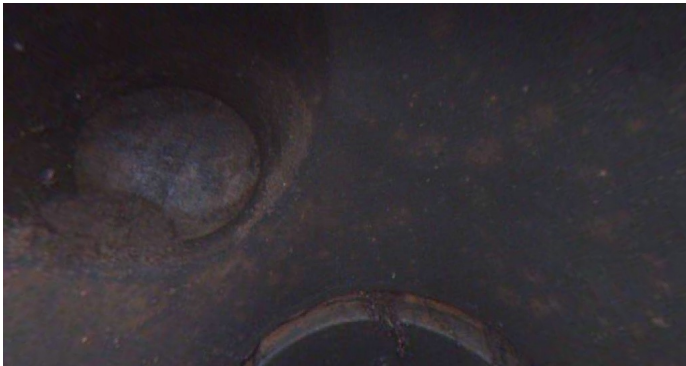
Code: **TFC**
Description: **Tap Factory Capped**

Distance (ft): **75.5**
Structural Grade: **0**
O&M Grade: **0**
Clock Start/From: **2**
Clock To:
1st Value: **4.000**
2nd Value:
Value Percent:
Continuous Index:
Within 8" of Joint:
Remarks:

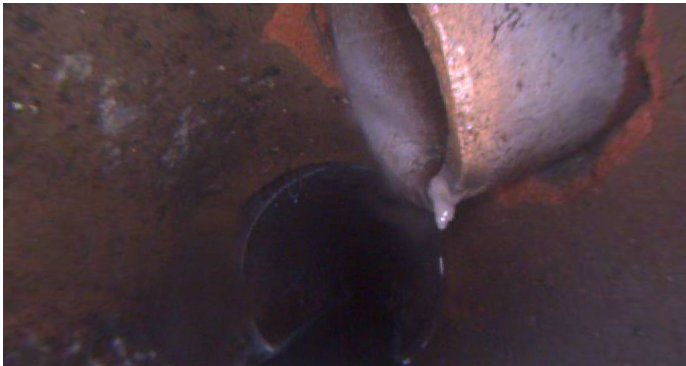
Code: **TBI**
Description: **Tap Break-in Intruding**

Distance (ft): **90.4**
Structural Grade: **0**
O&M Grade: **2**
Clock Start/From: **2**
Clock To:
1st Value: **4.000**
2nd Value: **3.000**
Value Percent:
Continuous Index:
Within 8" of Joint:
Remarks:

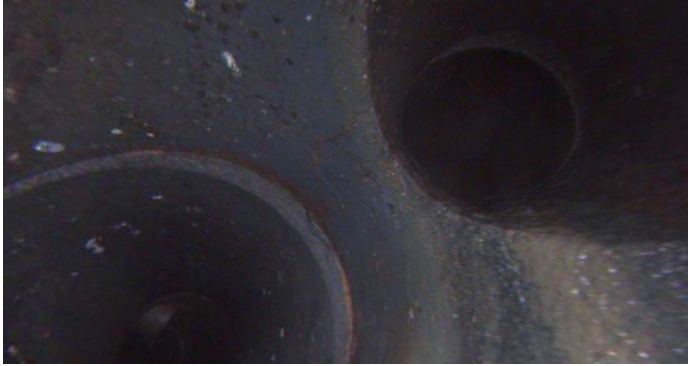
Code: **TF**
Description: **Tap Factory**

Distance (ft): **96.1**
Structural Grade: **0**
O&M Grade: **0**
Clock Start/From: **10**
Clock To:
1st Value: **4.000**
2nd Value:
Value Percent:
Continuous Index:
Within 8" of Joint:
Remarks:

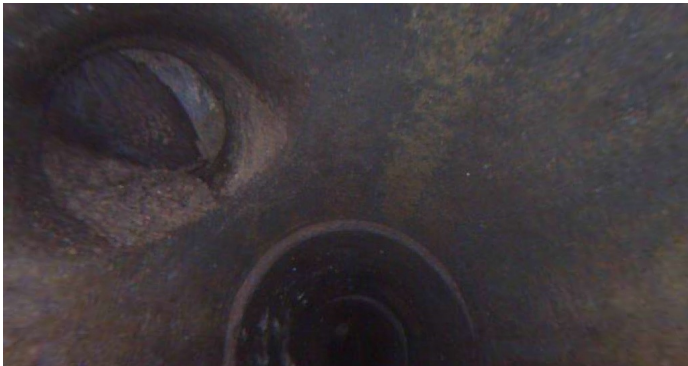
Code: **TF**
Description: **Tap Factory**

Distance (ft): **98.7**
Structural Grade: **0**
O&M Grade: **0**
Clock Start/From: **2**
Clock To:
1st Value: **4.000**
2nd Value:
Value Percent:
Continuous Index:
Within 8" of Joint:
Remarks:

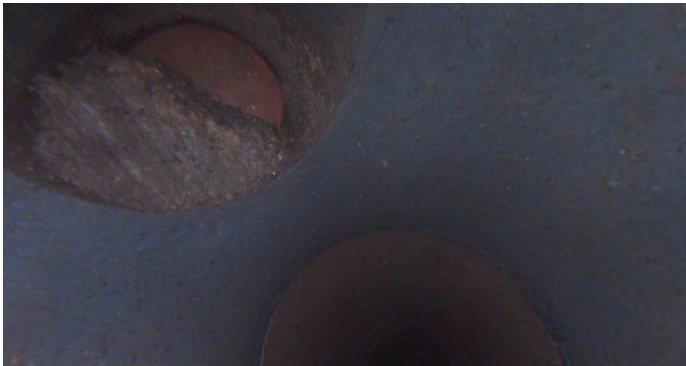
Code: **TFC**
Description: **Tap Factory Capped**

Distance (ft): **123.2**
Structural Grade: **0**
O&M Grade: **0**
Clock Start/From: **2**
Clock To:
1st Value: **4.000**
2nd Value:
Value Percent:
Continuous Index:
Within 8" of Joint:
Remarks:

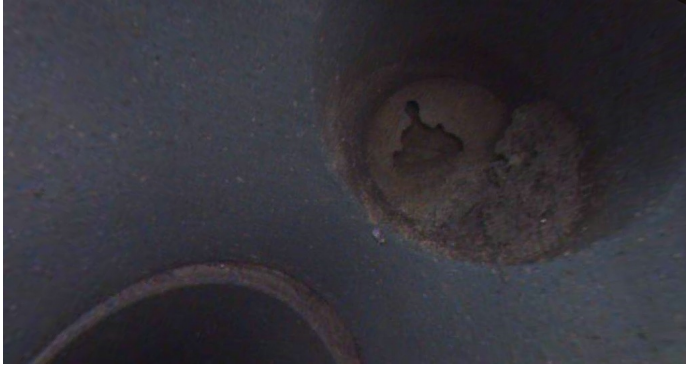
Code: **TFC**
Description: **Tap Factory Capped**

Distance (ft): **126.2**
Structural Grade: **0**
O&M Grade: **0**
Clock Start/From: **10**
Clock To:
1st Value: **4.000**
2nd Value:
Value Percent:
Continuous Index:
Within 8" of Joint:
Remarks:

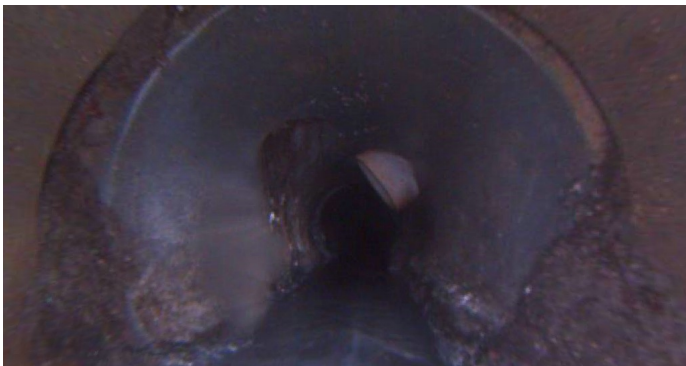
Code: **DAZ**
Description: **Deposits Attached Other**

Distance (ft): **142.9**
Structural Grade: **0**
O&M Grade: **2**
Clock Start/From: **7**
Clock To: **5**
1st Value:
2nd Value:
Value Percent: **5.000**
Continuous Index:
Within 8" of Joint: **YES**
Remarks:

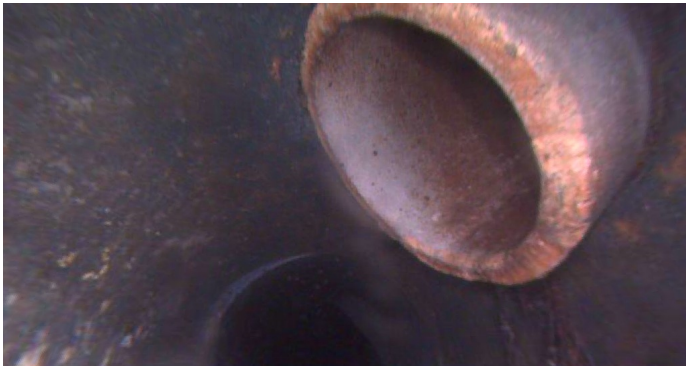
Code: **TBI**
Description: **Tap Break-in Intruding**

Distance (ft): **145.0**
Structural Grade: **0**
O&M Grade: **2**
Clock Start/From: **2**
Clock To:
1st Value: **4.000**
2nd Value: **3.000**
Value Percent:
Continuous Index:
Within 8" of Joint:
Remarks:

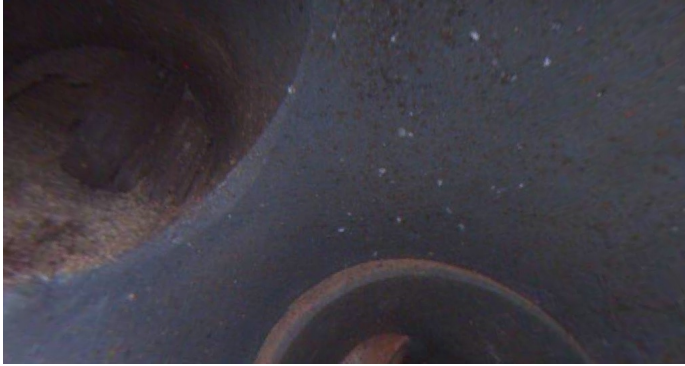
Code: **TFC**
Description: **Tap Factory Capped**

Distance (ft): **147.7**
Structural Grade: **0**
O&M Grade: **0**
Clock Start/From: **2**
Clock To:
1st Value: **4.000**
2nd Value:
Value Percent:
Continuous Index:
Within 8" of Joint:
Remarks:

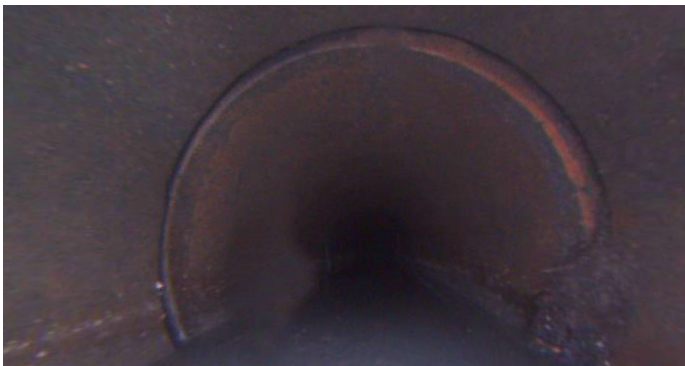
Code: **DAZ**
Description: **Deposits Attached Other**

Distance (ft): **155.0**
Structural Grade: **0**
O&M Grade: **2**
Clock Start/From: **5**
Clock To:
1st Value:
2nd Value:
Value Percent: **5.000**
Continuous Index:
Within 8" of Joint: **YES**
Remarks:

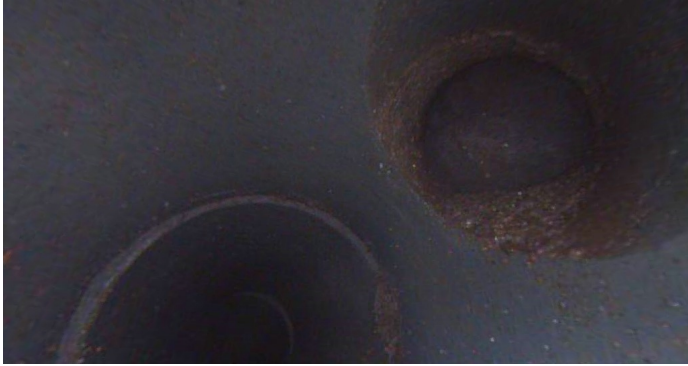
Code: **TF**
Description: **Tap Factory**

Distance (ft): **172.6**
Structural Grade: **0**
O&M Grade: **0**
Clock Start/From: **10**
Clock To:
1st Value: **4.000**
2nd Value:
Value Percent:
Continuous Index:
Within 8" of Joint:
Remarks:

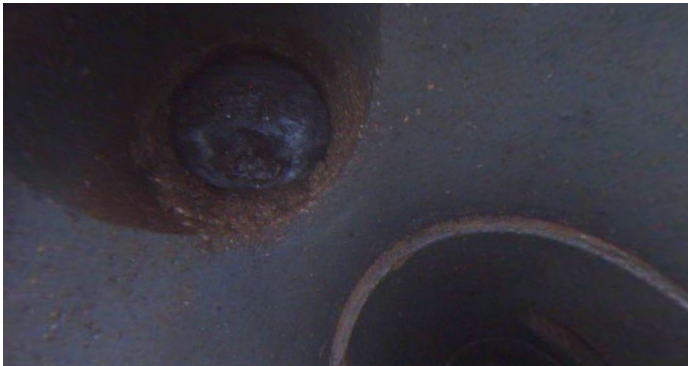
Code: **TFC**
Description: **Tap Factory Capped**

Distance (ft): **174.5**
Structural Grade: **0**
O&M Grade: **0**
Clock Start/From: **2**
Clock To:
1st Value: **4.000**
2nd Value:
Value Percent:
Continuous Index:
Within 8" of Joint:
Remarks:

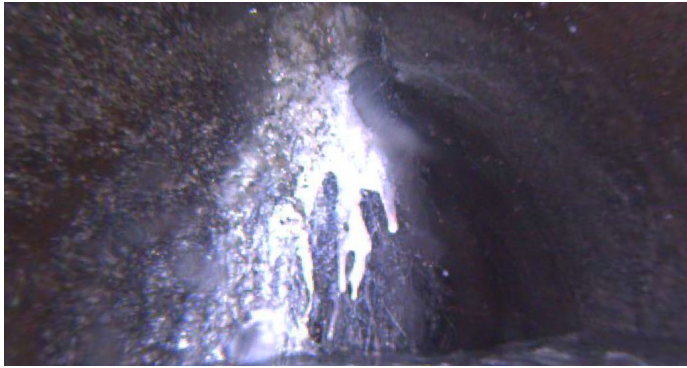
Code:	RMB
Description:	Roots Medium Barrel
Distance (ft):	189.5
Structural Grade:	0
O&M Grade:	4
Clock Start/From:	12
Clock To:	12
1st Value:	
2nd Value:	
Value Percent:	40.000
Continuous Index:	
Within 8" of Joint:	NO
Remarks:
