Profile/Photo Observation Report

Street:	E Home Ave	Flow Control:	Not Controlled
City:	Hobart, IN	Year Renewed:	
Location:	Other	Tape/Media #:	
Purpose:	Not Known	Dia/Height:	12"
Use:	Sanitary	Material:	VCP
Drain Area:	NA	Lining:	
Category:	NA		
Comment:

Location Details:		Direction of Survey:	Upstream
US MH:	M-704-014	DS MH:	M-704-015
		Total Length Surveyed (ft):	190.8

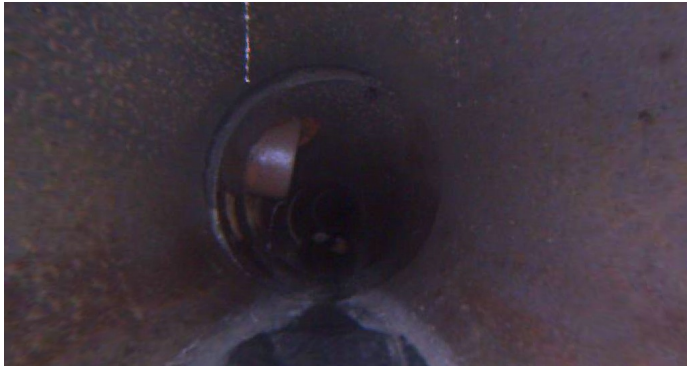
Code: **AMH**
Description: **Manhole**

Distance (ft): **.0**
Structural Grade: **0**
O&M Grade: **0**
Clock Start/From:
Clock To:
1st Value:
2nd Value:
Value Percent:
Continuous Index:
Within 8" of Joint: **NO**
Remarks: **M-704-015**

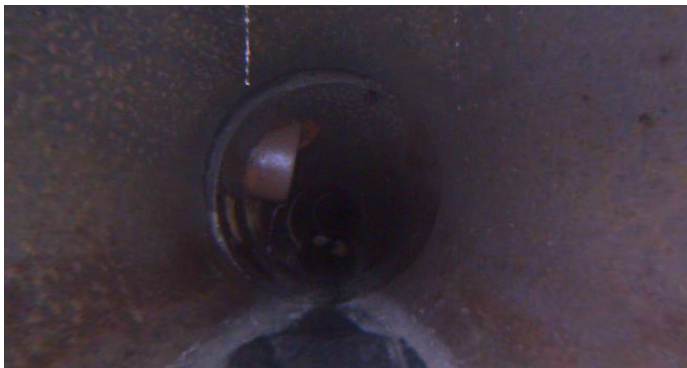
Code: **MWL**
Description: **Water Level**

Distance (ft): **.0**
Structural Grade: **0**
O&M Grade: **0**
Clock Start/From:
Clock To:
1st Value:
2nd Value:
Value Percent: **10.000**
Continuous Index:
Within 8" of Joint: **NO**
Remarks:

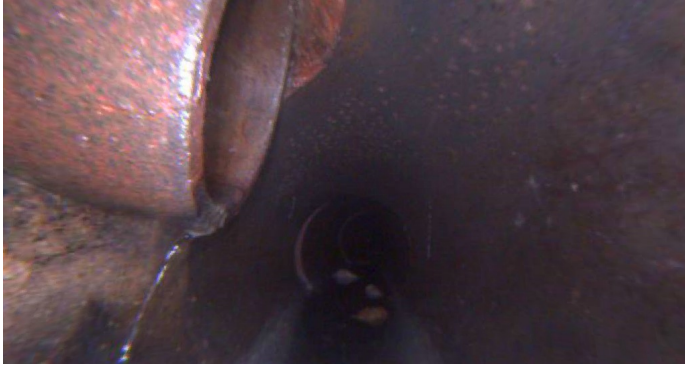
Code: **TBI**
Description: **Tap Break-in Intruding**

Distance (ft): **1.7**
Structural Grade: **0**
O&M Grade: **2**
Clock Start/From: **10**
Clock To:
1st Value: **4.000**
2nd Value: **3.000**
Value Percent:
Continuous Index:
Within 8" of Joint:
Remarks:

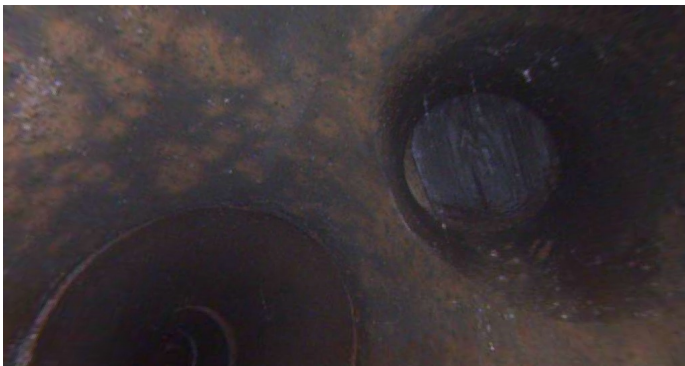
Code: **TFC**
Description: **Tap Factory Capped**

Distance (ft): **21.2**
Structural Grade: **0**
O&M Grade: **0**
Clock Start/From: **10**
Clock To:
1st Value: **4.000**
2nd Value:
Value Percent:
Continuous Index:
Within 8" of Joint:
Remarks:

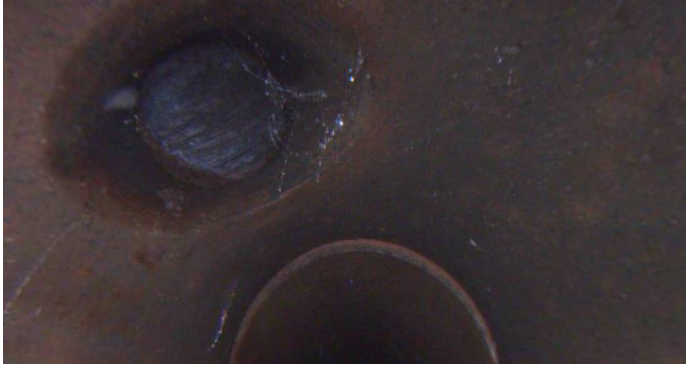
Code: **TFC**
Description: **Tap Factory Capped**

Distance (ft): **24.4**
Structural Grade: **0**
O&M Grade: **0**
Clock Start/From: **2**
Clock To:
1st Value: **4.000**
2nd Value:
Value Percent:
Continuous Index:
Within 8" of Joint:
Remarks:

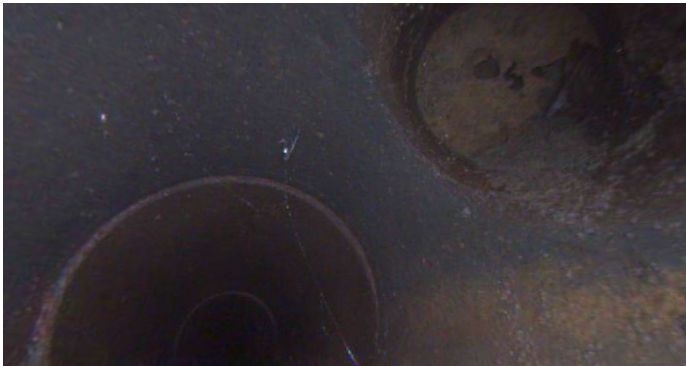
Code: **TFC**
Description: **Tap Factory Capped**

Distance (ft): **49.0**
Structural Grade: **0**
O&M Grade: **0**
Clock Start/From: **10**
Clock To:
1st Value: **4.000**
2nd Value:
Value Percent:
Continuous Index:
Within 8" of Joint:
Remarks:

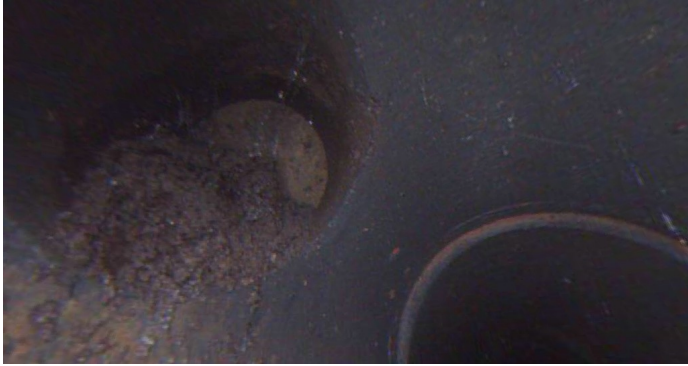
Code: **TFC**
Description: **Tap Factory Capped**

Distance (ft): **52.0**
Structural Grade: **0**
O&M Grade: **0**
Clock Start/From: **3**
Clock To:
1st Value: **4.000**
2nd Value:
Value Percent:
Continuous Index:
Within 8" of Joint:
Remarks:

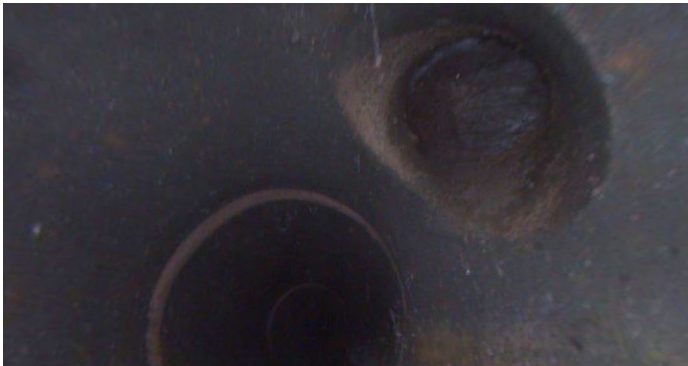
Code: **TFC**
Description: **Tap Factory Capped**

Distance (ft): **73.7**
Structural Grade: **0**
O&M Grade: **0**
Clock Start/From: **10**
Clock To:
1st Value: **4.000**
2nd Value:
Value Percent:
Continuous Index:
Within 8" of Joint:
Remarks:

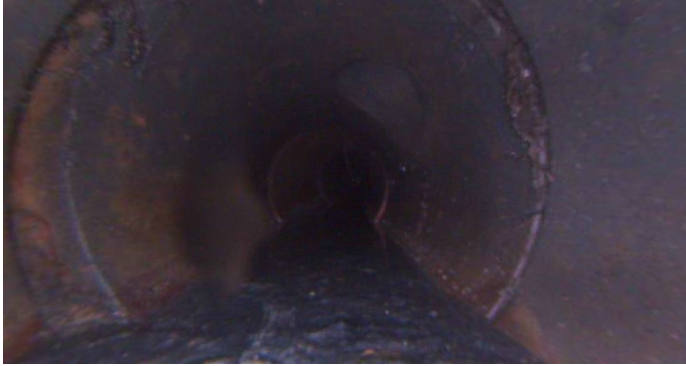
Code: **RFJ**
Description: **Roots Fine Joint**

Distance (ft): **73.7**
Structural Grade: **0**
O&M Grade: **1**
Clock Start/From: **7**
Clock To: **5**
1st Value:
2nd Value:
Value Percent:
Continuous Index:
Within 8" of Joint: **YES**
Remarks:

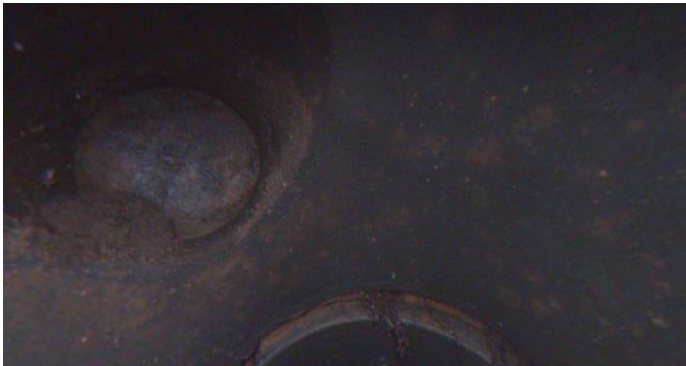
Code: **TFC**
Description: **Tap Factory Capped**

Distance (ft): **75.5**
Structural Grade: **0**
O&M Grade: **0**
Clock Start/From: **2**
Clock To:
1st Value: **4.000**
2nd Value:
Value Percent:
Continuous Index:
Within 8" of Joint:
Remarks:

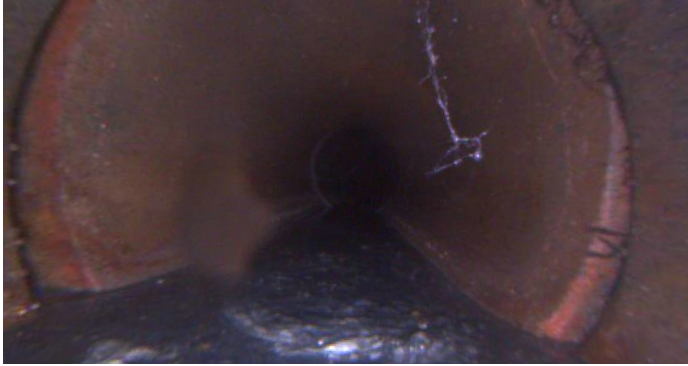
Code: **RFJ**
Description: **Roots Fine Joint**

Distance (ft): **75.9**
Structural Grade: **0**
O&M Grade: **1**
Clock Start/From: **2**
Clock To: **5**
1st Value:
2nd Value:
Value Percent:
Continuous Index:
Within 8" of Joint: **YES**
Remarks:

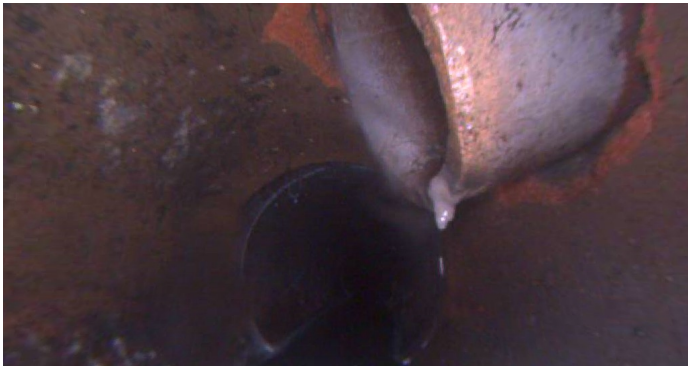
Code: **TBI**
Description: **Tap Break-in Intruding**

Distance (ft): **90.4**
Structural Grade: **0**
O&M Grade: **2**
Clock Start/From: **2**
Clock To:
1st Value: **4.000**
2nd Value: **3.000**
Value Percent:
Continuous Index:
Within 8" of Joint:
Remarks:

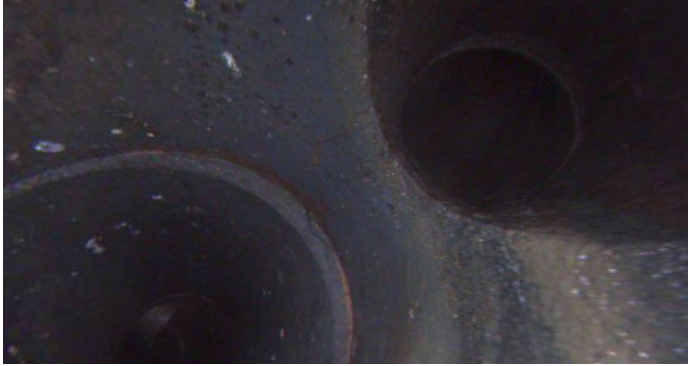
Code: **TF**
Description: **Tap Factory**

Distance (ft): **96.1**
Structural Grade: **0**
O&M Grade: **0**
Clock Start/From: **10**
Clock To:
1st Value: **4.000**
2nd Value:
Value Percent:
Continuous Index:
Within 8" of Joint:
Remarks:

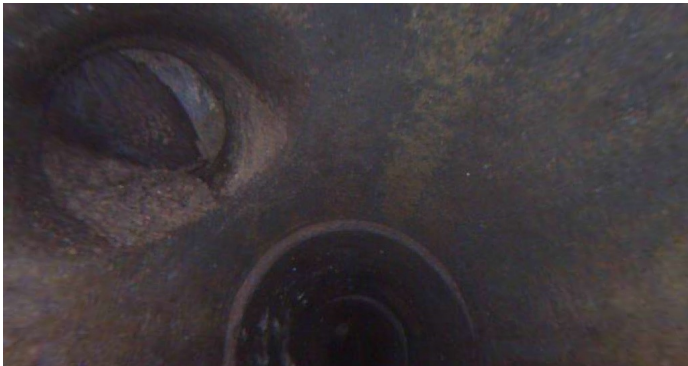
Code: **TF**
Description: **Tap Factory**

Distance (ft): **98.7**
Structural Grade: **0**
O&M Grade: **0**
Clock Start/From: **2**
Clock To:
1st Value: **4.000**
2nd Value:
Value Percent:
Continuous Index:
Within 8" of Joint:
Remarks:

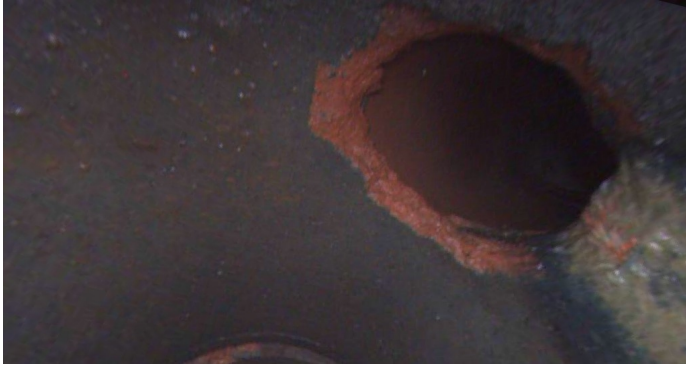
Code: **TB**
Description: **Tap Break-in**

Distance (ft): **117.0**
Structural Grade: **0**
O&M Grade: **0**
Clock Start/From: **10**
Clock To:
1st Value: **4.000**
2nd Value:
Value Percent:
Continuous Index:
Within 8" of Joint:
Remarks:

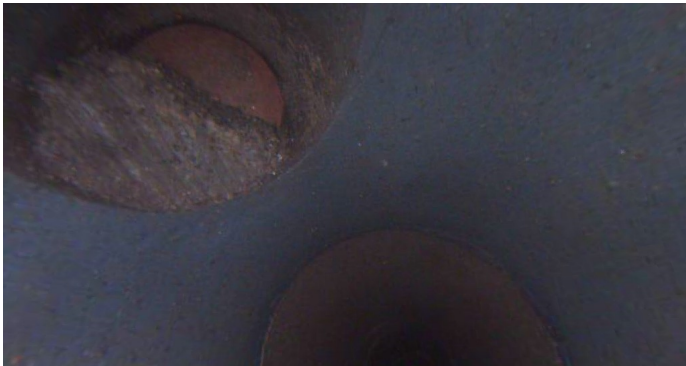
Code: **TFC**
Description: **Tap Factory Capped**

Distance (ft): **123.2**
Structural Grade: **0**
O&M Grade: **0**
Clock Start/From: **2**
Clock To:
1st Value: **4.000**
2nd Value:
Value Percent:
Continuous Index:
Within 8" of Joint:
Remarks:

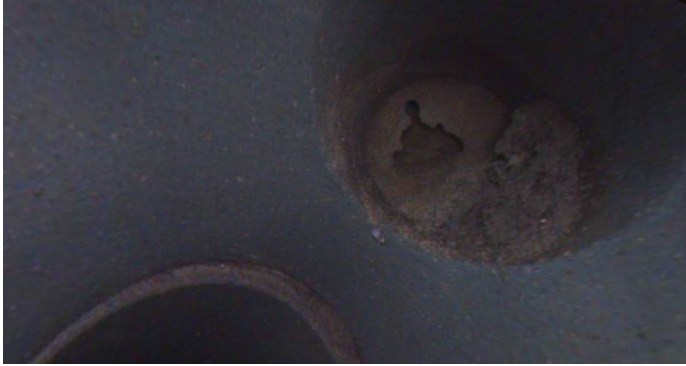
Code: **TFC**
Description: **Tap Factory Capped**

Distance (ft): **126.2**
Structural Grade: **0**
O&M Grade: **0**
Clock Start/From: **10**
Clock To:
1st Value: **4.000**
2nd Value:
Value Percent:
Continuous Index:
Within 8" of Joint:
Remarks:

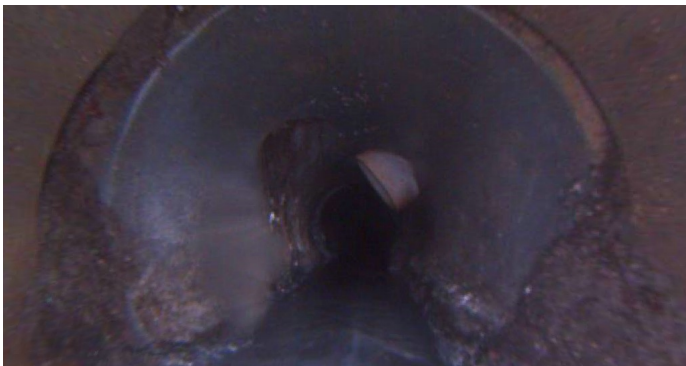
Code: **DAZ**
Description: **Deposits Attached Other**

Distance (ft): **142.9**
Structural Grade: **0**
O&M Grade: **2**
Clock Start/From: **7**
Clock To: **5**
1st Value:
2nd Value:
Value Percent: **5.000**
Continuous Index:
Within 8" of Joint: **YES**
Remarks:

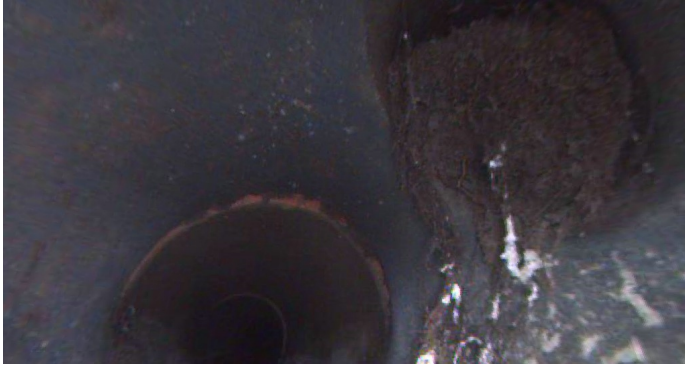
Code: **TFD**
Description: **Tap Factory Defective**

Distance (ft): **145.0**
Structural Grade: **0**
O&M Grade: **2**
Clock Start/From: **10**
Clock To:
1st Value: **4.000**
2nd Value:
Value Percent:
Continuous Index:
Within 8" of Joint:
Remarks: **ROOTS**

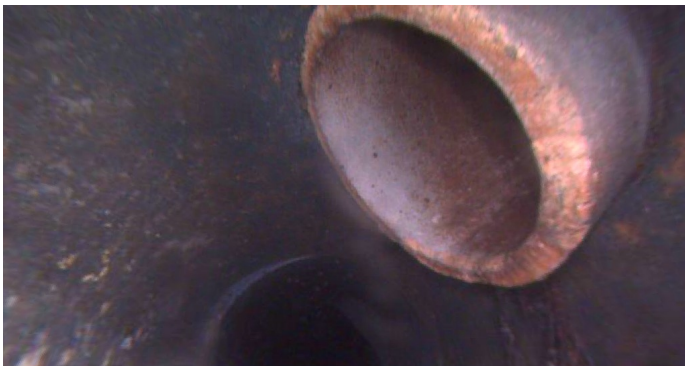
Code: **TBI**
Description: **Tap Break-in Intruding**

Distance (ft): **145.0**
Structural Grade: **0**
O&M Grade: **2**
Clock Start/From: **2**
Clock To:
1st Value: **4.000**
2nd Value: **3.000**
Value Percent:
Continuous Index:
Within 8" of Joint:
Remarks:

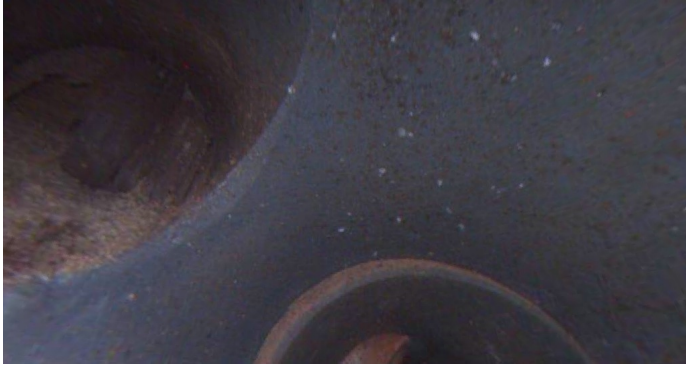
Code: **TFC**
Description: **Tap Factory Capped**

Distance (ft): **147.7**
Structural Grade: **0**
O&M Grade: **0**
Clock Start/From: **2**
Clock To:
1st Value: **4.000**
2nd Value:
Value Percent:
Continuous Index:
Within 8" of Joint:
Remarks:

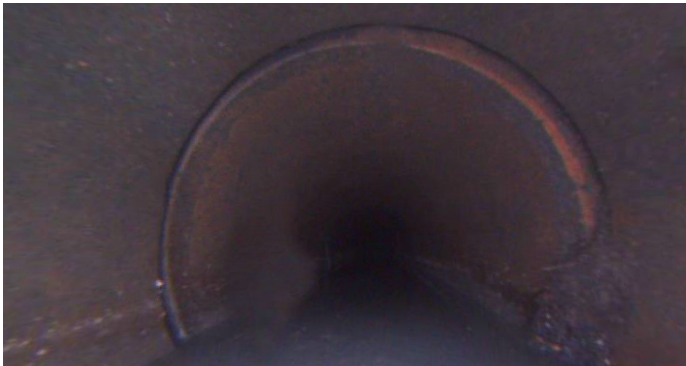
Code: **DAZ**
Description: **Deposits Attached Other**

Distance (ft): **155.0**
Structural Grade: **0**
O&M Grade: **2**
Clock Start/From: **5**
Clock To:
1st Value:
2nd Value:
Value Percent: **5.000**
Continuous Index:
Within 8" of Joint: **YES**
Remarks:

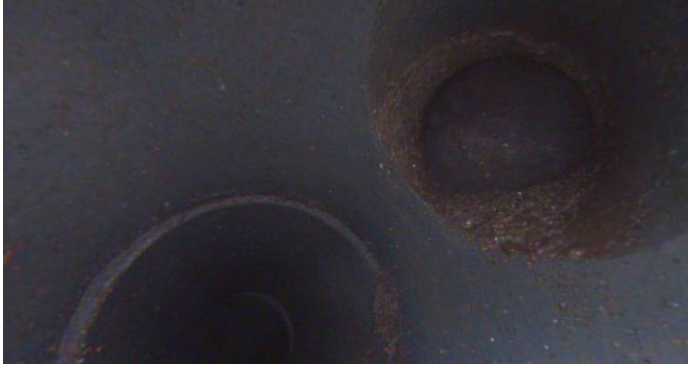
Code: **TF**
Description: **Tap Factory**

Distance (ft): **172.6**
Structural Grade: **0**
O&M Grade: **0**
Clock Start/From: **10**
Clock To:
1st Value: **4.000**
2nd Value:
Value Percent:
Continuous Index:
Within 8" of Joint:
Remarks:

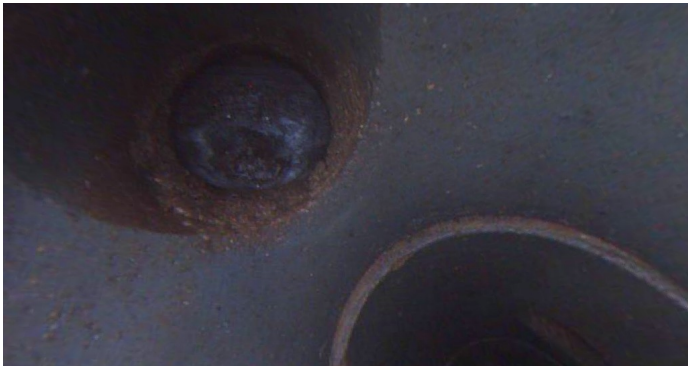
Code: **TFC**
Description: **Tap Factory Capped**

Distance (ft): **174.5**
Structural Grade: **0**
O&M Grade: **0**
Clock Start/From: **2**
Clock To:
1st Value: **4.000**
2nd Value:
Value Percent:
Continuous Index:
Within 8" of Joint:
Remarks:

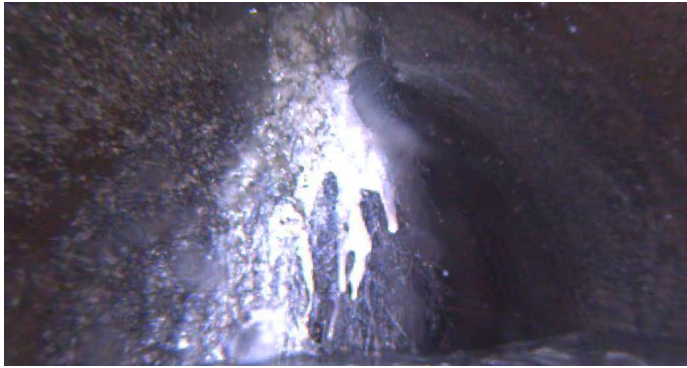
Code: **RMB**
Description: **Roots Medium Barrel**

Distance (ft): **189.5**
Structural Grade: **0**
O&M Grade: **4**
Clock Start/From: **12**
Clock To: **12**
1st Value:
2nd Value:
Value Percent: **40.000**
Continuous Index:
Within 8" of Joint: **NO**
Remarks:
