Profile/Photo Observation Report

Street:	N MICHIGAN AVE	Flow Control:	Not Controlled
City:	Hobart, IN	Year Renewed:	
Location:	Other	Tape/Media #:	
Purpose:	Not Known	Dia/Height:	8"
Use:	Sanitary	Material:	VCP
Drain Area:	NA	Lining:	
Category:	NA		
Comment:

Location Details:		Direction of Survey:	Downstream
US MH:	M-704-016	DS MH:	M-704-014
		Total Length Surveyed (ft):	30.4

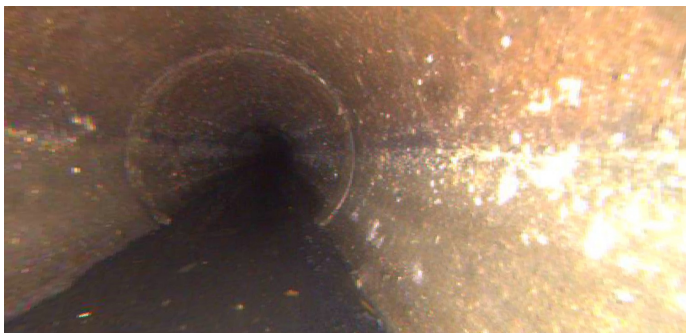
Code: **AMH**
Description: **Manhole**

Distance (ft): **.0**
Structural Grade: **0**
O&M Grade: **0**
Clock Start/From:
Clock To:
1st Value:
2nd Value:
Value Percent:
Continuous Index:
Within 8" of Joint: **NO**
Remarks: **M-704-016**

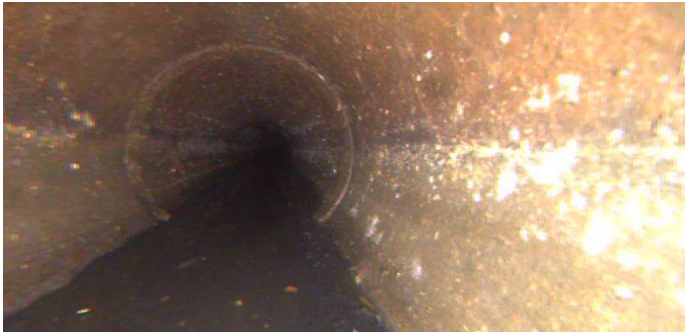
Code:	MWL
Description:	Water Level

Distance (ft):	.0
Structural Grade:	0
O&M Grade:	0
Clock Start/From:	
Clock To:	
1st Value:	
2nd Value:	
Value Percent:	5.000
Continuous Index:	
Within 8" of Joint:	NO
Remarks:

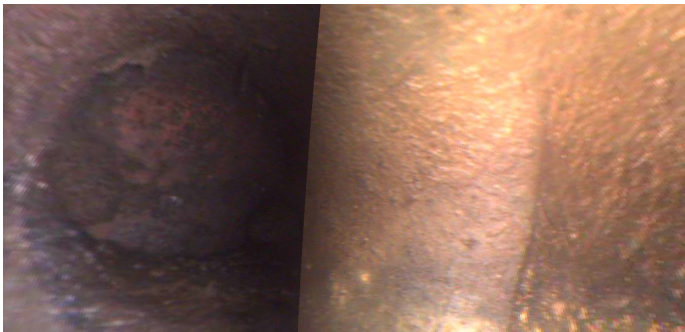
Code:	TFC
Description:	Tap Factory Capped

Distance (ft):	11.1
Structural Grade:	0
O&M Grade:	0
Clock Start/From:	10
Clock To:	
1st Value:	4.000
2nd Value:	
Value Percent:	
Continuous Index:	
Within 8" of Joint:	YES
Remarks:

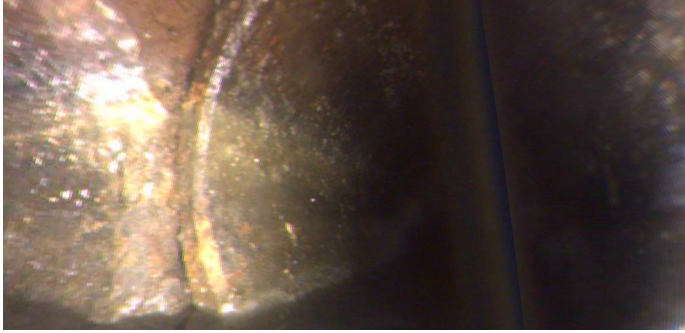
Code: **TF**
Description: **Tap Factory**

Distance (ft): **15.4**
Structural Grade: **0**
O&M Grade: **0**
Clock Start/From: **3**
Clock To:
1st Value: **8.000**
2nd Value:
Value Percent:
Continuous Index:
Within 8" of Joint:
Remarks:

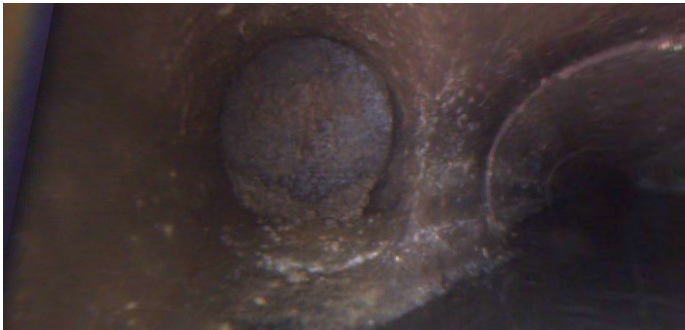
Code: **TFC**
Description: **Tap Factory Capped**

Distance (ft): **25.3**
Structural Grade: **0**
O&M Grade: **0**
Clock Start/From: **3**
Clock To:
1st Value: **4.000**
2nd Value:
Value Percent:
Continuous Index:
Within 8" of Joint: **YES**
Remarks:

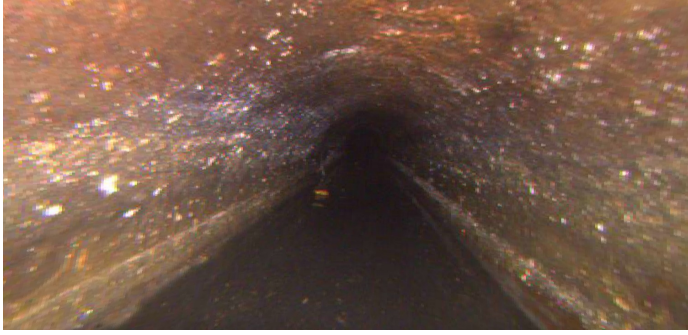
Code:	MSA
Description:	Abandoned Survey
Distance (ft):	30.4
Structural Grade:	0
O&M Grade:	0
Clock Start/From:	
Clock To:	
1st Value:	
2nd Value:	
Value Percent:	
Continuous Index:	
Within 8" of Joint:	NO
Remarks:	no blockage
