Profile/Photo Observation Report

Street:	N MICHIGAN AVE	Flow Control:	Not Controlled
City:	Hobart, IN	Year Renewed:	
Location:	Other	Tape/Media #:	
Purpose:	Not Known	Dia/Height:	8"
Use:	Sanitary	Material:	VCP
Drain Area:	NA	Lining:	
Category:	NA		
Comment:

Location Details:		Direction of Survey:	Upstream
US MH:	M-704-017	DS MH:	M-704-016
		Total Length Surveyed (ft):	20.4

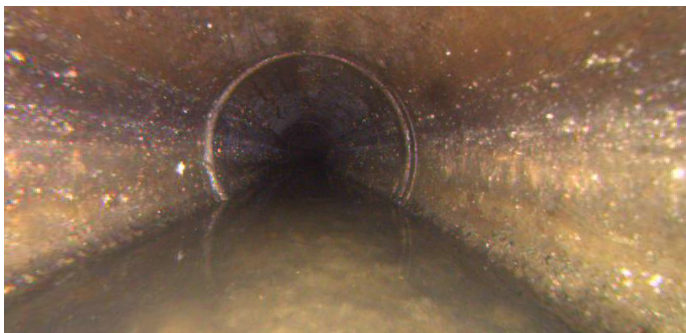
Code: **AMH**
Description: **Manhole**

Distance (ft): **.0**
Structural Grade: **0**
O&M Grade: **0**
Clock Start/From:
Clock To:
1st Value:
2nd Value:
Value Percent:
Continuous Index:
Within 8" of Joint: **NO**
Remarks: **M-704-016**

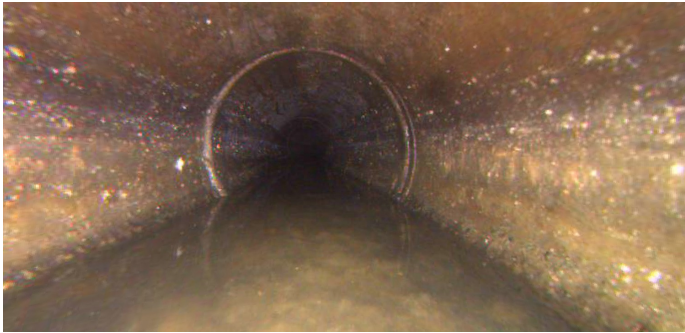
Code:	MWL
Description:	Water Level

Distance (ft):	.0
Structural Grade:	0
O&M Grade:	0
Clock Start/From:	
Clock To:	
1st Value:	
2nd Value:	
Value Percent:	20.000
Continuous Index:	
Within 8" of Joint:	NO
Remarks:

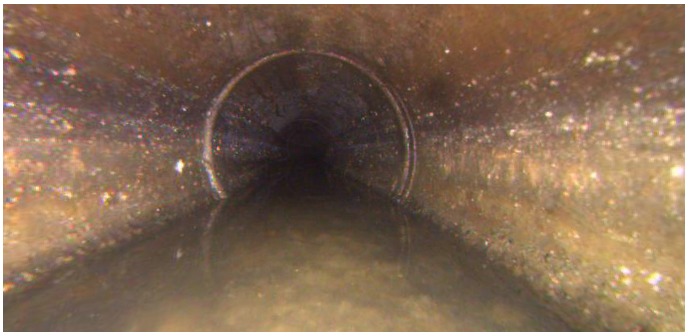
Code:	DAGS
Description:	Deposits Attached Grease

Distance (ft):	.0
Structural Grade:	0
O&M Grade:	2
Clock Start/From:	8
Clock To:	4
1st Value:	
2nd Value:	
Value Percent:	5.000
Continuous Index:	S01
Within 8" of Joint:	NO
Remarks:

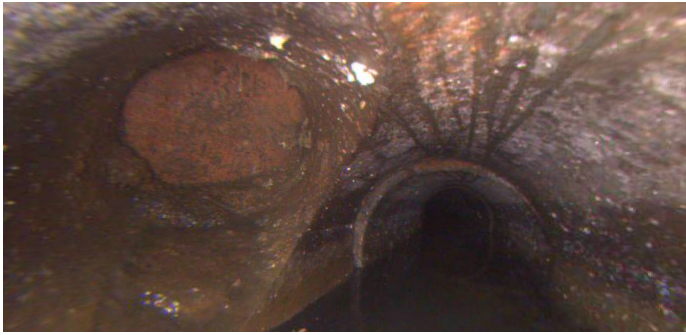
Code: **TFC**
Description: **Tap Factory Capped**

Distance (ft): **11.0**
Structural Grade: **0**
O&M Grade: **0**
Clock Start/From: **9**
Clock To:
1st Value: **4.000**
2nd Value:
Value Percent:
Continuous Index:
Within 8" of Joint:
Remarks:

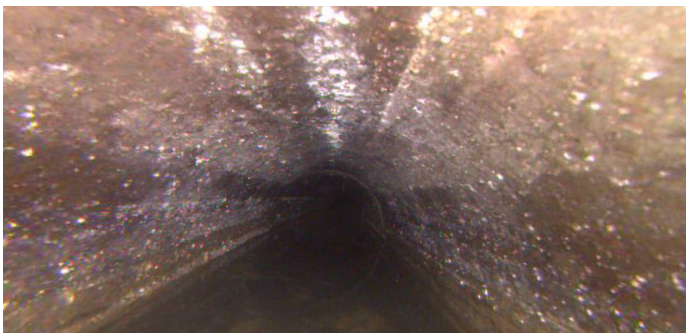
Code: **DAGS**
Description: **Deposits Attached Grease**

Distance (ft): **20.4**
Structural Grade: **0**
O&M Grade: **2**
Clock Start/From: **8**
Clock To: **4**
1st Value:
2nd Value:
Value Percent: **5.000**
Continuous Index: **F01**
Within 8" of Joint: **NO**
Remarks:

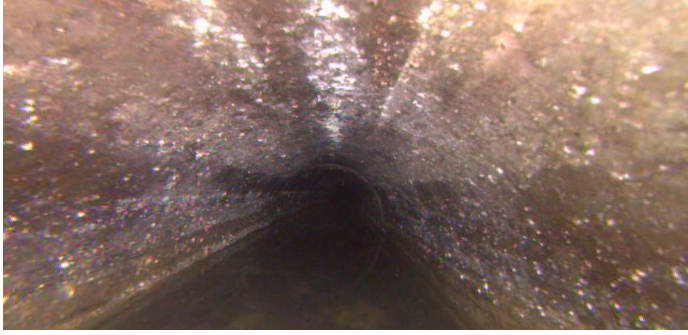
Code:	MSA
Description:	Abandoned Survey
Distance (ft):	20.4
Structural Grade:	0
O&M Grade:	0
Clock Start/From:	
Clock To:	
1st Value:	
2nd Value:	
Value Percent:	
Continuous Index:	
Within 8" of Joint:	NO
Remarks:	debris under water
