Profile/Photo Observation Report

Date:	04/09/2018	Weather:		Coding:	PACP 6.0
Pipe Length (ft):	333.5	Owner:	NA	Pre Clean:	Not Known
P.O.#:		Surveyor:	Jen Costello	PSR:	P-704-017-016
Customer:		Clean Date:	01/01/1900	Shape:	C

Location Details:		Direction of Survey:	Upstream
US MH:	M-704-017	DS MH:	M-704-016
		Total Length Surveyed (ft):	20.4

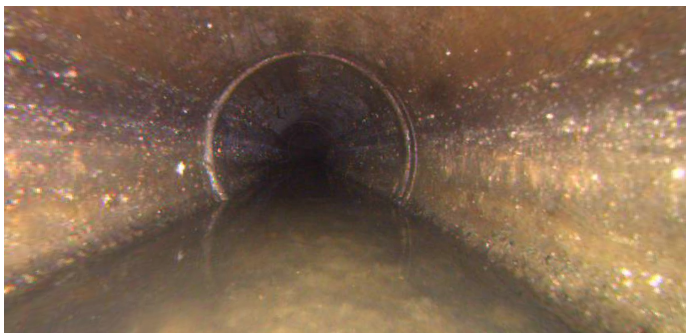
Code: **AMH**
Description: **Manhole**

Distance (ft): **.0**
Structural Grade: **0**
O&M Grade: **0**
Clock Start/From:
Clock To:
1st Value:
2nd Value:
Value Percent:
Continuous Index:
Within 8" of Joint: **NO**
Remarks: **M-704-016**

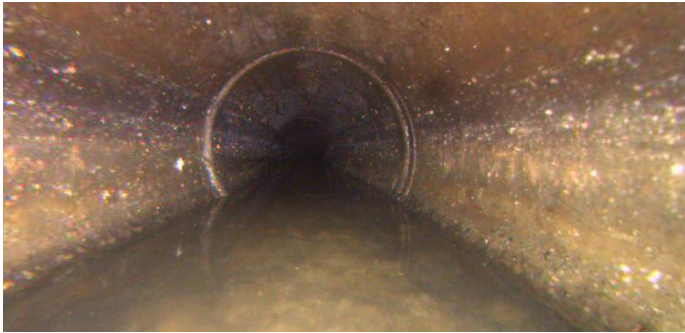
Code:	MWL
Description:	Water Level

Distance (ft):	.0
Structural Grade:	0
O&M Grade:	0
Clock Start/From:	
Clock To:	
1st Value:	
2nd Value:	
Value Percent:	20.000
Continuous Index:	
Within 8" of Joint:	NO
Remarks:

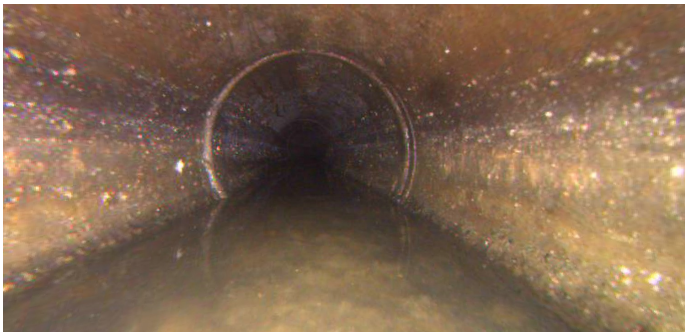
Code:	DAGS
Description:	Deposits Attached Grease

Distance (ft):	.0
Structural Grade:	0
O&M Grade:	2
Clock Start/From:	8
Clock To:	4
1st Value:	
2nd Value:	
Value Percent:	5.000
Continuous Index:	S01
Within 8" of Joint:	NO
Remarks:

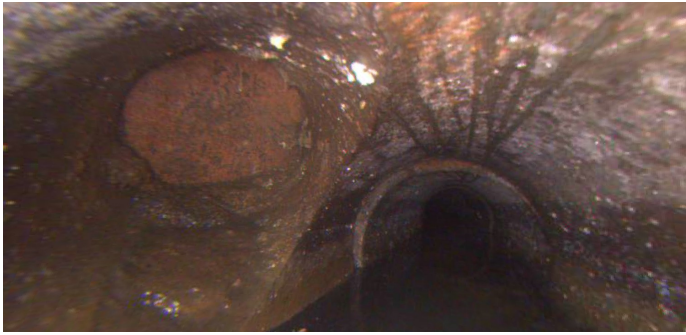
Code: **TFC**
Description: **Tap Factory Capped**

Distance (ft): **11.0**
Structural Grade: **0**
O&M Grade: **0**
Clock Start/From: **9**
Clock To:
1st Value: **4.000**
2nd Value:
Value Percent:
Continuous Index:
Within 8" of Joint:
Remarks:

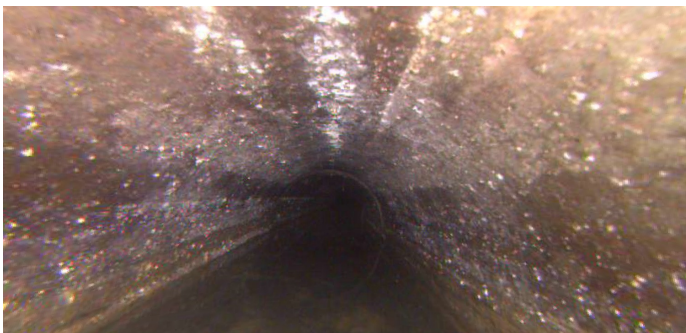
Code: **DAGS**
Description: **Deposits Attached Grease**

Distance (ft): **20.4**
Structural Grade: **0**
O&M Grade: **2**
Clock Start/From: **8**
Clock To: **4**
1st Value:
2nd Value:
Value Percent: **5.000**
Continuous Index: **F01**
Within 8" of Joint: **NO**
Remarks:

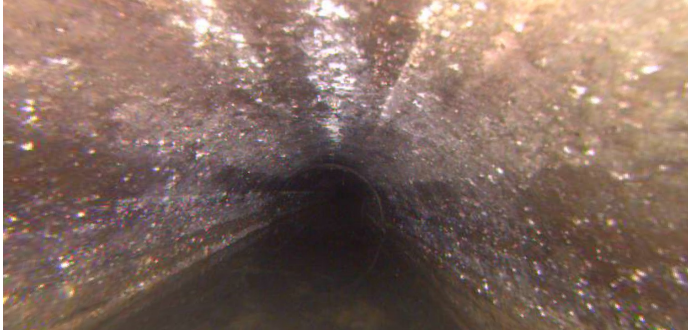
Code:	MSA
Description:	Abandoned Survey
Distance (ft):	20.4
Structural Grade:	0
O&M Grade:	0
Clock Start/From:	
Clock To:	
1st Value:	
2nd Value:	
Value Percent:	
Continuous Index:	
Within 8" of Joint:	NO
Remarks:	debris under water
