Profile/Photo Observation Report

Street:	N MICHIGAN AVE	Flow Control:	Not Controlled
City:	Hobart, IN	Year Renewed:	
Location:	Other	Tape/Media #:	
Purpose:	Not Known	Dia/Height:	8"
Use:	Sanitary	Material:	VCP
Drain Area:	NA	Lining:	
Category:	NA		
Comment:

Location Details:		Direction of Survey:	Upstream
US MH:	M-704-018	DS MH:	M-704-017
		Total Length Surveyed (ft):	13.3

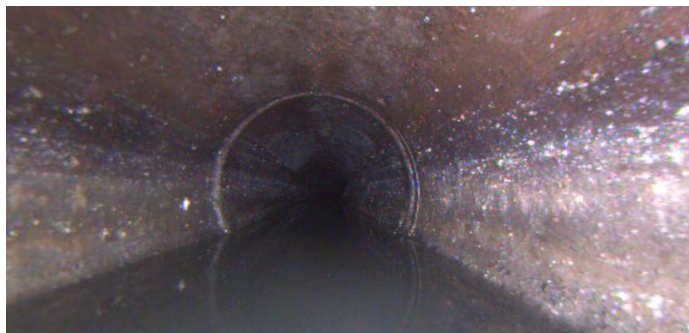
Code: **AMH**
 Description: **Manhole**
 Distance (ft): **.0**
 Structural Grade: **0**
 O&M Grade: **0**
 Clock Start/From:
 Clock To:
 1st Value:
 2nd Value:
 Value Percent:
 Continuous Index:
 Within 8" of Joint: **NO**
 Remarks: **M-704-017**

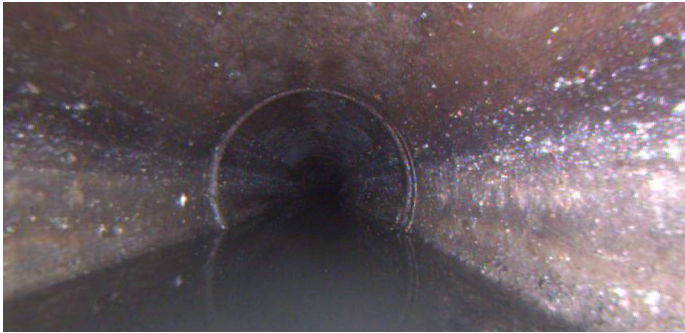
Code:	MWL
Description:	Water Level

Distance (ft):	.0
Structural Grade:	0
O&M Grade:	0
Clock Start/From:	
Clock To:	
1st Value:	
2nd Value:	
Value Percent:	40.000
Continuous Index:	
Within 8" of Joint:	NO
Remarks:

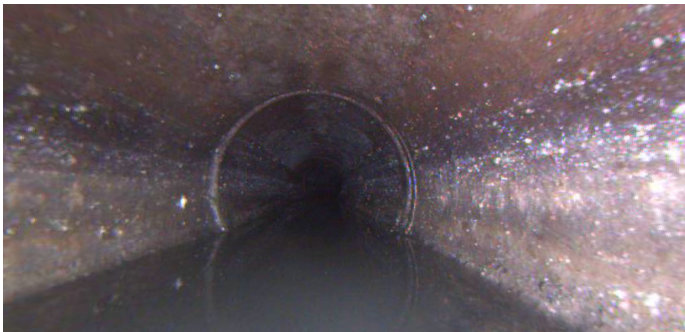
Code:	DAGS
Description:	Deposits Attached Grease

Distance (ft):	.0
Structural Grade:	0
O&M Grade:	2
Clock Start/From:	8
Clock To:	4
1st Value:	
2nd Value:	
Value Percent:	5.000
Continuous Index:	
Within 8" of Joint:	NO
Remarks:

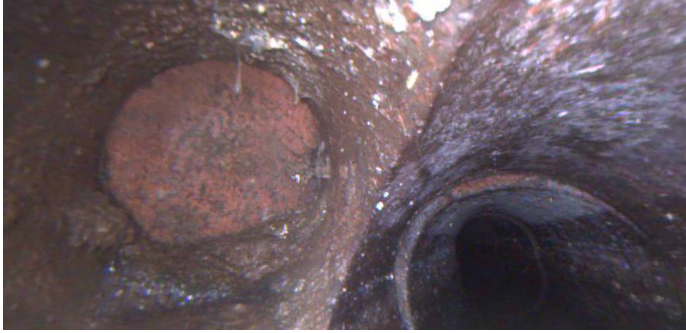
Code: **TFC**
Description: **Tap Factory Capped**

Distance (ft): **11.0**
Structural Grade: **0**
O&M Grade: **0**
Clock Start/From: **9**
Clock To:
1st Value: **4.000**
2nd Value:
Value Percent:
Continuous Index:
Within 8" of Joint:
Remarks:

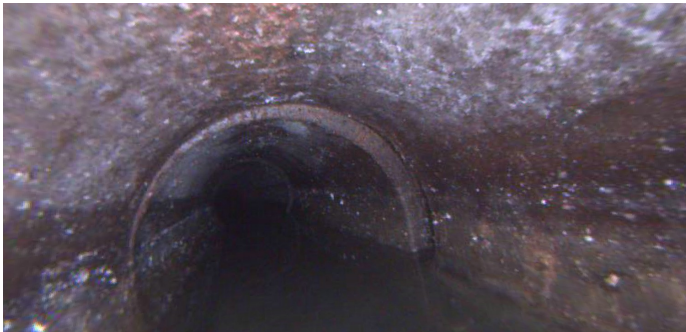
Code: **MSA**
Description: **Abandoned Survey**

Distance (ft): **13.3**
Structural Grade: **0**
O&M Grade: **0**
Clock Start/From:
Clock To:
1st Value:
2nd Value:
Value Percent:
Continuous Index:
Within 8" of Joint: **NO**
Remarks: **UNKNOWN**
