Profile/Photo Observation Report

Date:	04/09/2018	Weather:		Coding:	PACP 6.0
Pipe Length (ft):	330.6	Owner:	NA	Pre Clean:	Not Known
P.O.#:		Surveyor:	Jen Costello	PSR:	P-704-018-017
Customer:		Clean Date:	01/01/1900	Shape:	C

Street:	N Michigan Ave.	Flow Control:	Not Controlled
City:	Hobart, IN	Year Renewed:	
Location:	Other	Tape/Media #:	
Purpose:	Not Known	Dia/Height:	8"
Use:	Sanitary	Material:	VCP
Drain Area:	NA	Lining:	
Category:	NA		
Comment:

Location Details:		Direction of Survey:	Upstream
US MH:	M-704-018	DS MH:	M-704-017
		Total Length Surveyed (ft):	13.3

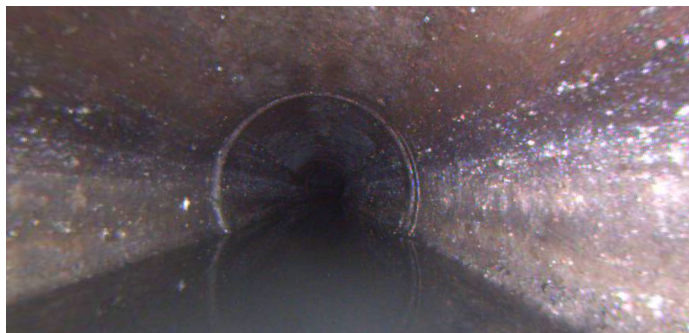
Code: **AMH**
 Description: **Manhole**

Distance (ft): **.0**
 Structural Grade: **0**
 O&M Grade: **0**
 Clock Start/From:
 Clock To:
 1st Value:
 2nd Value:
 Value Percent:
 Continuous Index:
 Within 8" of Joint: **NO**
 Remarks: **M-704-017**

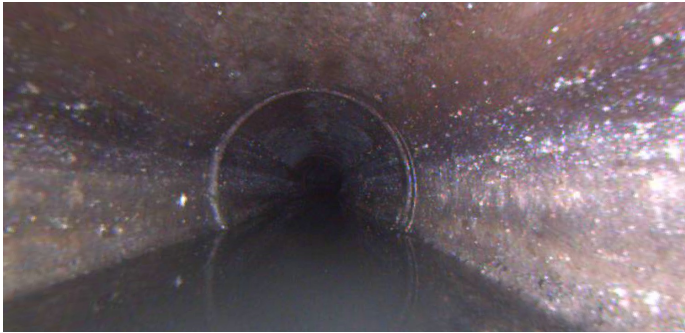
Code:	MWL
Description:	Water Level

Distance (ft):	.0
Structural Grade:	0
O&M Grade:	0
Clock Start/From:	
Clock To:	
1st Value:	
2nd Value:	
Value Percent:	40.000
Continuous Index:	
Within 8" of Joint:	NO
Remarks:

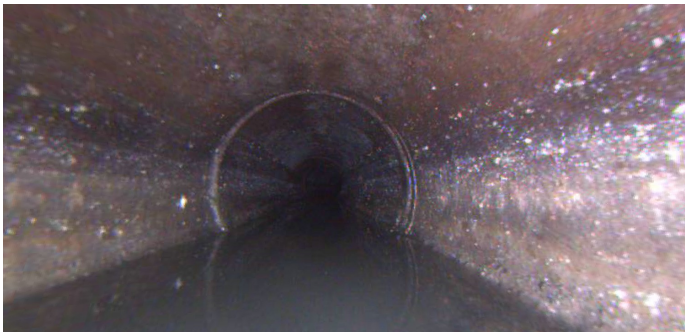
Code:	DAGS
Description:	Deposits Attached Grease

Distance (ft):	.0
Structural Grade:	0
O&M Grade:	2
Clock Start/From:	8
Clock To:	4
1st Value:	
2nd Value:	
Value Percent:	5.000
Continuous Index:	
Within 8" of Joint:	NO
Remarks:

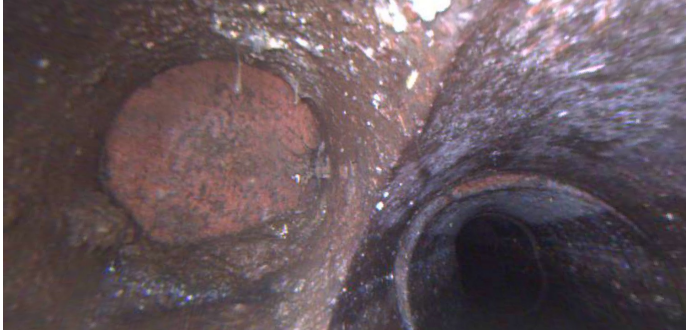
Code: **TFC**
Description: **Tap Factory Capped**

Distance (ft): **11.0**
Structural Grade: **0**
O&M Grade: **0**
Clock Start/From: **9**
Clock To:
1st Value: **4.000**
2nd Value:
Value Percent:
Continuous Index:
Within 8" of Joint:
Remarks:

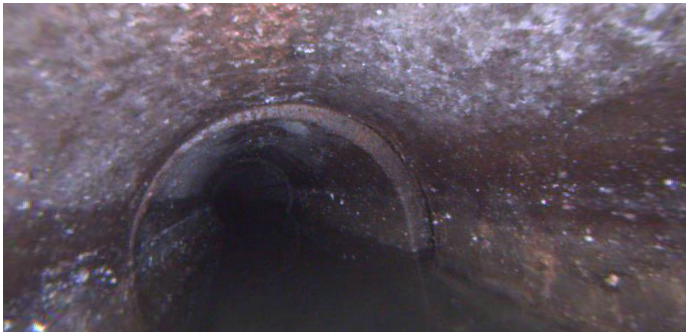
Code: **MSA**
Description: **Abandoned Survey**

Distance (ft): **13.3**
Structural Grade: **0**
O&M Grade: **0**
Clock Start/From:
Clock To:
1st Value:
2nd Value:
Value Percent:
Continuous Index:
Within 8" of Joint: **NO**
Remarks: **UNKNOWN**
