Profile/Photo Observation Report

Street:	East Old Ridge Street	Flow Control:	Not Controlled
City:	Hobart, IN	Year Renewed:	
Location:	Light Highway	Tape/Media #:	DEP 138
Purpose:	Routine Assessment	Dia/Height:	18"
Use:	Sanitary	Material:	CP
Drain Area:		Lining:	
Category:	NA		
Comment:	5-21-2018		
Location Details:		Direction of Survey:	Downstream
US MH:	M-704-021	DS MH:	M-705-063
		Total Length Surveyed (ft):	13.5

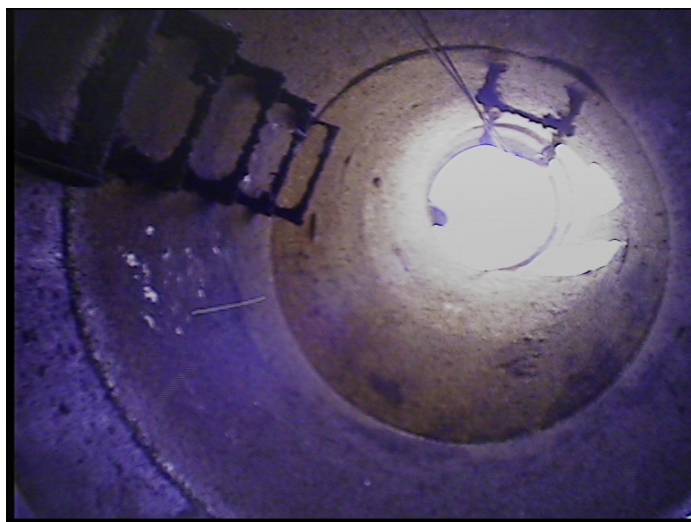
Code: **AMH**
Description: **Manhole**

Distance (ft): **.0**
Structural Grade: **0**
O&M Grade: **0**
Clock Start/From:
Clock To:
1st Value:
2nd Value:
Value Percent:
Continuous Index:
Within 8" of Joint: **NO**
Remarks: **M-704-021**

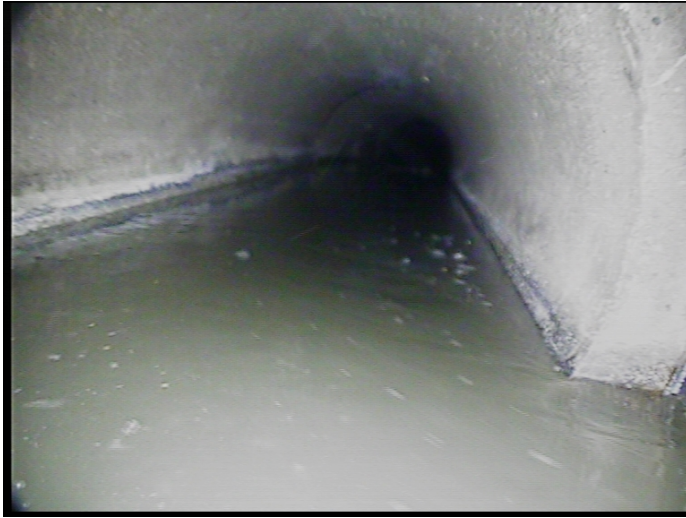
Code: **MWL**
Description: **Water Level**

Distance (ft): **.0**
Structural Grade: **0**
O&M Grade: **0**
Clock Start/From:
Clock To:
1st Value:
2nd Value:
Value Percent: **15.000**
Continuous Index:
Within 8" of Joint: **NO**
Remarks:

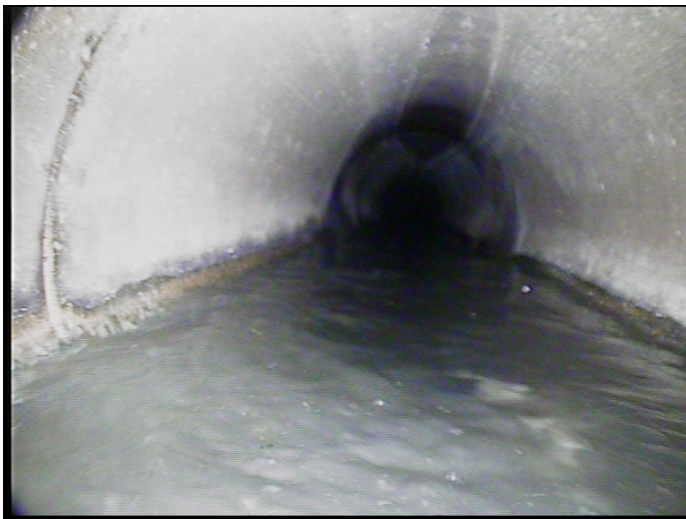
Code: **DSF**
Description: **Deposits Settled Fine**

Distance (ft): **11.9**
Structural Grade: **0**
O&M Grade: **3**
Clock Start/From: **4**
Clock To: **8**
1st Value:
2nd Value:
Value Percent: **15.000**
Continuous Index:
Within 8" of Joint: **YES**
Remarks:

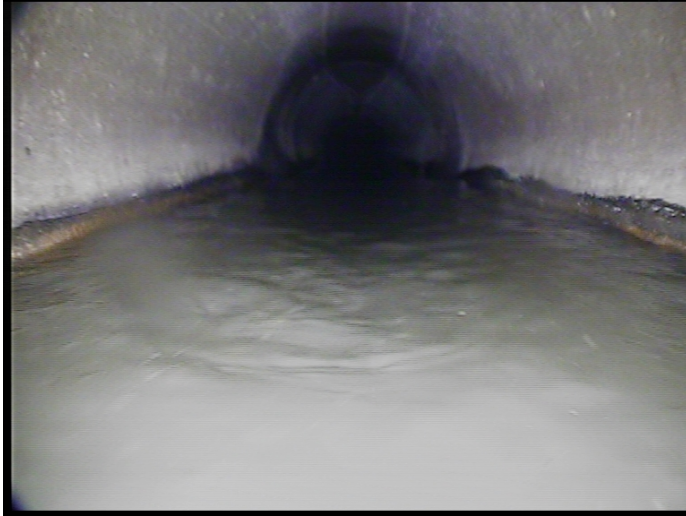
Code:	MSA
Description:	Abandoned Survey
Distance (ft):	13.3
Structural Grade:	0
O&M Grade:	0
Clock Start/From:	
Clock To:	
1st Value:	
2nd Value:	
Value Percent:	
Continuous Index:	
Within 8" of Joint:	NO
Remarks:	sediment/debris
