Profile/Photo Observation Report

Date:	04/29/2018	Weather:		Coding:	PACP 6.0
Pipe Length (ft):		Owner:	City of Hobart	Pre Clean:	No Pre-Cleaning
P.O.#:	139	Surveyor:	M. Pielacha	PSR:	P-704-027-021
Customer:	City of Hobart	Clean Date:		Shape:	C

Street:	Off Old Ridge Road	Flow Control:	Not Controlled
City:	Hobart, IN	Year Renewed:	
Location:	Easement/Right of Way	Tape/Media #:	DEP 139
Purpose:	Routine Assessment	Dia/Height:	18"
Use:	Sanitary	Material:	VCP
Drain Area:		Lining:	
Category:	NA		
Comment:	5-21-2018		
Location Details:		Direction of Survey:	Upstream
US MH:	M-704-027	DS MH:	M-704-021
		Total Length Surveyed (ft):	131.8

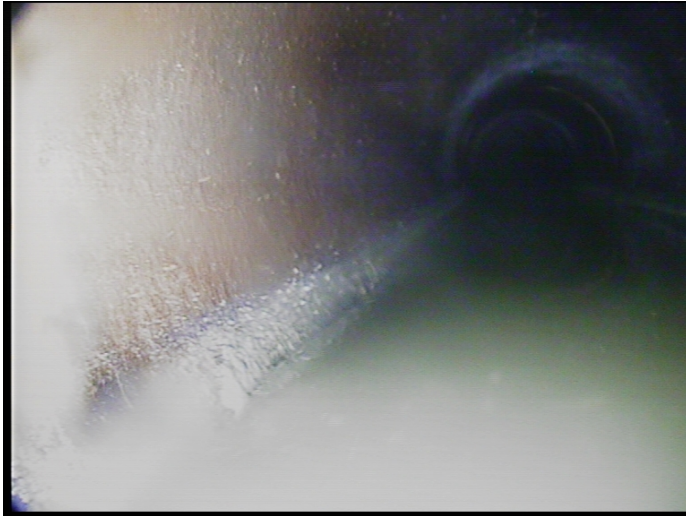
Code: **MWL**
Description: **Water Level**

Distance (ft): **.0**
Structural Grade: **0**
O&M Grade: **0**
Clock Start/From:
Clock To:
1st Value:
2nd Value:
Value Percent: **15.000**
Continuous Index:
Within 8" of Joint: **NO**
Remarks:

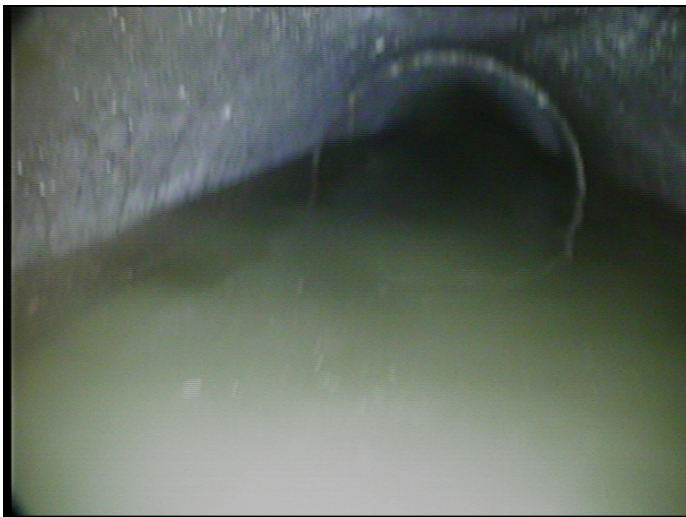
Code: **MSA**
Description: **Abandoned Survey**

Distance (ft): **131.8**
Structural Grade: **0**
O&M Grade: **0**
Clock Start/From:
Clock To:
1st Value:
2nd Value:
Value Percent:
Continuous Index:
Within 8" of Joint: **NO**
Remarks: **underwater debris**
