Profile/Photo Observation Report

Street:	Ruta Dr.	Flow Control:	Not Controlled
City:	Hobart, IN	Year Renewed:	
Location:	Other	Tape/Media #:	
Purpose:	Not Known	Dia/Height:	8"
Use:	Sanitary	Material:	VCP
Drain Area:	NA	Lining:	
Category:	NA		
Comment:

Location Details:		Direction of Survey:	Upstream
US MH:	M-704-058	DS MH:	M-704-056
		Total Length Surveyed (ft):	5.3

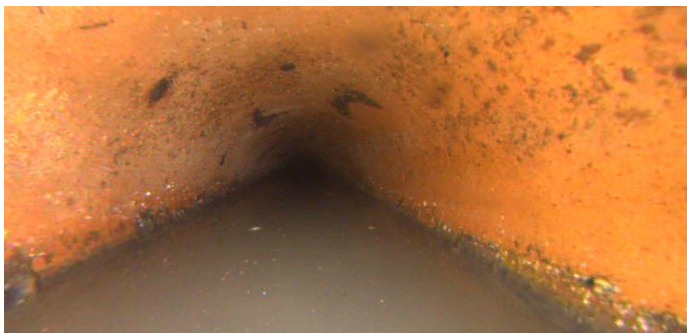
Code: **AMH**
 Description: **Manhole**

Distance (ft): **.0**
 Structural Grade: **0**
 O&M Grade: **0**
 Clock Start/From:
 Clock To:
 1st Value:
 2nd Value:
 Value Percent:
 Continuous Index:
 Within 8" of Joint: **NO**
 Remarks: **M-704-056**

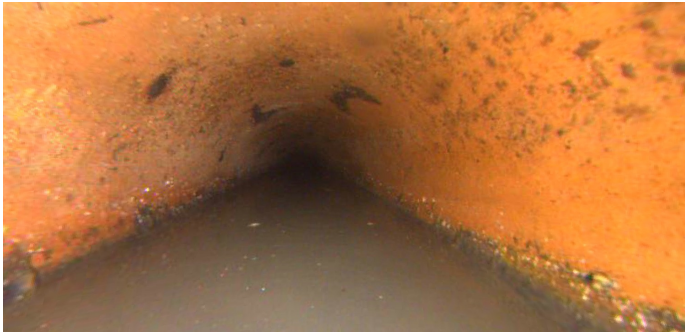
Code:	MWL
Description:	Water Level

Distance (ft):	.0
Structural Grade:	0
O&M Grade:	0
Clock Start/From:	
Clock To:	
1st Value:	
2nd Value:	
Value Percent:	40.000
Continuous Index:	
Within 8" of Joint:	NO
Remarks:

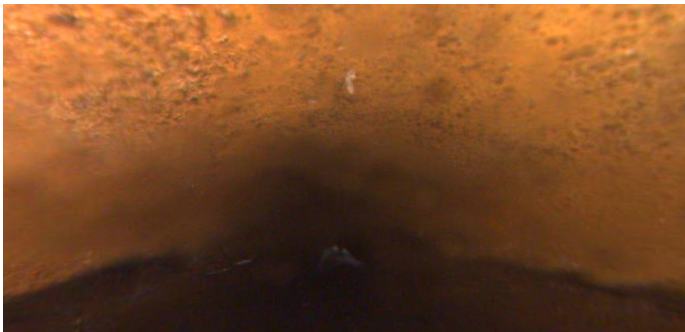
Code:	MSA
Description:	Abandoned Survey

Distance (ft):	5.3
Structural Grade:	0
O&M Grade:	0
Clock Start/From:	
Clock To:	
1st Value:	
2nd Value:	
Value Percent:	
Continuous Index:	
Within 8" of Joint:	NO
Remarks:	debris under water
