Profile/Photo Observation Report

Street:	Ruta Dr.	Flow Control:	Not Controlled
City:	Hobart, IN	Year Renewed:	
Location:	Other	Tape/Media #:	
Purpose:	Not Known	Dia/Height:	8"
Use:	Sanitary	Material:	VCP
Drain Area:	NA	Lining:	
Category:	NA		
Comment:

Location Details:		Direction of Survey:	Downstream
US MH:	M-704-058	DS MH:	M-704-056
		Total Length Surveyed (ft):	38.6

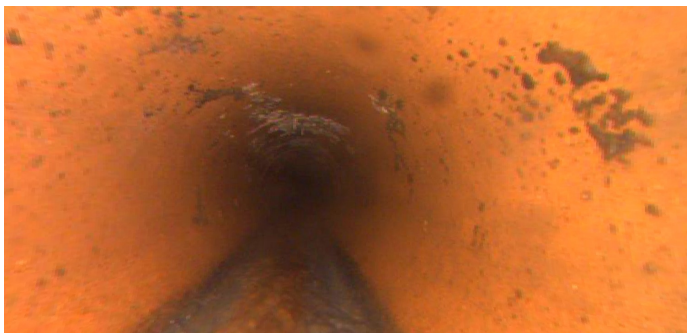
Code: **AMH**
Description: **Manhole**

Distance (ft): **.0**
Structural Grade: **0**
O&M Grade: **0**
Clock Start/From:
Clock To:
1st Value:
2nd Value:
Value Percent:
Continuous Index:
Within 8" of Joint: **NO**
Remarks: **M-704-058**

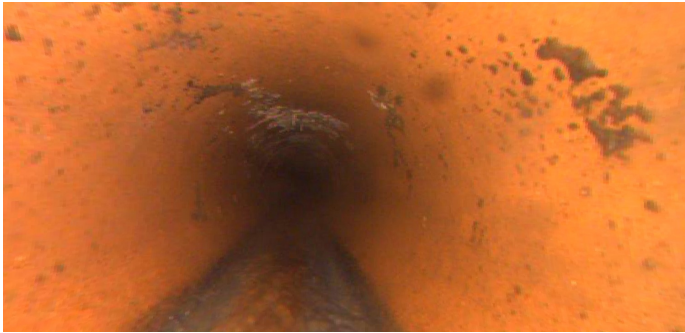
Code:	MWL
Description:	Water Level

Distance (ft):	.0
Structural Grade:	0
O&M Grade:	0
Clock Start/From:	
Clock To:	
1st Value:	
2nd Value:	
Value Percent:	5.000
Continuous Index:	
Within 8" of Joint:	NO
Remarks:

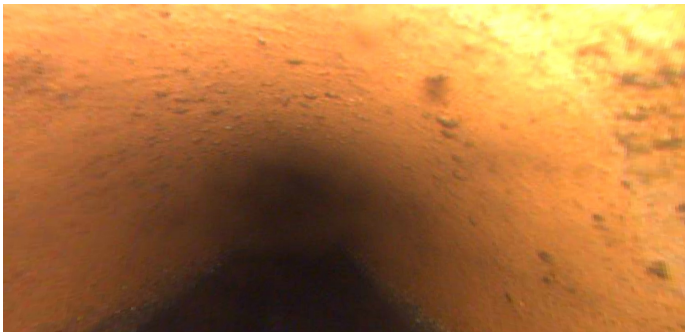
Code:	MSA
Description:	Abandoned Survey

Distance (ft):	38.6
Structural Grade:	0
O&M Grade:	0
Clock Start/From:	
Clock To:	
1st Value:	
2nd Value:	
Value Percent:	
Continuous Index:	
Within 8" of Joint:	NO
Remarks:	debris under water
