## Profile/Photo Observation Report

Street:	<b>OFF PRIVATE DR</b>	Flow Control:	<b>Not Controlled</b>
City:	<b>Hobart, IN</b>	Year Renewed:	
Location:	<b>Other</b>	Tape/Media #:	
Purpose:	<b>Not Known</b>	Dia/Height:	<b>8"</b>
Use:	<b>Sanitary</b>	Material:	<b>VCP</b>
Drain Area:	<b>NA</b>	Lining:	
Category:	<b>NA</b>		
Comment:

Location Details:		Direction of Survey:	<b>Upstream</b>
US MH:	<b>M-704-058</b>	DS MH:	<b>M-704-070</b>
		Total Length Surveyed (ft):	<b>97.5</b>

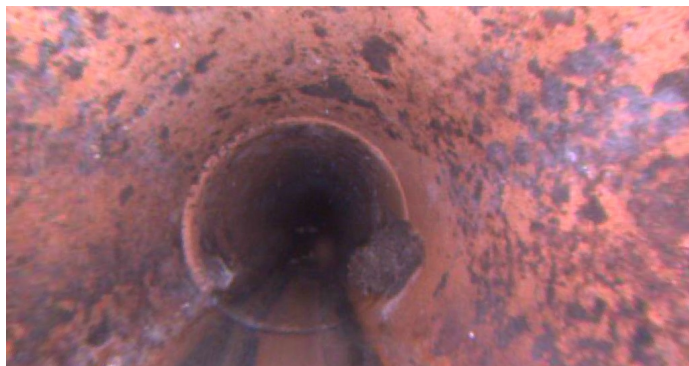
Code: **AMH**  
 Description: **Manhole**

Distance (ft): **.0**  
 Structural Grade: **0**  
 O&M Grade: **0**  
 Clock Start/From:  
 Clock To:  
 1st Value:  
 2nd Value:  
 Value Percent:  
 Continuous Index:  
 Within 8" of Joint: **NO**  
 Remarks: **M-704-070**

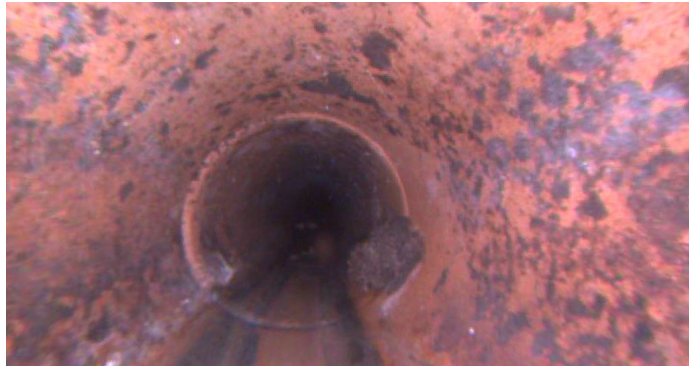
Code: **MWL**  
Description: **Water Level**

Distance (ft): **.0**  
Structural Grade: **0**  
O&M Grade: **0**  
Clock Start/From:  
Clock To:  
1st Value:  
2nd Value:  
Value Percent: **10.000**  
Continuous Index:  
Within 8" of Joint: **NO**  
Remarks:

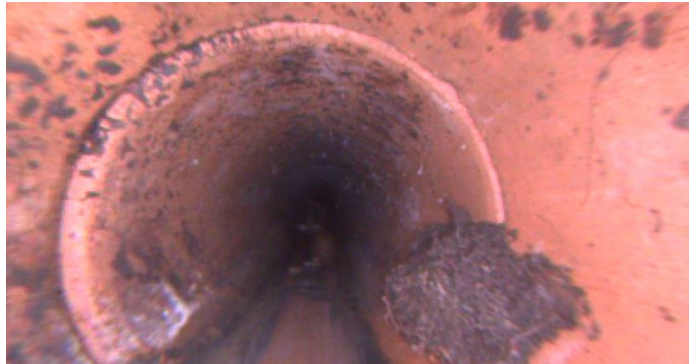
Code: **RFJ**  
Description: **Roots Fine Joint**

Distance (ft): **.9**  
Structural Grade: **0**  
O&M Grade: **1**  
Clock Start/From: **5**  
Clock To:  
1st Value:  
2nd Value:  
Value Percent:  
Continuous Index:  
Within 8" of Joint: **YES**  
Remarks:

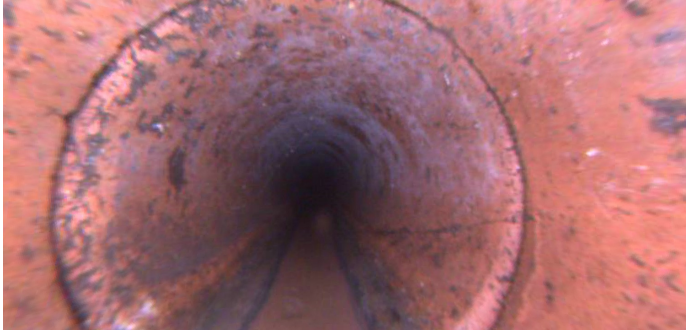
Code: **RFJ**  
Description: **Roots Fine Joint**

Distance (ft): **6.2**  
Structural Grade: **0**  
O&M Grade: **1**  
Clock Start/From: **3**  
Clock To:  
1st Value:  
2nd Value:  
Value Percent:  
Continuous Index:  
Within 8" of Joint: **YES**  
Remarks:

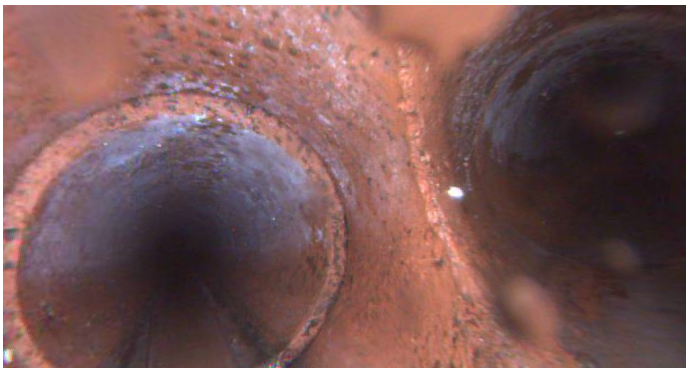
Code: **TF**  
Description: **Tap Factory**

Distance (ft): **37.2**  
Structural Grade: **0**  
O&M Grade: **0**  
Clock Start/From: **9**  
Clock To:  
1st Value: **4.000**  
2nd Value:  
Value Percent:  
Continuous Index:  
Within 8" of Joint:  
Remarks:

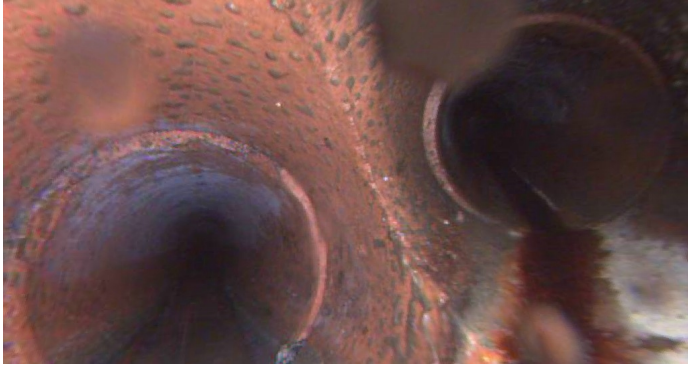
Code: **TF**  
Description: **Tap Factory**

Distance (ft): **49.3**  
Structural Grade: **0**  
O&M Grade: **0**  
Clock Start/From: **10**  
Clock To:  
1st Value: **4.000**  
2nd Value:  
Value Percent:  
Continuous Index:  
Within 8" of Joint:  
Remarks:

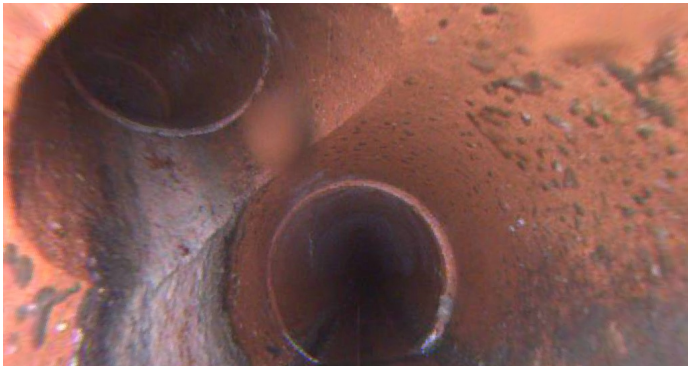
Code: **TF**  
Description: **Tap Factory**

Distance (ft): **91.4**  
Structural Grade: **0**  
O&M Grade: **0**  
Clock Start/From: **2**  
Clock To:  
1st Value: **4.000**  
2nd Value:  
Value Percent:  
Continuous Index:  
Within 8" of Joint:  
Remarks:

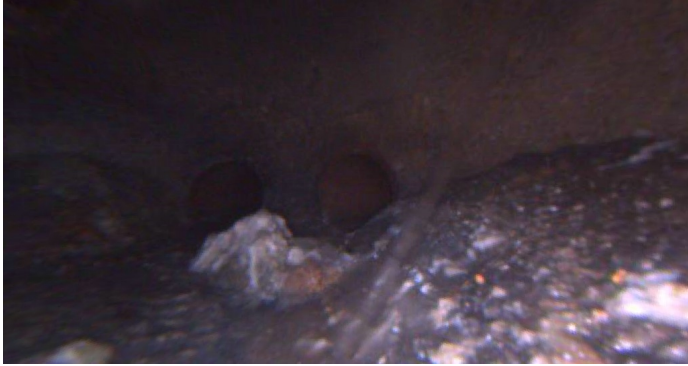
Code:	AMH
Description:	Manhole
Distance (ft):	97.5
Structural Grade:	0
O&M Grade:	0
Clock Start/From:	
Clock To:	
1st Value:	
2nd Value:	
Value Percent:	
Continuous Index:	
Within 8" of Joint:	NO
Remarks:	M-704-058
