## Profile/Photo Observation Report

Street:	<b>Ruta Dr.</b>	Flow Control:	<b>Not Controlled</b>
City:	<b>Hobart, IN</b>	Year Renewed:	
Location:	<b>Other</b>	Tape/Media #:	
Purpose:	<b>Not Known</b>	Dia/Height:	<b>8"</b>
Use:	<b>Sanitary</b>	Material:	<b>VCP</b>
Drain Area:	<b>NA</b>	Lining:	
Category:	<b>NA</b>		
Comment:

Location Details:		Direction of Survey:	<b>Upstream</b>
US MH:	<b>M-704-058</b>	DS MH:	<b>M-704-070</b>
		Total Length Surveyed (ft):	<b>97.5</b>

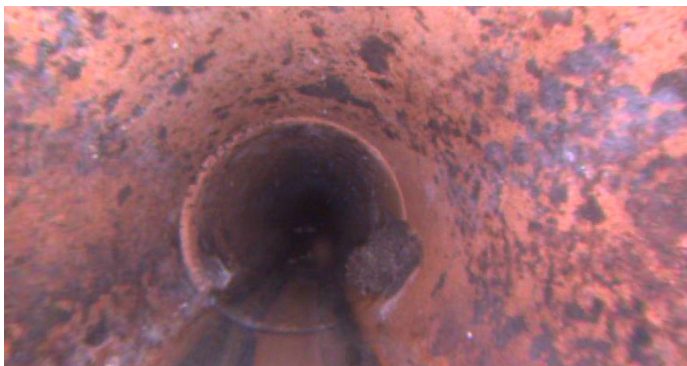
Code: **AMH**  
 Description: **Manhole**

Distance (ft): **.0**  
 Structural Grade: **0**  
 O&M Grade: **0**  
 Clock Start/From:  
 Clock To:  
 1st Value:  
 2nd Value:  
 Value Percent:  
 Continuous Index:  
 Within 8" of Joint: **NO**  
 Remarks: **M-704-070**

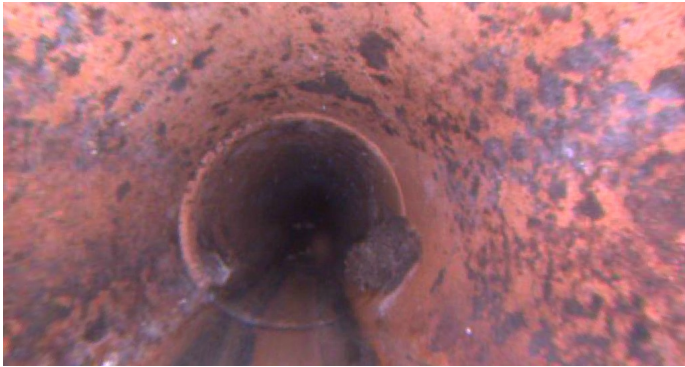
Code: **MWL**  
Description: **Water Level**

Distance (ft): **.0**  
Structural Grade: **0**  
O&M Grade: **0**  
Clock Start/From:  
Clock To:  
1st Value:  
2nd Value:  
Value Percent: **10.000**  
Continuous Index:  
Within 8" of Joint: **NO**  
Remarks:

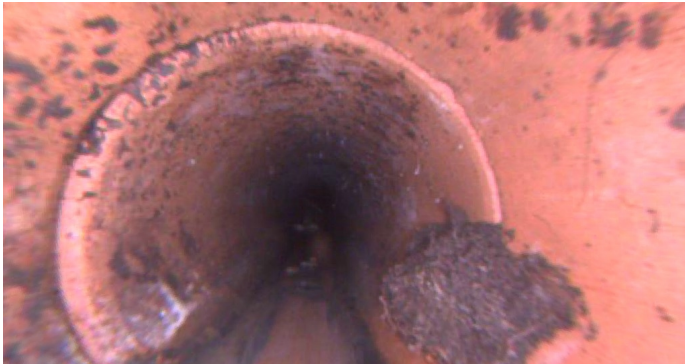
Code: **RFJ**  
Description: **Roots Fine Joint**

Distance (ft): **.9**  
Structural Grade: **0**  
O&M Grade: **1**  
Clock Start/From: **5**  
Clock To:  
1st Value:  
2nd Value:  
Value Percent:  
Continuous Index:  
Within 8" of Joint: **YES**  
Remarks:

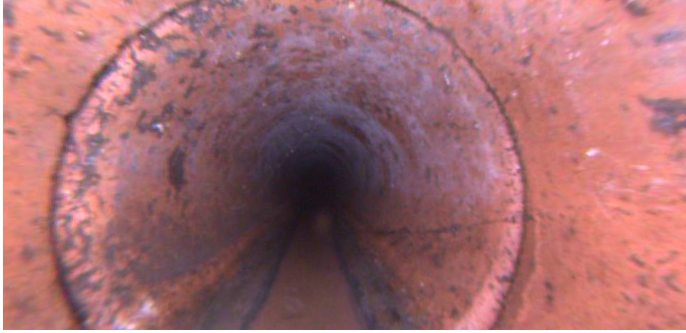
Code: **RFJ**  
Description: **Roots Fine Joint**

Distance (ft): **6.2**  
Structural Grade: **0**  
O&M Grade: **1**  
Clock Start/From: **3**  
Clock To:  
1st Value:  
2nd Value:  
Value Percent:  
Continuous Index:  
Within 8" of Joint: **YES**  
Remarks:

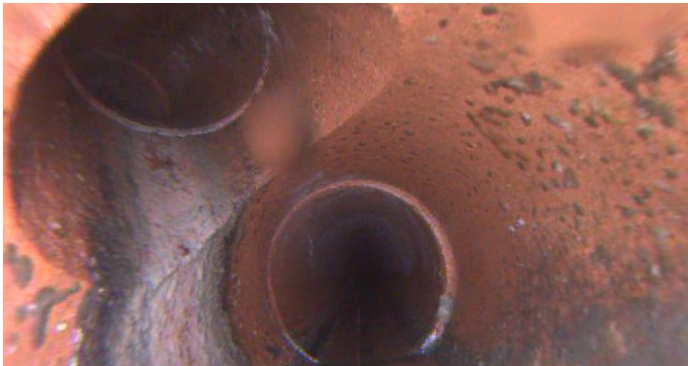
Code: **TF**  
Description: **Tap Factory**

Distance (ft): **91.4**  
Structural Grade: **0**  
O&M Grade: **0**  
Clock Start/From: **2**  
Clock To:  
1st Value: **4.000**  
2nd Value:  
Value Percent:  
Continuous Index:  
Within 8" of Joint:  
Remarks:

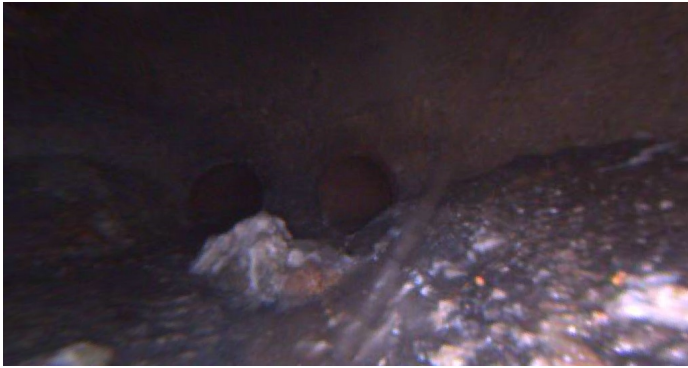
Code:	AMH
Description:	Manhole
Distance (ft):	97.5
Structural Grade:	0
O&M Grade:	0
Clock Start/From:	
Clock To:	
1st Value:	
2nd Value:	
Value Percent:	
Continuous Index:	
Within 8" of Joint:	NO
Remarks:	M-704-058
