## Profile/Photo Observation Report

Street:	<b>NERINGA LN</b>	Flow Control:	<b>Not Controlled</b>
City:	<b>Hobart, IN</b>	Year Renewed:	
Location:	<b>Other</b>	Tape/Media #:	
Purpose:	<b>Not Known</b>	Dia/Height:	<b>8"</b>
Use:	<b>Sanitary</b>	Material:	<b>VCP</b>
Drain Area:	<b>NA</b>	Lining:	
Category:	<b>NA</b>		
Comment:

Location Details:		Direction of Survey:	<b>Downstream</b>
US MH:	<b>M-704-064</b>	DS MH:	<b>M-703-040</b>
		Total Length Surveyed (ft):	<b>282.2</b>

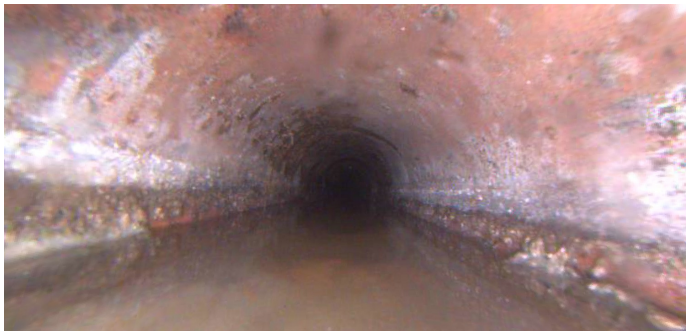
Code: **DAGS**  
Description: **Deposits Attached Grease**

Distance (ft): **.0**  
Structural Grade: **0**  
O&M Grade: **2**  
Clock Start/From: **8**  
Clock To: **4**  
1st Value:  
2nd Value:  
Value Percent: **5.000**  
Continuous Index: **S01**  
Within 8" of Joint: **NO**  
Remarks:

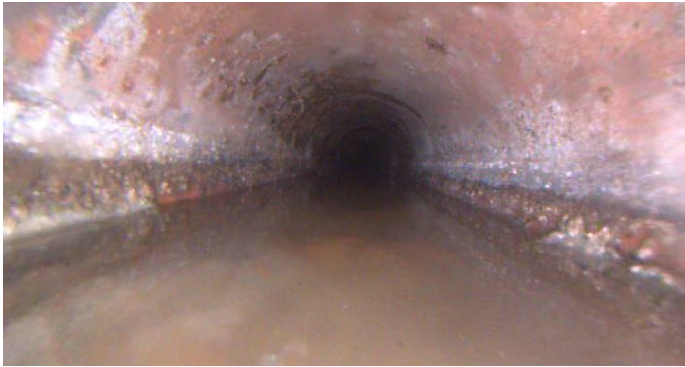
Code:	<b>AMH</b>
Description:	<b>Manhole</b>

Distance (ft):	<b>.0</b>
Structural Grade:	<b>0</b>
O&M Grade:	<b>0</b>
Clock Start/From:	
Clock To:	
1st Value:	
2nd Value:	
Value Percent:	
Continuous Index:	
Within 8" of Joint:	<b>NO</b>
Remarks:	<b>M-704-064</b>

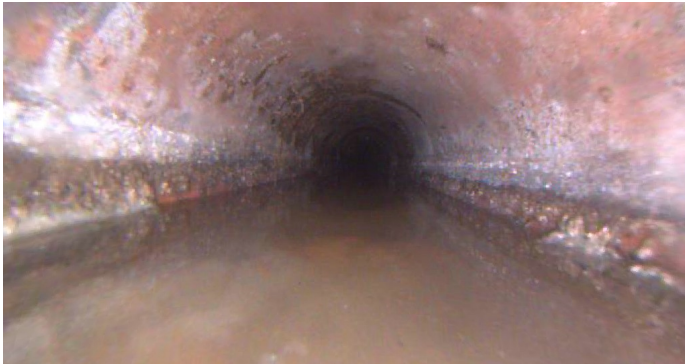
Code:	<b>MWL</b>
Description:	<b>Water Level</b>

Distance (ft):	<b>.0</b>
Structural Grade:	<b>0</b>
O&M Grade:	<b>0</b>
Clock Start/From:	
Clock To:	
1st Value:	
2nd Value:	
Value Percent:	<b>10.000</b>
Continuous Index:	
Within 8" of Joint:	<b>NO</b>
Remarks:

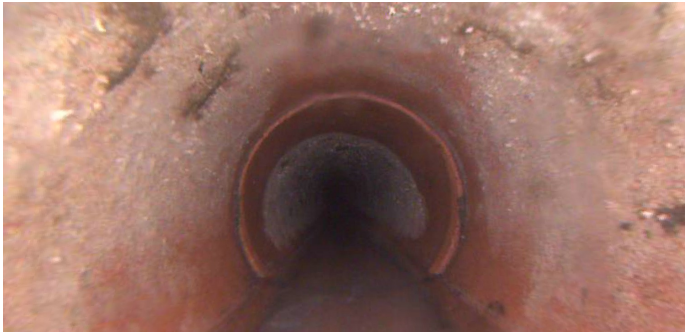
Code: **DAGS**  
Description: **Deposits Attached Grease**

Distance (ft): **8.7**  
Structural Grade: **0**  
O&M Grade: **2**  
Clock Start/From: **8**  
Clock To: **4**  
1st Value:  
2nd Value:  
Value Percent: **5.000**  
Continuous Index: **F01**  
Within 8" of Joint: **NO**  
Remarks:

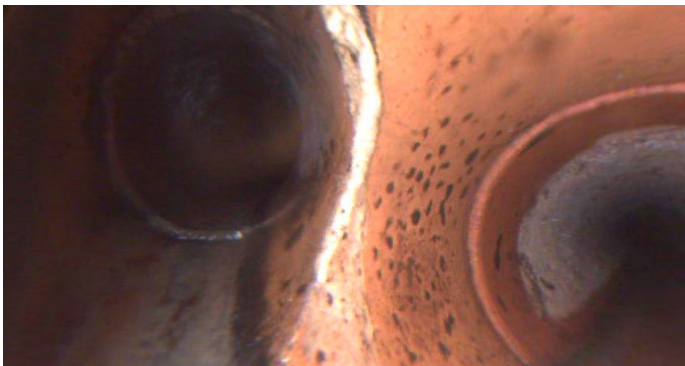
Code: **TF**  
Description: **Tap Factory**

Distance (ft): **35.7**  
Structural Grade: **0**  
O&M Grade: **0**  
Clock Start/From: **10**  
Clock To:  
1st Value: **4.000**  
2nd Value:  
Value Percent:  
Continuous Index:  
Within 8" of Joint:  
Remarks:

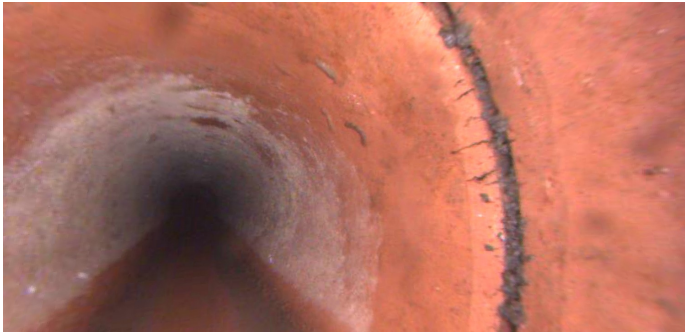
Code: **RFJ**  
Description: **Roots Fine Joint**

Distance (ft): **61.4**  
Structural Grade: **0**  
O&M Grade: **1**  
Clock Start/From: **2**  
Clock To: **3**  
1st Value:  
2nd Value:  
Value Percent:  
Continuous Index:  
Within 8" of Joint: **YES**  
Remarks:

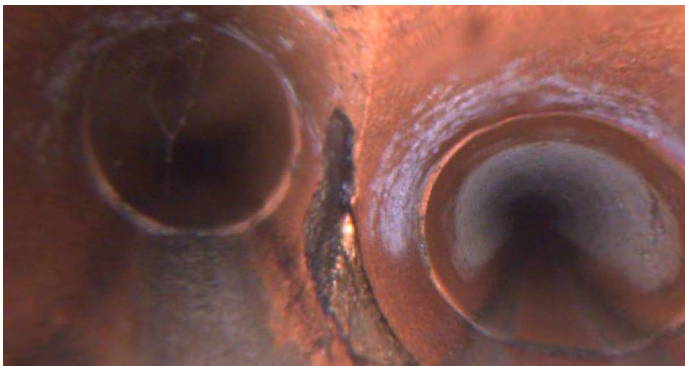
Code: **TF**  
Description: **Tap Factory**

Distance (ft): **82.6**  
Structural Grade: **0**  
O&M Grade: **0**  
Clock Start/From: **10**  
Clock To:  
1st Value: **4.000**  
2nd Value:  
Value Percent:  
Continuous Index:  
Within 8" of Joint:  
Remarks:

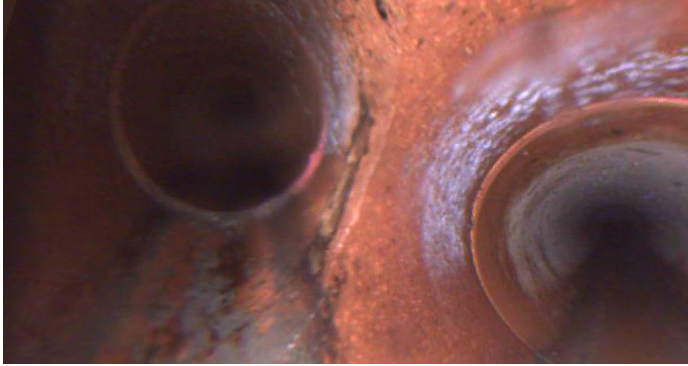
Code: **TF**  
Description: **Tap Factory**

Distance (ft): **94.7**  
Structural Grade: **0**  
O&M Grade: **0**  
Clock Start/From: **10**  
Clock To:  
1st Value: **4.000**  
2nd Value:  
Value Percent:  
Continuous Index:  
Within 8" of Joint:  
Remarks:

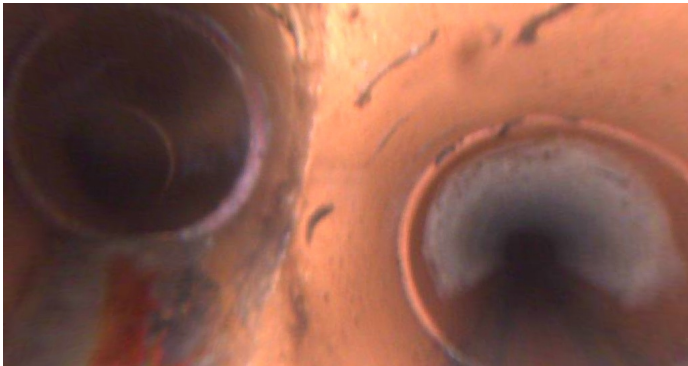
Code: **TF**  
Description: **Tap Factory**

Distance (ft): **131.2**  
Structural Grade: **0**  
O&M Grade: **0**  
Clock Start/From: **9**  
Clock To:  
1st Value: **4.000**  
2nd Value:  
Value Percent:  
Continuous Index:  
Within 8" of Joint:  
Remarks:

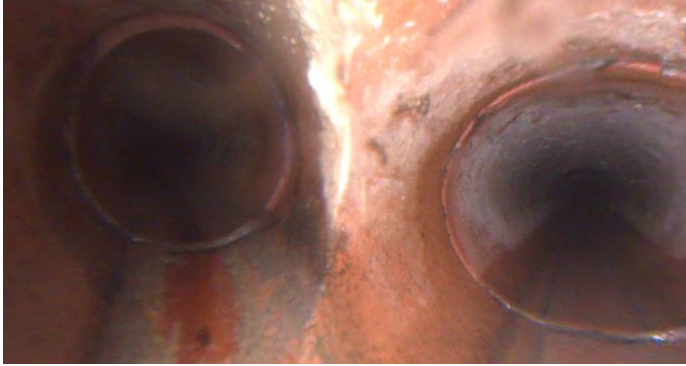
Code: **TF**  
Description: **Tap Factory**

Distance (ft): **138.2**  
Structural Grade: **0**  
O&M Grade: **0**  
Clock Start/From: **9**  
Clock To:  
1st Value: **4.000**  
2nd Value:  
Value Percent:  
Continuous Index:  
Within 8" of Joint:  
Remarks:

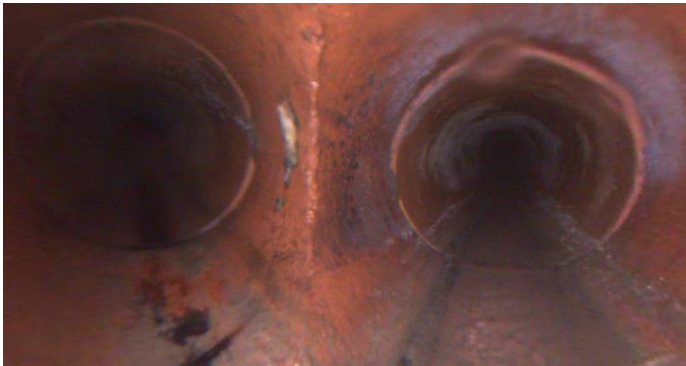
Code: **TF**  
Description: **Tap Factory**

Distance (ft): **175.0**  
Structural Grade: **0**  
O&M Grade: **0**  
Clock Start/From: **9**  
Clock To:  
1st Value: **4.000**  
2nd Value:  
Value Percent:  
Continuous Index:  
Within 8" of Joint:  
Remarks:

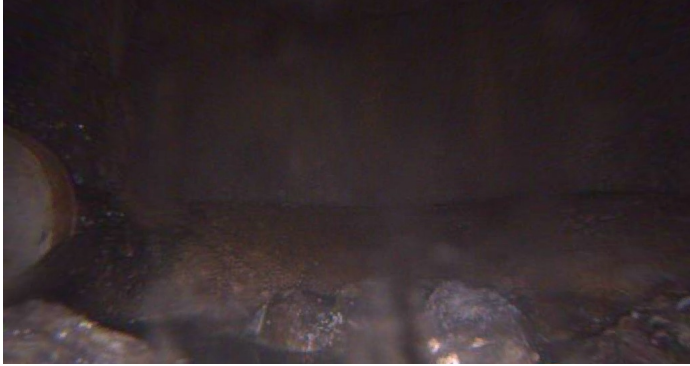
Code:	AMH
Description:	Manhole
Distance (ft):	282.2
Structural Grade:	0
O&M Grade:	0
Clock Start/From:	
Clock To:	
1st Value:	
2nd Value:	
Value Percent:	
Continuous Index:	
Within 8" of Joint:	NO
Remarks:	M-703-040
