Profile/Photo Observation Report

Street:	EDGEWATER DR	Flow Control:	Not Controlled
City:	Hobart, IN	Year Renewed:	
Location:	Other	Tape/Media #:	
Purpose:	Not Known	Dia/Height:	8"
Use:	Sanitary	Material:	PVC
Drain Area:	NA	Lining:	
Category:	NA		
Comment:

Location Details:		Direction of Survey:	Downstream
US MH:	M-704-065	DS MH:	M-704-074
		Total Length Surveyed (ft):	171.8

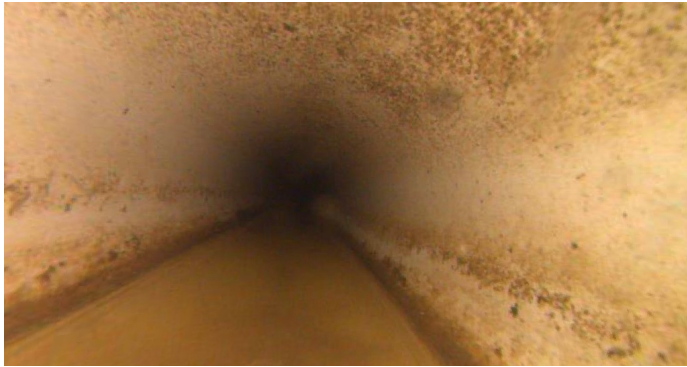
Code:	MWL
Description:	Water Level
Distance (ft):	.0
Structural Grade:	0
O&M Grade:	0
Clock Start/From:	
Clock To:	
1st Value:	
2nd Value:	
Value Percent:	10.000
Continuous Index:	
Within 8" of Joint:	NO
Remarks:

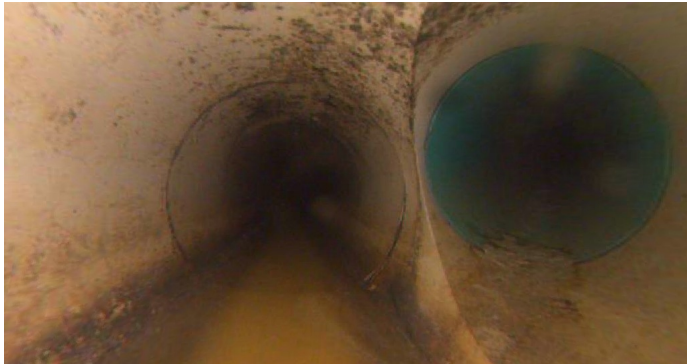
Code:	TF
Description:	Tap Factory
Distance (ft):	46.6
Structural Grade:	0
O&M Grade:	0
Clock Start/From:	4
Clock To:	
1st Value:	4.000
2nd Value:	
Value Percent:	
Continuous Index:	
Within 8" of Joint:	
Remarks:

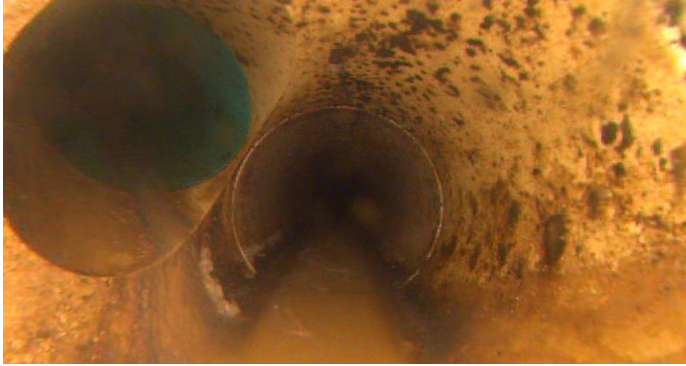
Code: **TF**
Description: **Tap Factory**

Distance (ft): **52.2**
Structural Grade: **0**
O&M Grade: **0**
Clock Start/From: **10**
Clock To:
1st Value: **4.000**
2nd Value:
Value Percent:
Continuous Index:
Within 8" of Joint:
Remarks:

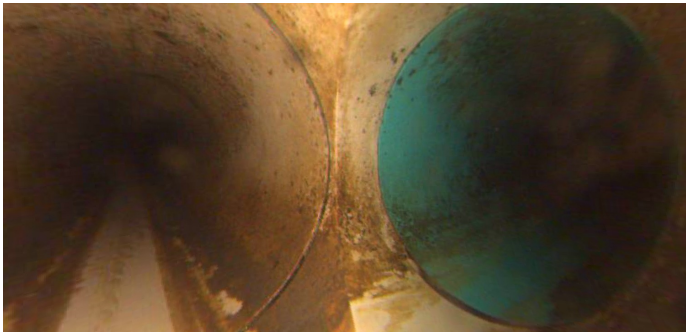
Code: **TF**
Description: **Tap Factory**

Distance (ft): **123.0**
Structural Grade: **0**
O&M Grade: **0**
Clock Start/From: **3**
Clock To:
1st Value: **4.000**
2nd Value:
Value Percent:
Continuous Index:
Within 8" of Joint:
Remarks:

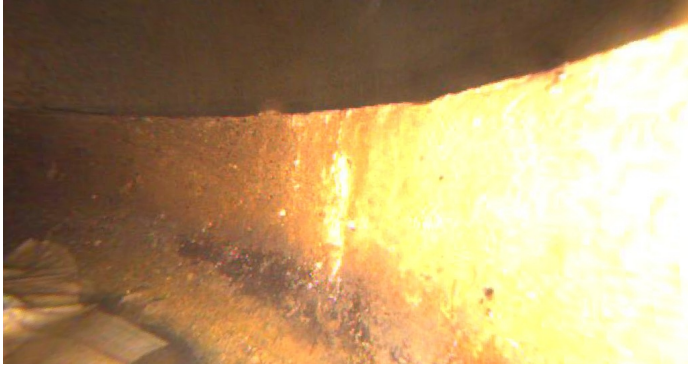
Code:	AMH
Description:	Manhole
Distance (ft):	171.8
Structural Grade:	0
O&M Grade:	0
Clock Start/From:	
Clock To:	
1st Value:	
2nd Value:	
Value Percent:	
Continuous Index:	
Within 8" of Joint:	NO
Remarks:	M-704-074
