Profile/Photo Observation Report

Date:	04/10/2018	Weather:		Coding:	PACP 6.0
Pipe Length (ft):	178.8	Owner:	NA	Pre Clean:	Not Known
P.O.#:		Surveyor:	Mark Ruby	PSR:	P-704-074-065
Customer:		Clean Date:	01/01/1900	Shape:	C

Street:	Edgewater Dr.	Flow Control:	Not Controlled
City:	Hobart, IN	Year Renewed:	
Location:	Other	Tape/Media #:	
Purpose:	Not Known	Dia/Height:	8"
Use:	Sanitary	Material:	PVC
Drain Area:	NA	Lining:	
Category:	NA		
Comment:

Location Details:		Direction of Survey:	Downstream
US MH:	M-704-065	DS MH:	M-704-074
		Total Length Surveyed (ft):	171.8

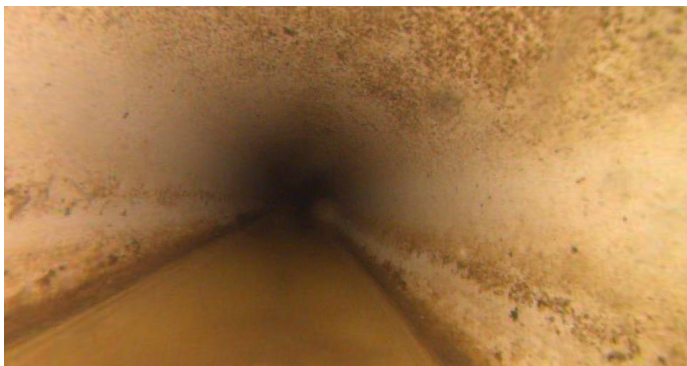
Code: **AMH**
Description: **Manhole**

Distance (ft): **.0**
Structural Grade: **0**
O&M Grade: **0**
Clock Start/From:
Clock To:
1st Value:
2nd Value:
Value Percent:
Continuous Index:
Within 8" of Joint: **NO**
Remarks: **M-704-065**

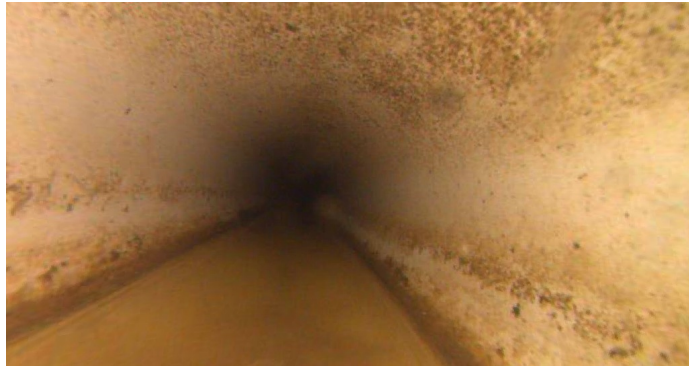
Code:	MWL
Description:	Water Level
Distance (ft):	.0
Structural Grade:	0
O&M Grade:	0
Clock Start/From:	
Clock To:	
1st Value:	
2nd Value:	
Value Percent:	10.000
Continuous Index:	
Within 8" of Joint:	NO
Remarks:

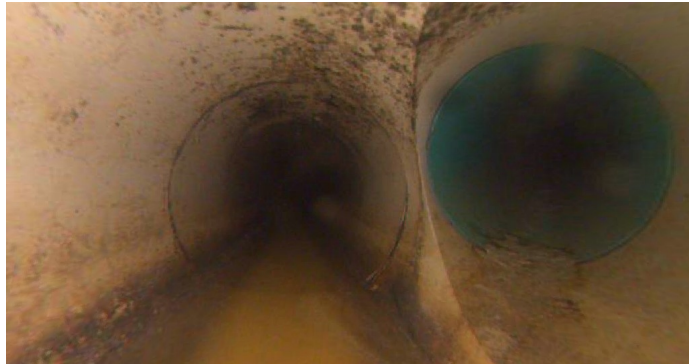
Code:	TF
Description:	Tap Factory
Distance (ft):	46.6
Structural Grade:	0
O&M Grade:	0
Clock Start/From:	4
Clock To:	
1st Value:	4.000
2nd Value:	
Value Percent:	
Continuous Index:	
Within 8" of Joint:	
Remarks:

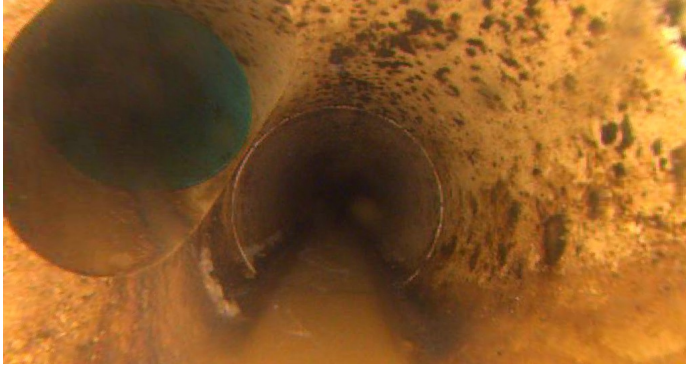
Code: **TF**
Description: **Tap Factory**

Distance (ft): **52.2**
Structural Grade: **0**
O&M Grade: **0**
Clock Start/From: **10**
Clock To:
1st Value: **4.000**
2nd Value:
Value Percent:
Continuous Index:
Within 8" of Joint:
Remarks:

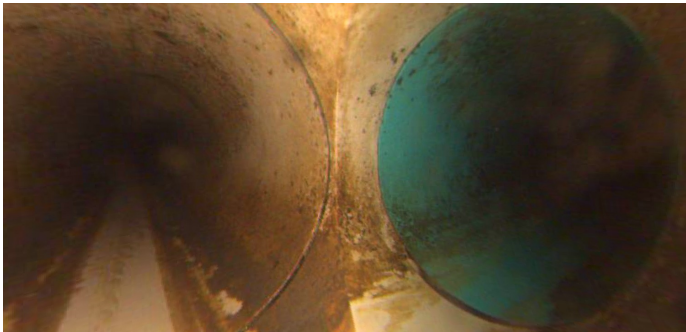
Code: **TF**
Description: **Tap Factory**

Distance (ft): **123.0**
Structural Grade: **0**
O&M Grade: **0**
Clock Start/From: **3**
Clock To:
1st Value: **4.000**
2nd Value:
Value Percent:
Continuous Index:
Within 8" of Joint:
Remarks:

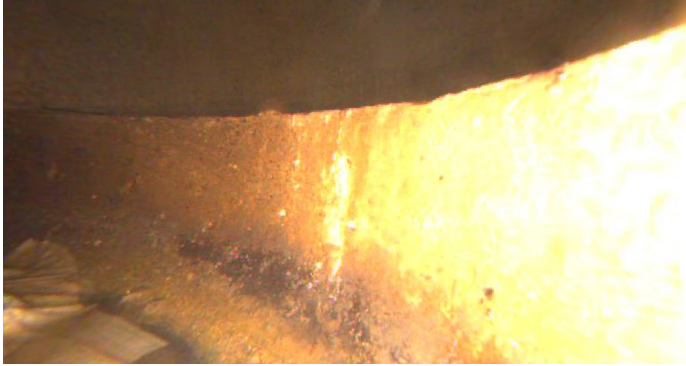
Code:	AMH
Description:	Manhole
Distance (ft):	171.8
Structural Grade:	0
O&M Grade:	0
Clock Start/From:	
Clock To:	
1st Value:	
2nd Value:	
Value Percent:	
Continuous Index:	
Within 8" of Joint:	NO
Remarks:	M-704-074
