Profile/Photo Observation Report

Date:	04/10/2018	Weather:		Coding:	PACP 6.0
Pipe Length (ft):	120.7	Owner:	NA	Pre Clean:	Not Known
P.O.#:		Surveyor:	Mark Ruby	PSR:	P-704-065-066
Customer:		Clean Date:	01/01/1900	Shape:	C

Street:	Edgewater Dr.	Flow Control:	Not Controlled
City:	Hobart, IN	Year Renewed:	
Location:	Other	Tape/Media #:	
Purpose:	Not Known	Dia/Height:	8"
Use:	Sanitary	Material:	PVC
Drain Area:	NA	Lining:	
Category:	NA		
Comment:

Location Details:		Direction of Survey:	Upstream
US MH:	M-704-066	DS MH:	M-704-065
		Total Length Surveyed (ft):	118.4

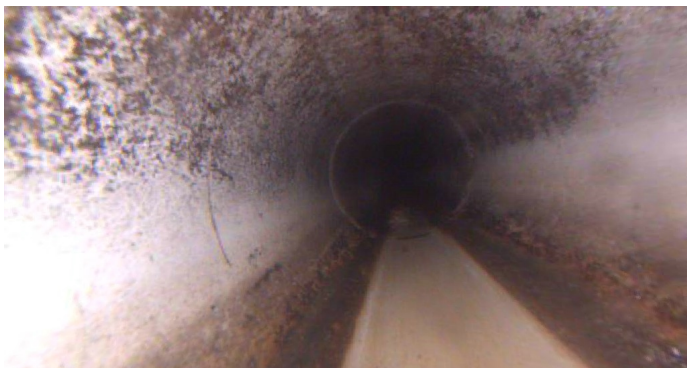
Code: **AMH**
Description: **Manhole**

Distance (ft): **.0**
Structural Grade: **0**
O&M Grade: **0**
Clock Start/From:
Clock To:
1st Value:
2nd Value:
Value Percent:
Continuous Index:
Within 8" of Joint: **NO**
Remarks: **M-704-065**

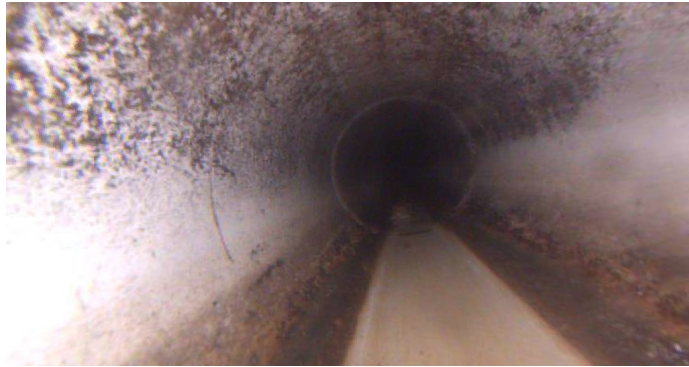
Code: **MWL**
Description: **Water Level**

Distance (ft): **.0**
Structural Grade: **0**
O&M Grade: **0**
Clock Start/From:
Clock To:
1st Value:
2nd Value:
Value Percent: **10.000**
Continuous Index:
Within 8" of Joint: **NO**
Remarks:

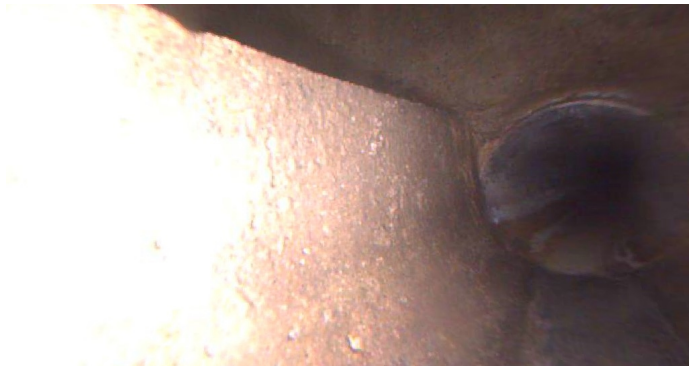
Code: **AMH**
Description: **Manhole**

Distance (ft): **118.4**
Structural Grade: **0**
O&M Grade: **0**
Clock Start/From:
Clock To:
1st Value:
2nd Value:
Value Percent:
Continuous Index:
Within 8" of Joint: **NO**
Remarks: **M-704-066**
