Profile/Photo Observation Report

Street:	Edgewater Dr.	Flow Control:	Not Controlled
City:	Hobart, IN	Year Renewed:	
Location:	Other	Tape/Media #:	
Purpose:	Not Known	Dia/Height:	8"
Use:	Sanitary	Material:	PVC
Drain Area:	NA	Lining:	
Category:	NA		
Comment:

Location Details:		Direction of Survey:	Downstream
US MH:	M-704-067	DS MH:	M-704-063
		Total Length Surveyed (ft):	140.4

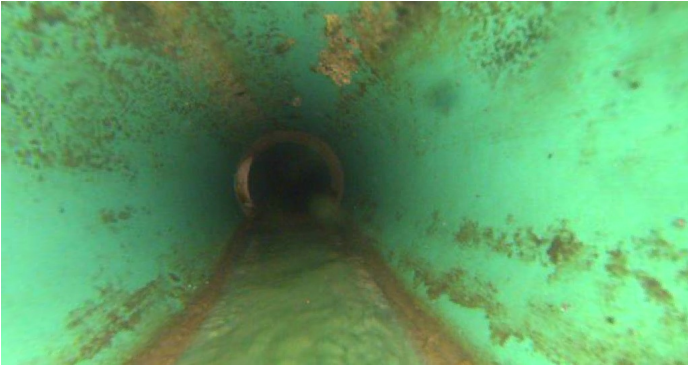
Code: **AMH**
Description: **Manhole**

Distance (ft): **.0**
Structural Grade: **0**
O&M Grade: **0**
Clock Start/From:
Clock To:
1st Value:
2nd Value:
Value Percent:
Continuous Index:
Within 8" of Joint: **NO**
Remarks: **M-704-067**

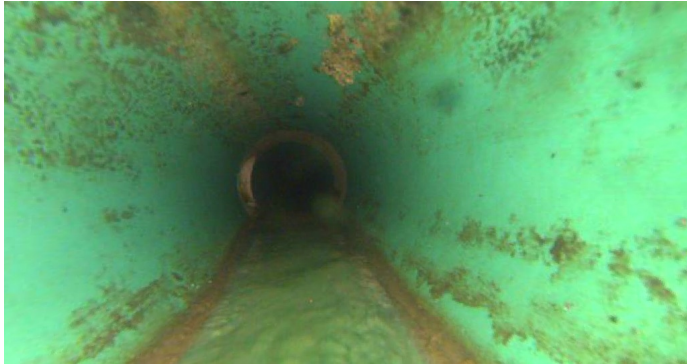
Code: **MWL**
Description: **Water Level**

Distance (ft): **.0**
Structural Grade: **0**
O&M Grade: **0**
Clock Start/From:
Clock To:
1st Value:
2nd Value:
Value Percent: **10.000**
Continuous Index:
Within 8" of Joint: **NO**
Remarks:

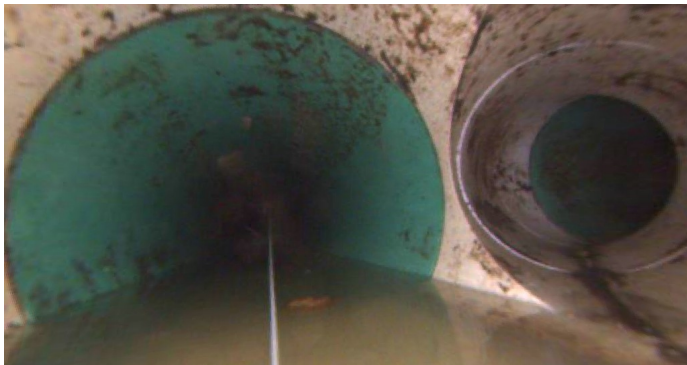
Code: **TF**
Description: **Tap Factory**

Distance (ft): **4.1**
Structural Grade: **0**
O&M Grade: **0**
Clock Start/From: **8**
Clock To:
1st Value: **4.000**
2nd Value:
Value Percent:
Continuous Index:
Within 8" of Joint: **NO**
Remarks:

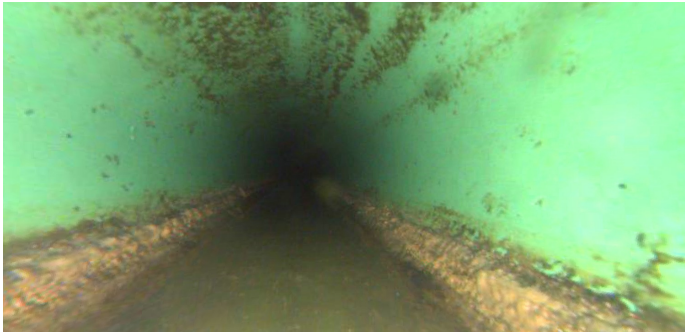
Code: **DAGS**
Description: **Deposits Attached Grease**

Distance (ft): **41.4**
Structural Grade: **0**
O&M Grade: **2**
Clock Start/From: **8**
Clock To: **4**
1st Value:
2nd Value:
Value Percent: **5.000**
Continuous Index: **S01**
Within 8" of Joint: **NO**
Remarks:

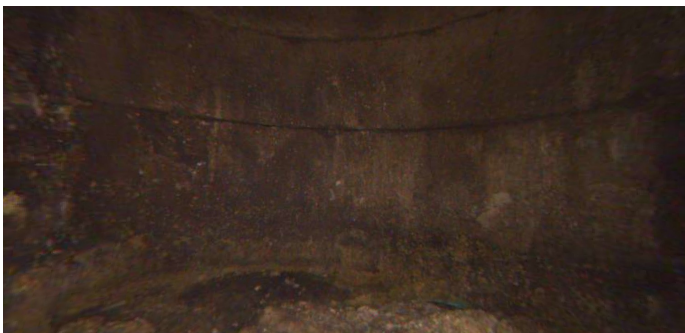
Code: **DAGS**
Description: **Deposits Attached Grease**

Distance (ft): **140.4**
Structural Grade: **0**
O&M Grade: **2**
Clock Start/From: **8**
Clock To: **4**
1st Value:
2nd Value:
Value Percent: **5.000**
Continuous Index: **F01**
Within 8" of Joint: **NO**
Remarks:

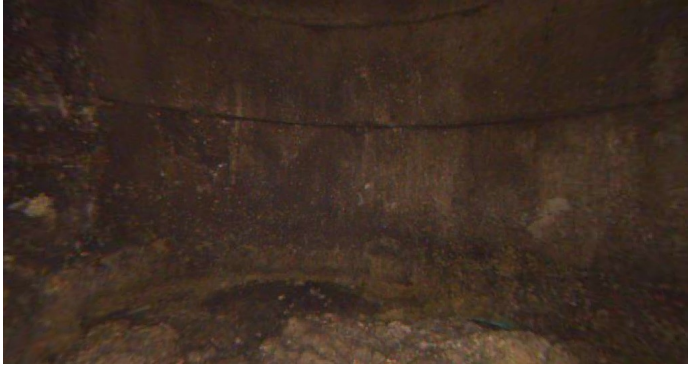
Code:	AMH
Description:	Manhole
Distance (ft):	140.4
Structural Grade:	0
O&M Grade:	0
Clock Start/From:	
Clock To:	
1st Value:	
2nd Value:	
Value Percent:	
Continuous Index:	
Within 8" of Joint:	NO
Remarks:	M-704-063
