Profile/Photo Observation Report

Street:	EDGEWATER DR	Flow Control:	Not Controlled
City:	Hobart, IN	Year Renewed:	
Location:	Other	Tape/Media #:	
Purpose:	Not Known	Dia/Height:	8"
Use:	Sanitary	Material:	PVC
Drain Area:	NA	Lining:	
Category:	NA		
Comment:

Location Details:		Direction of Survey:	Downstream
US MH:	M-704-067	DS MH:	M-704-066
		Total Length Surveyed (ft):	72.4

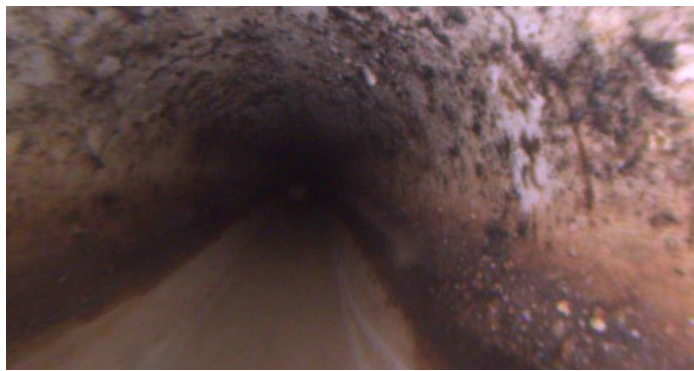
Code: **AMH**
Description: **Manhole**

Distance (ft): **.0**
Structural Grade: **0**
O&M Grade: **0**
Clock Start/From:
Clock To:
1st Value:
2nd Value:
Value Percent:
Continuous Index:
Within 8" of Joint: **NO**
Remarks: **M-704-067**

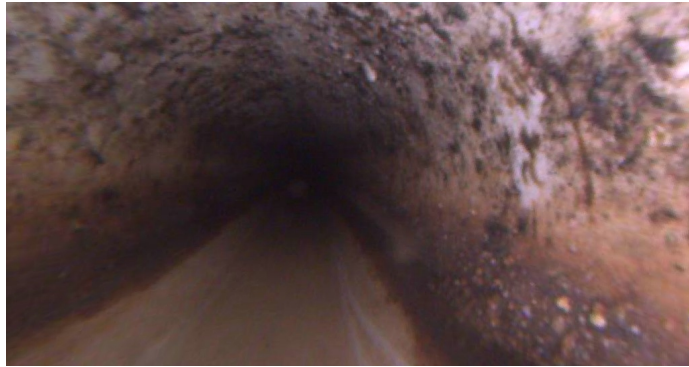
Code:	MWL
Description:	Water Level
Distance (ft):	.0
Structural Grade:	0
O&M Grade:	0
Clock Start/From:	
Clock To:	
1st Value:	
2nd Value:	
Value Percent:	10.000
Continuous Index:	
Within 8" of Joint:	NO
Remarks:

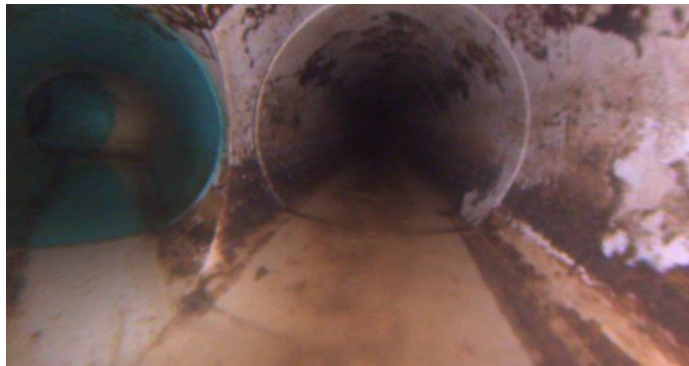
Code:	TF
Description:	Tap Factory
Distance (ft):	24.3
Structural Grade:	0
O&M Grade:	0
Clock Start/From:	8
Clock To:	
1st Value:	4.000
2nd Value:	
Value Percent:	
Continuous Index:	
Within 8" of Joint:	
Remarks:

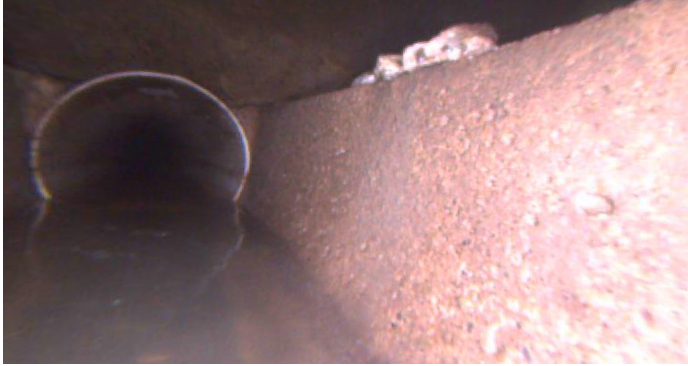
Code:	AMH
Description:	Manhole
Distance (ft):	72.4
Structural Grade:	0
O&M Grade:	0
Clock Start/From:	
Clock To:	
1st Value:	
2nd Value:	
Value Percent:	
Continuous Index:	
Within 8" of Joint:	NO
Remarks:	M-704-066
