Profile/Photo Observation Report

Street:	Edgewater Dr.	Flow Control:	Not Controlled
City:	Hobart, IN	Year Renewed:	
Location:	Other	Tape/Media #:	
Purpose:	Not Known	Dia/Height:	8"
Use:	Sanitary	Material:	PVC
Drain Area:	NA	Lining:	
Category:	NA		
Comment:

Location Details:		Direction of Survey:	Downstream
US MH:	M-704-067	DS MH:	M-704-066
		Total Length Surveyed (ft):	72.4

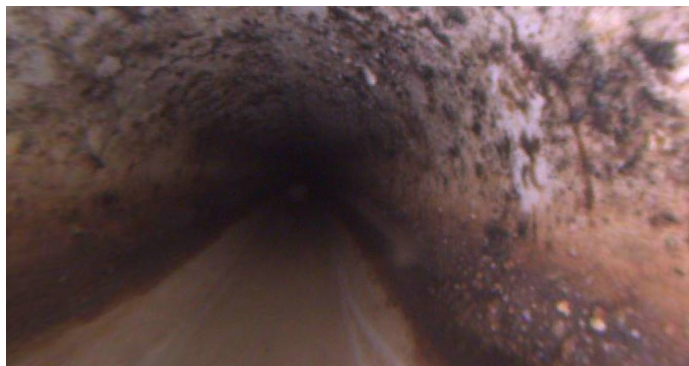
Code: **AMH**
Description: **Manhole**

Distance (ft): **.0**
Structural Grade: **0**
O&M Grade: **0**
Clock Start/From:
Clock To:
1st Value:
2nd Value:
Value Percent:
Continuous Index:
Within 8" of Joint: **NO**
Remarks: **M-704-067**

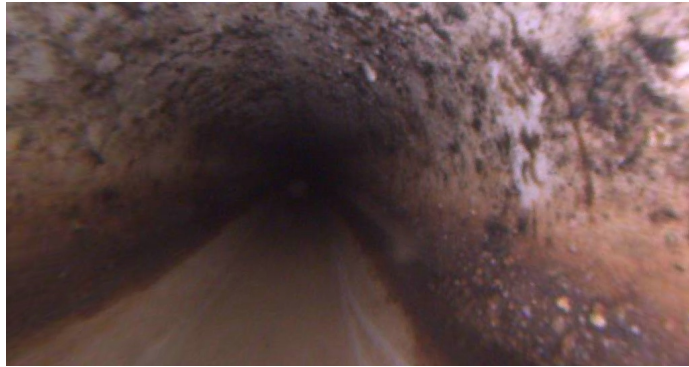
Code:	MWL
Description:	Water Level
Distance (ft):	.0
Structural Grade:	0
O&M Grade:	0
Clock Start/From:	
Clock To:	
1st Value:	
2nd Value:	
Value Percent:	10.000
Continuous Index:	
Within 8" of Joint:	NO
Remarks:

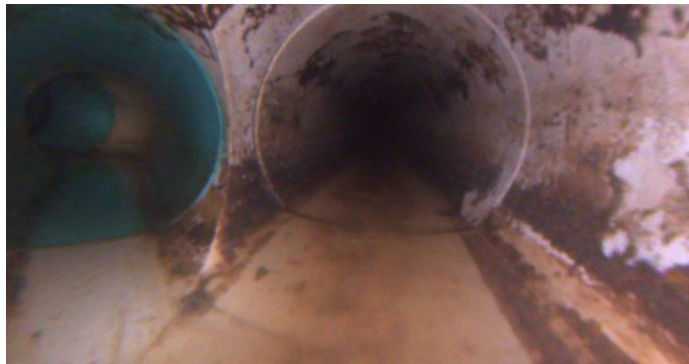
Code:	TF
Description:	Tap Factory
Distance (ft):	24.3
Structural Grade:	0
O&M Grade:	0
Clock Start/From:	8
Clock To:	
1st Value:	4.000
2nd Value:	
Value Percent:	
Continuous Index:	
Within 8" of Joint:	
Remarks:

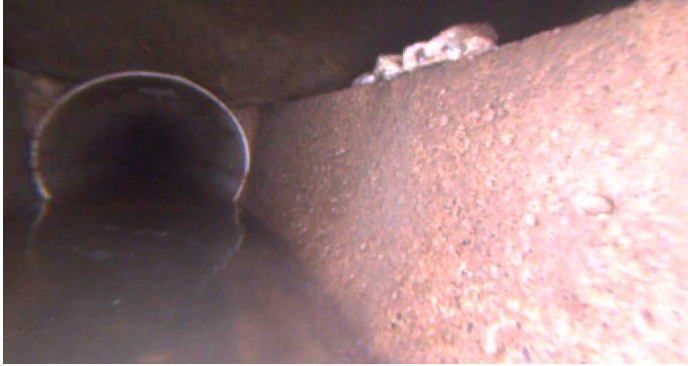
Code:	AMH
Description:	Manhole
Distance (ft):	72.4
Structural Grade:	0
O&M Grade:	0
Clock Start/From:	
Clock To:	
1st Value:	
2nd Value:	
Value Percent:	
Continuous Index:	
Within 8" of Joint:	NO
Remarks:	M-704-066
