Profile/Photo Observation Report

Date:	03/09/2024	Weather:		Coding:	PACP 7.0
Pipe Length (ft):	329.0	Owner:	City of Hobart	Pre Clean:	Light Cleaning
P.O.#:		Surveyor:	S. Bucklin	PSR:	P-704-072-068
Customer:	City of Hobart	Clean Date:	03/09/2024	Shape:	C

Street:	LAKEWOOD DR	Flow Control:	Not Controlled
City:	Hobart, IN	Year Renewed:	
Location:	Easement/Right of Way	Tape/Media #:	
Purpose:	Sewer System Evaluation Survey (SS	Dia/Height:	8"
Use:	Sanitary Sewage Pipe	Material:	PVC
Drain Area:		Lining:	None
Category:	NA		
Comment:			
Location Details:		Direction of Survey:	Downstream
US MH:	M-704-068	DS MH:	M-704-072
		Total Length Surveyed (ft):	193.4

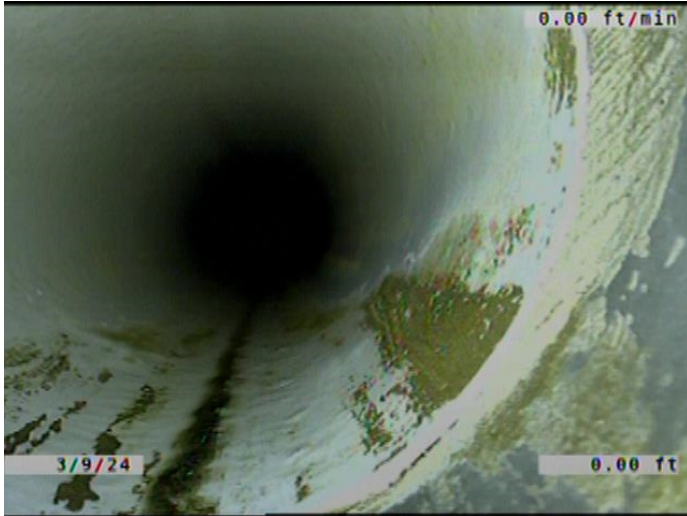
Code:	MWL
Description:	Miscellaneous Water Level
Distance (ft):	.0
Structural Grade:	0
O&M Grade:	0
Clock Start/From:	
Clock To:	
1st Value:	
2nd Value:	
Value Percent:	5.000
Continuous Index:	
Within 8" of Joint:	NO
Remarks:

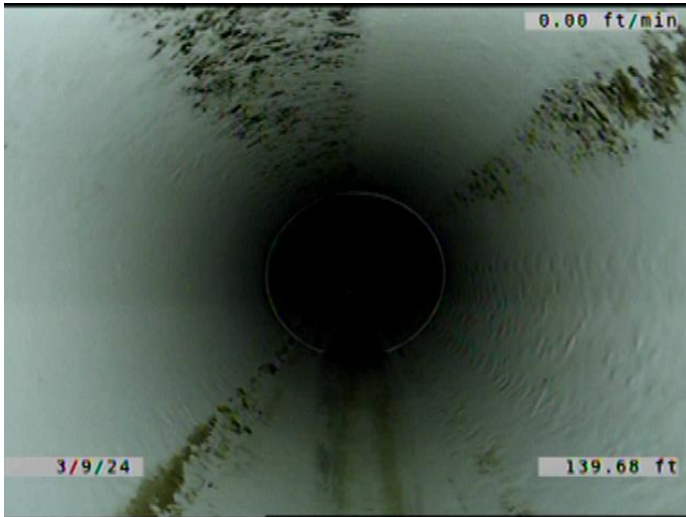
Code: **MWLS**
Description: **Miscellaneous Water Level Sag**

Distance (ft): **139.7**
Structural Grade: **2**
O&M Grade: **0**
Clock Start/From:
Clock To:
1st Value:
2nd Value:
Value Percent: **5.000**
Continuous Index: **S01**
Within 8" of Joint: **NO**
Remarks:

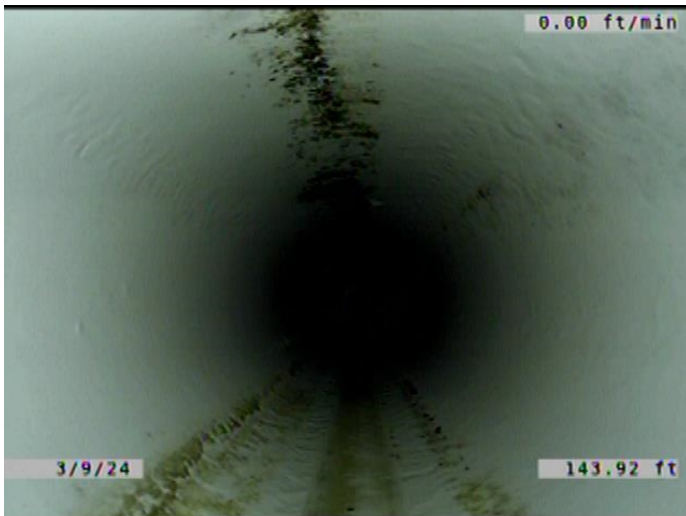
Code: **MWLS**
Description: **Miscellaneous Water Level Sag**

Distance (ft): **143.9**
Structural Grade: **2**
O&M Grade: **0**
Clock Start/From:
Clock To:
1st Value:
2nd Value:
Value Percent: **5.000**
Continuous Index: **F01**
Within 8" of Joint: **NO**
Remarks:

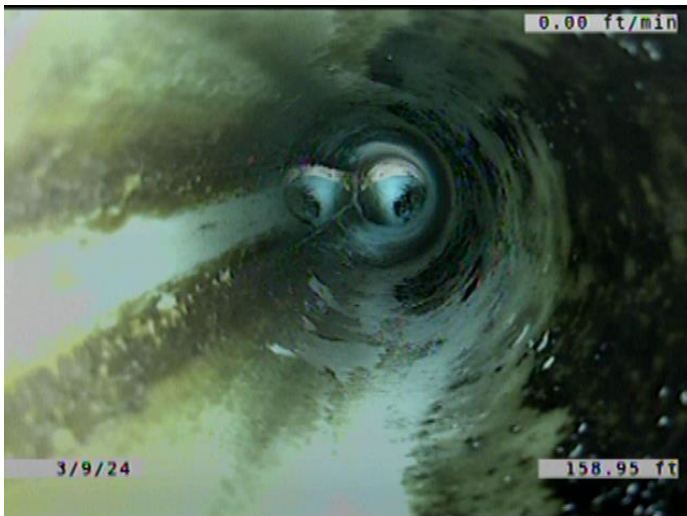
Code: **TF**
Description: **Tap Factory**

Distance (ft): **158.9**
Structural Grade: **0**
O&M Grade: **0**
Clock Start/From: **9**
Clock To:
1st Value: **6.000**
2nd Value:
Value Percent:
Continuous Index:
Within 8" of Joint: **YES**
Remarks:

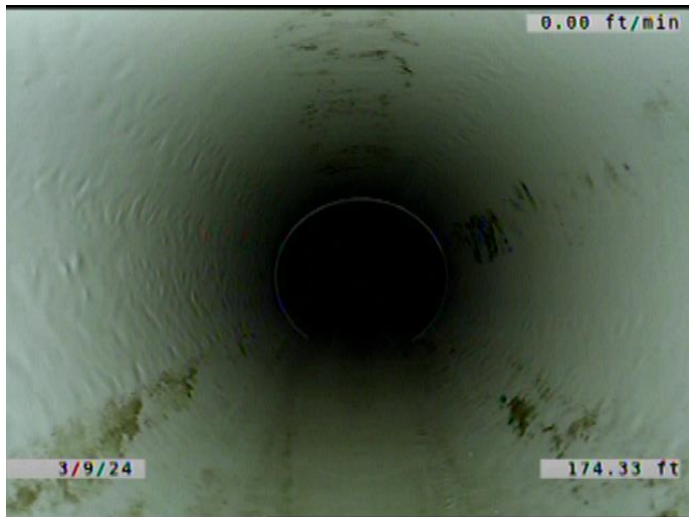
Code: **MWLS**
Description: **Miscellaneous Water Level Sag**

Distance (ft): **174.3**
Structural Grade: **2**
O&M Grade: **0**
Clock Start/From:
Clock To:
1st Value:
2nd Value:
Value Percent: **15.000**
Continuous Index: **S02**
Within 8" of Joint: **NO**
Remarks:

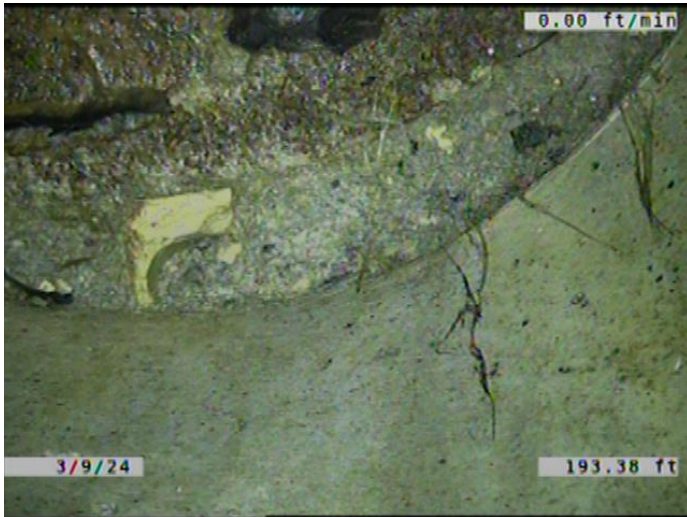
Code: **MGO**
 Description: **Miscellaneous General Observation**

Distance (ft): **193.4**
 Structural Grade: **0**
 O&M Grade: **0**
 Clock Start/From:
 Clock To:
 1st Value:
 2nd Value:
 Value Percent:
 Continuous Index:
 Within 8" of Joint: **NO**
 Remarks: **MANHOLE FRAME HAS SHIFTED. SOIL VISIBLE.**

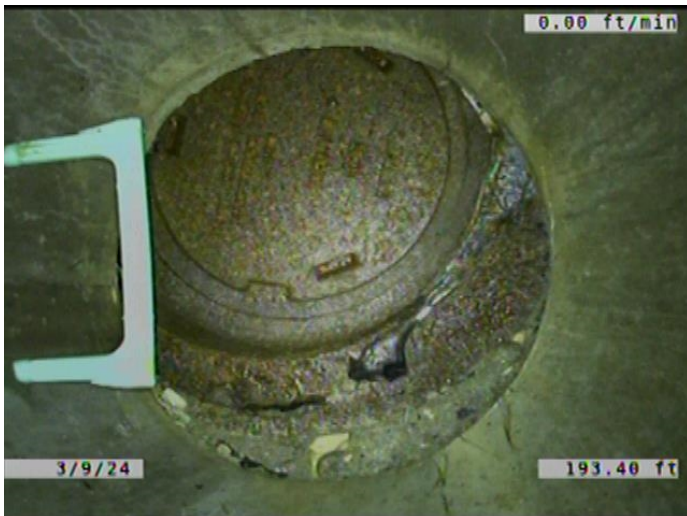
Code: **AMH**
 Description: **Manhole**

Distance (ft): **193.4**
 Structural Grade: **0**
 O&M Grade: **0**
 Clock Start/From:
 Clock To:
 1st Value:
 2nd Value:
 Value Percent:
 Continuous Index:
 Within 8" of Joint: **NO**
 Remarks: **M-704-072**
